Considerations for returning plumbing to safe use after chemical contamination

Andrew J. Whelton, Ph.D.
Civil, Environmental, and
Ecological Engineering

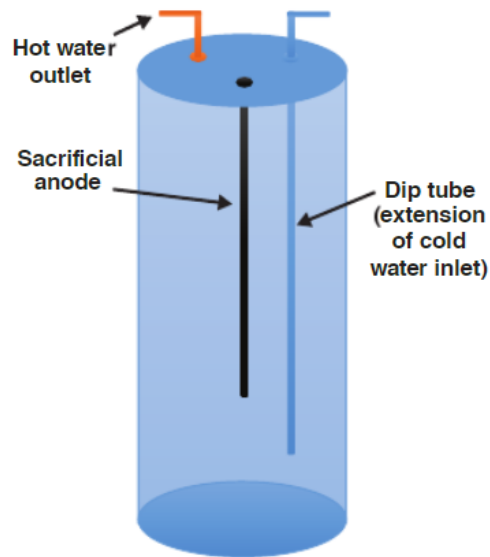
"Tallboy" stand water heater: 30–49 gal
Typical of American residences

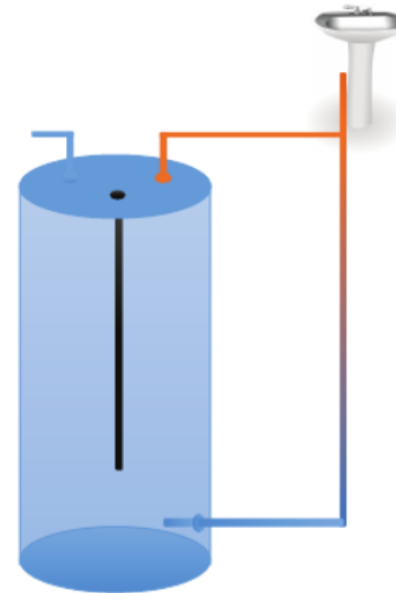
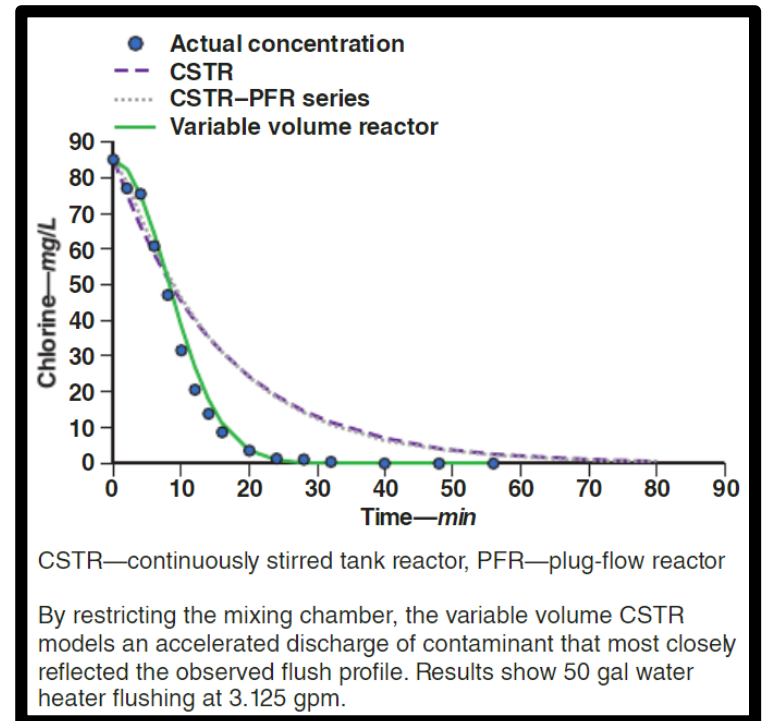
Hot water recirculation water heater
Recirculation water heater systems return cold water in the supply line to the heater, resulting in a near-instant hot water source at the tap.

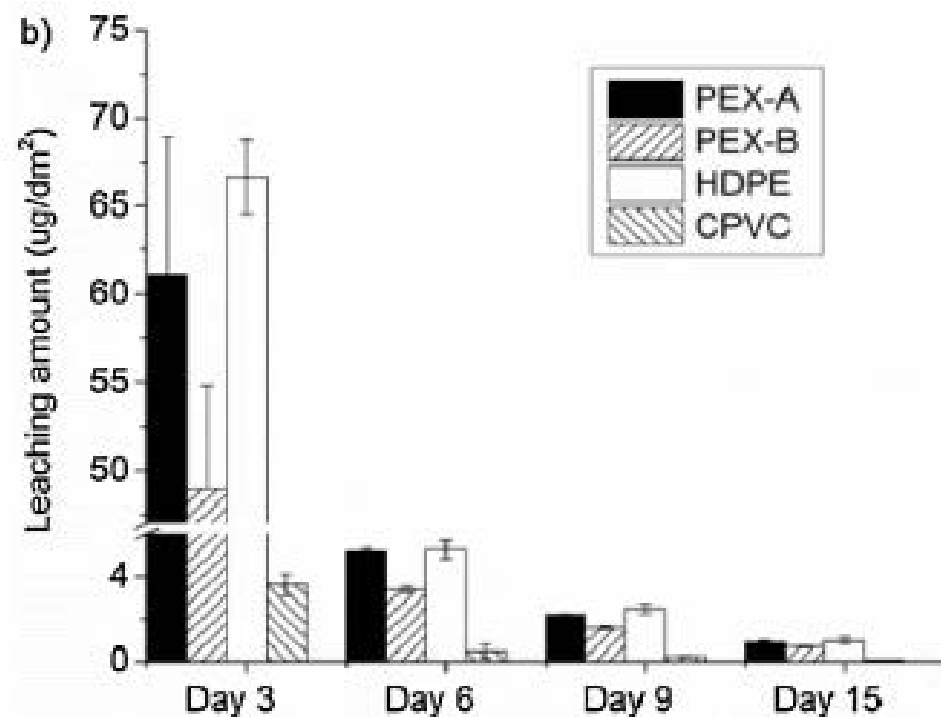
Not Considered: VOCs Diffuse In and Out of Plastic Plumbing Slowly

Surfactant-Plastic Interactions are Not Trivial

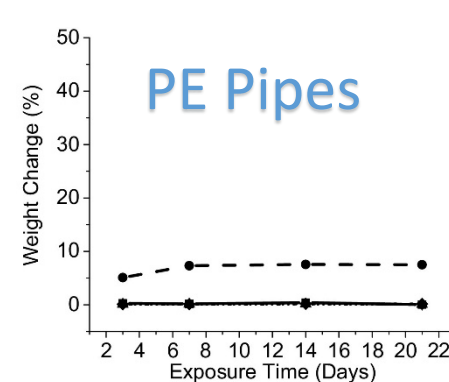
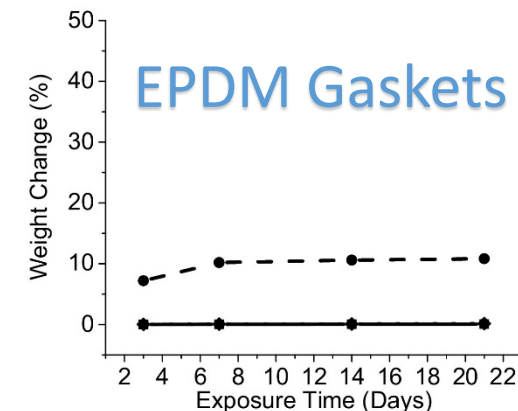
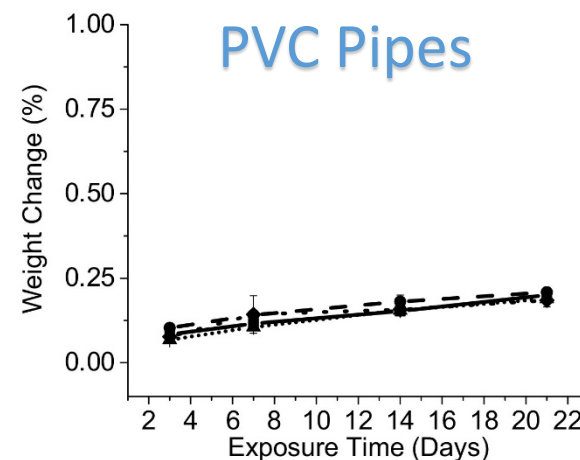
Surfactant Liquids

Alconox (●)
MAG (*)
Dawn (▲)
Tap (■)

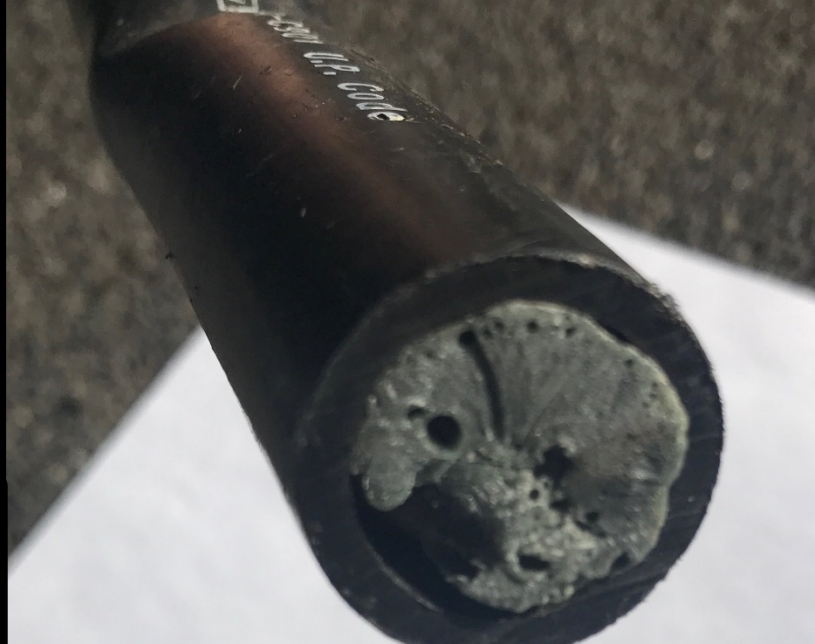
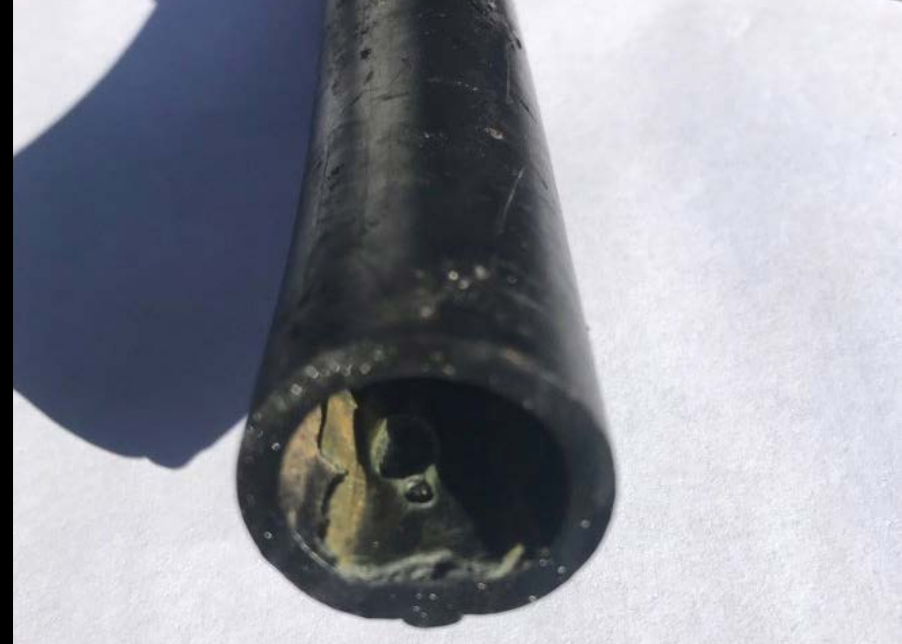
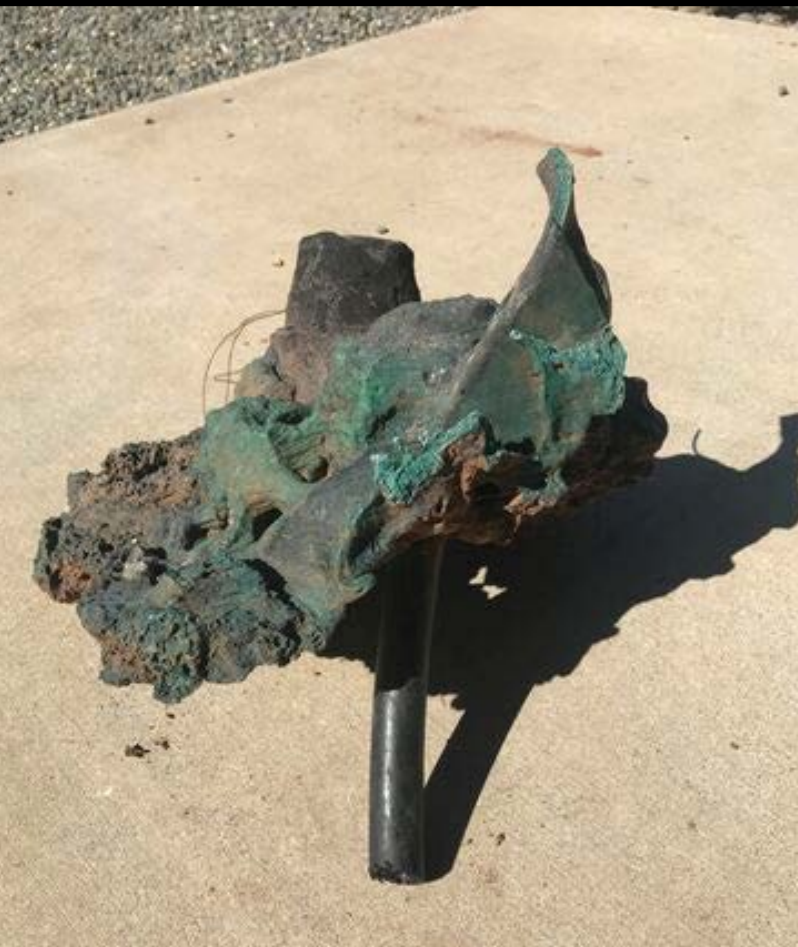
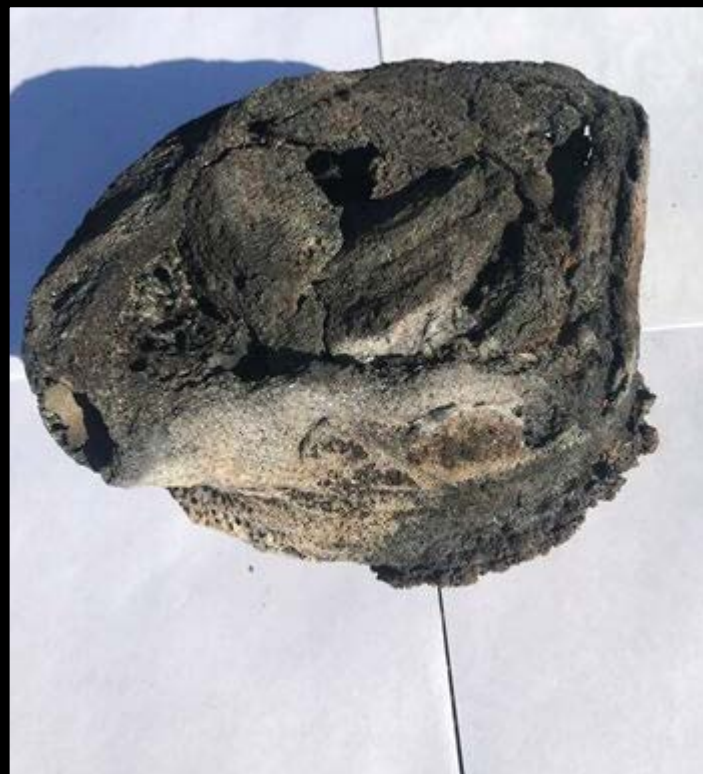
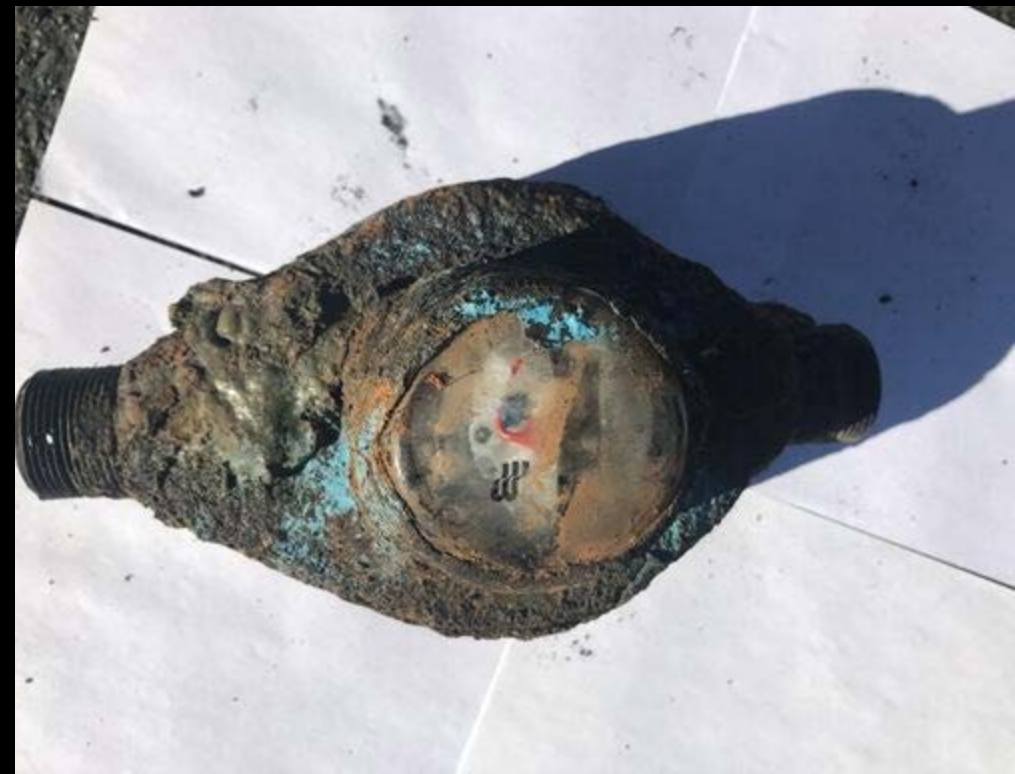
Damage

90%+ of their 172 mile
water distribution system
depressurized for hours to
weeks

100s+ of leaks

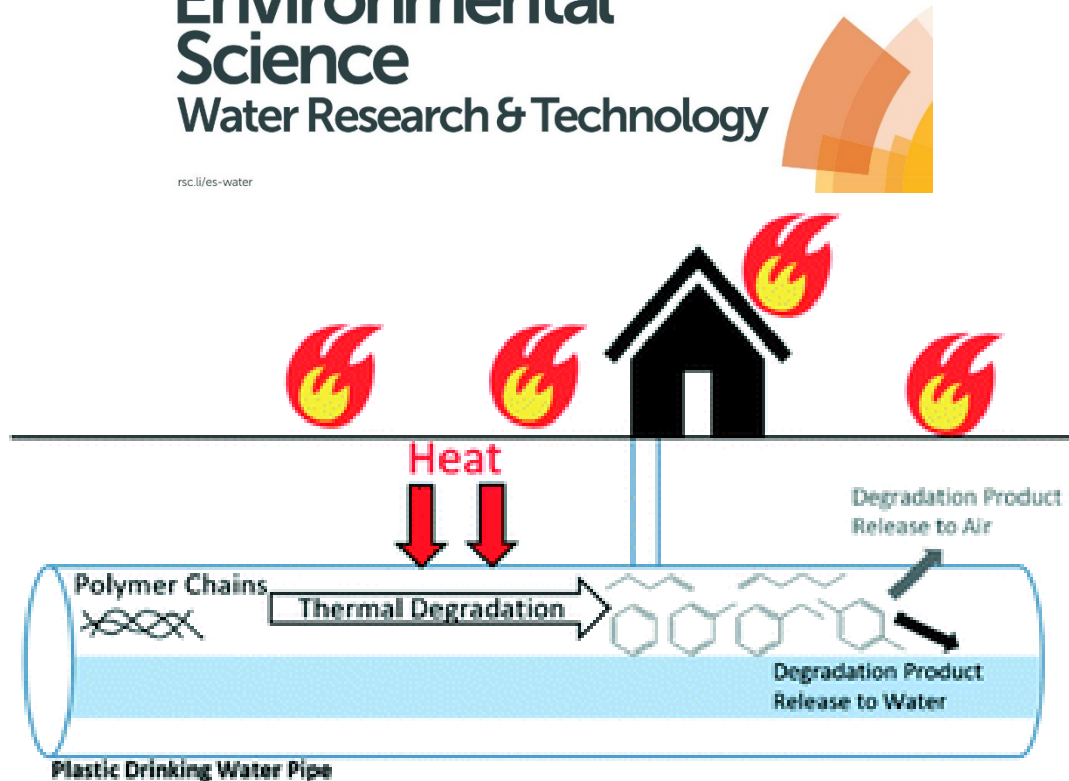
**Drinking water contamination
from the thermal degradation of
plastics: implications for wildfire
and structure fire response**

Heating new PE, PEX, PVC, CPVC, and PP pipes
< Tdeg generated VOCs and SVOCs

Benzene generated by all pipes except PP

Once plastic cooled, chemicals leached into water

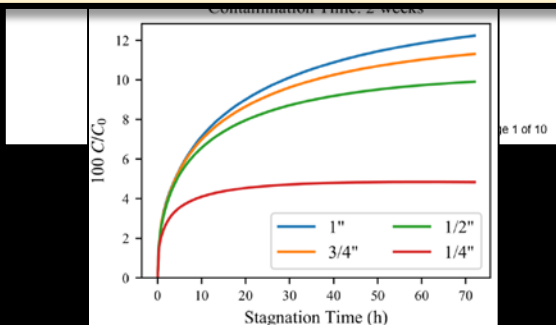
Numerical modeling:
Greater than 286 days vs.
less than 64 days of
continuous water flushing
for 1-inch HDPE service line
(Hauptert et al. 2019)

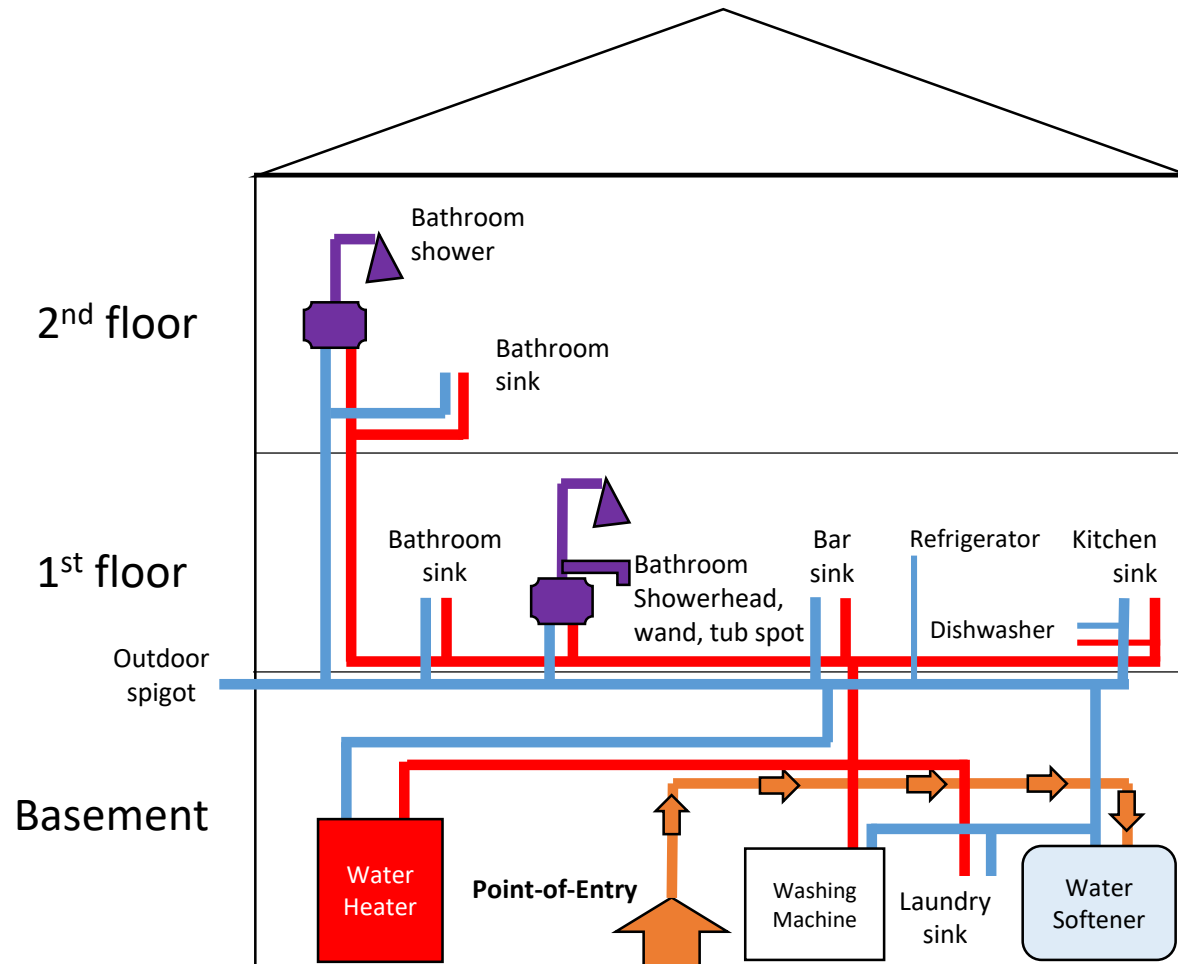
Single family home trunk and branch design with a centralized water heater

Cold and hot water flow through separate pipes
Some locations are downstream from others,
but branch off into separate pipes

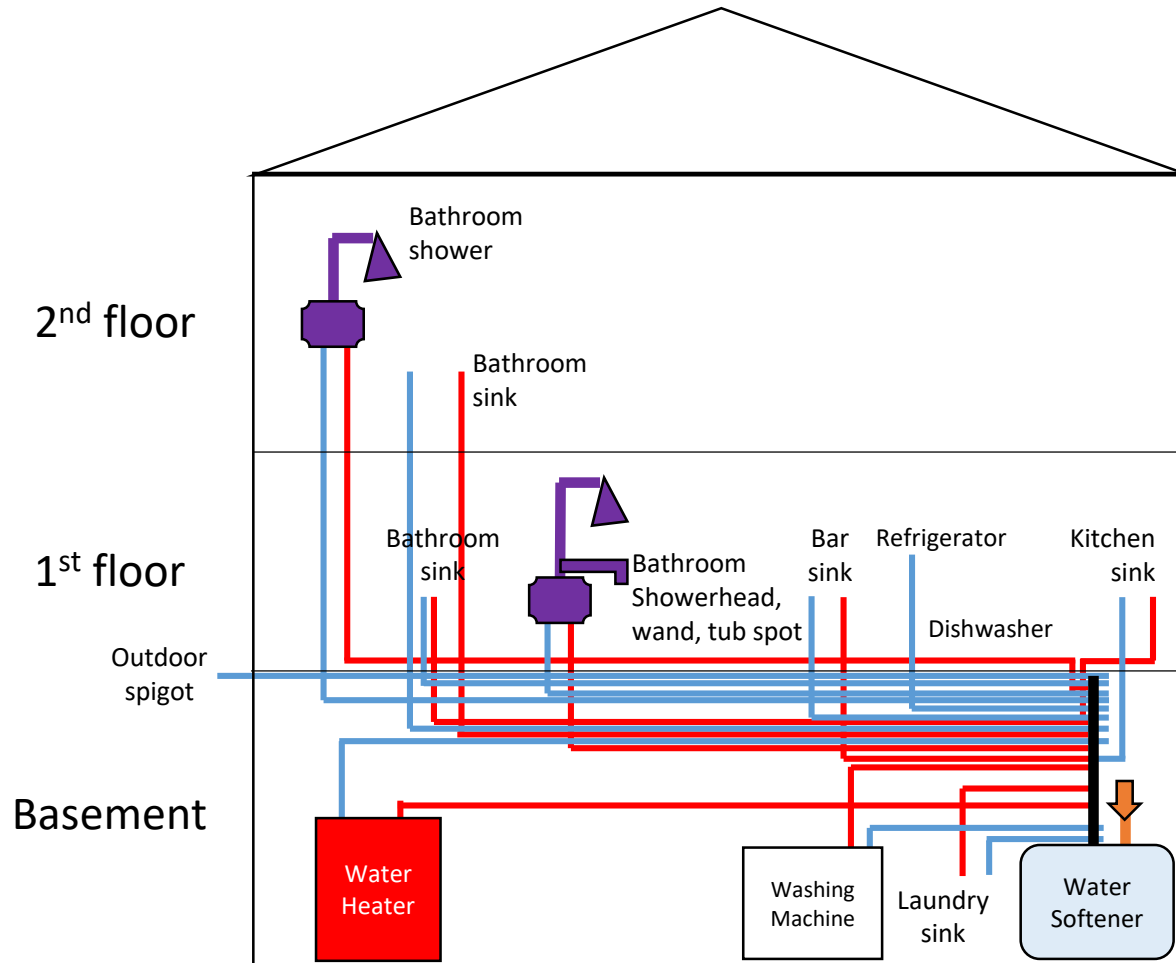
A home with PEX manifold plumbing and central water heater

Cold and hot water flow through separate pipes
Each fixture has it's own isolated pipe
No 2 pipes convey the same water
Co-located shutoff location for all each fixture
Smaller diameter pipes compared to T/B design

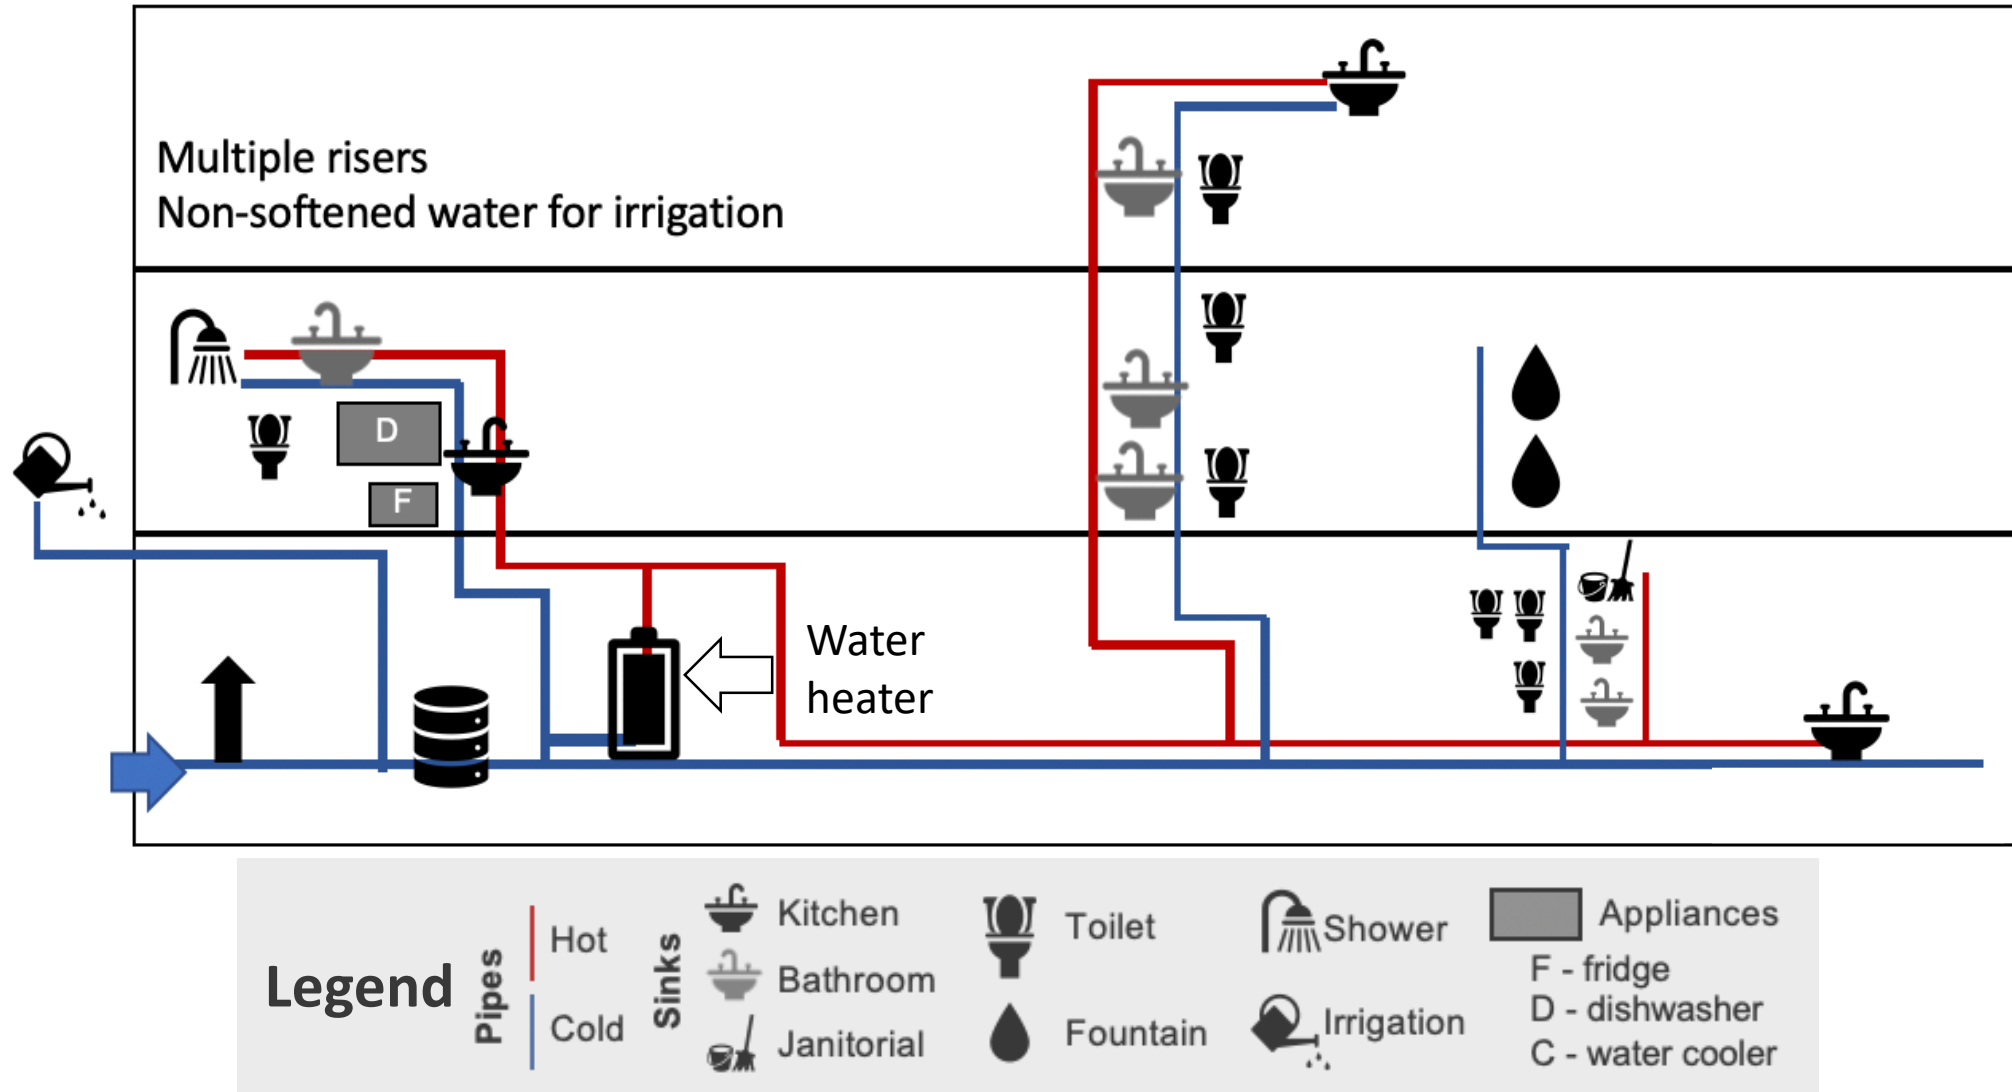
A 3 story office building with 3 risers and a centralized water heater
