# Drinking Water Quality Changes at a Middle School Under Low vs. Normal Water Use Conditions

June 12, 2019  
ACE 19

- LEED certified, 7 Years Old
- 800 students
- Public water system: wellfield and river
- Chloraminated water
- Copper plumbing
- Hot water recirculation
- Water saving devices

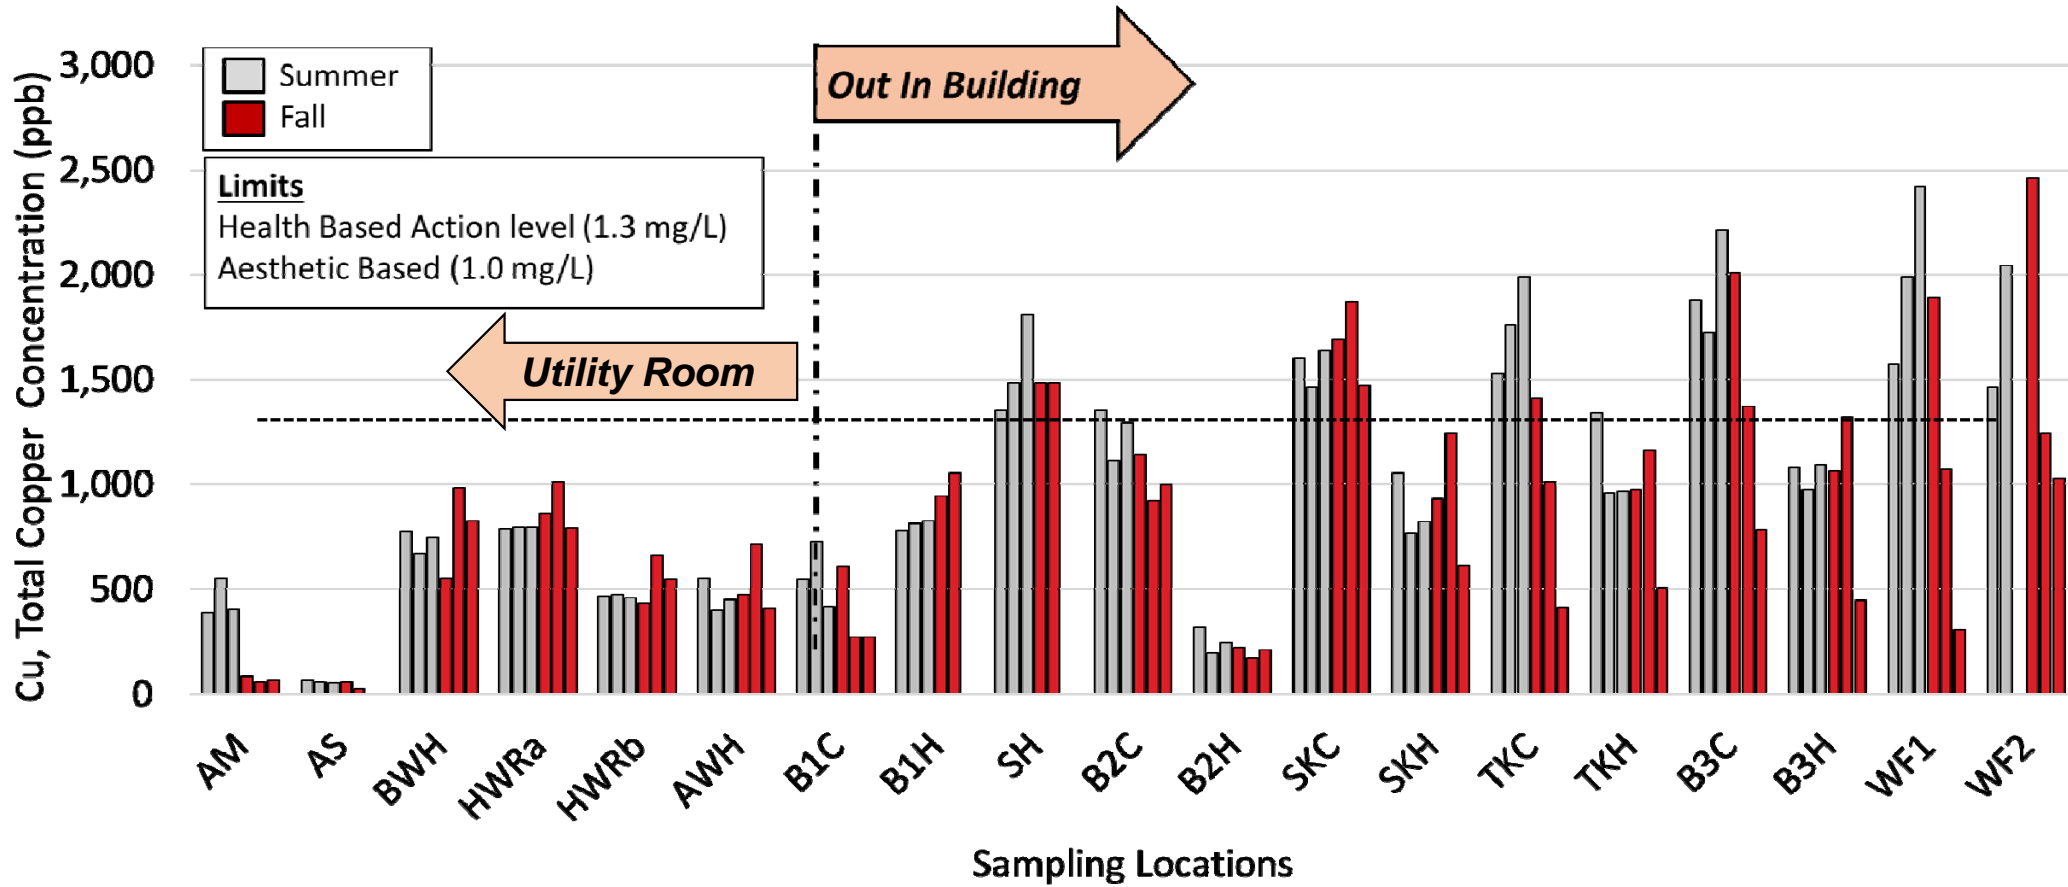
# Chemical Water Quality Initial Results - Copper

**Cu exceed action level mostly in cold water samples**

Routine Sampling Locations in October	1 <sup>st</sup> grab (mg/L)	2 <sup>nd</sup> grab (mg/L)	Our Experience with Locations
B2C	0.996	1.470	3 of 7 prior samples exceeded the AL
SKC	1.470	0.561	7 of 7 prior samples exceeded the AL

None of our other routine locations exceeded the copper AL during the October sampling event

New Sampling Locations in October	1 <sup>st</sup> grab (mg/L)	2 <sup>nd</sup> grab (mg/L)
SRS - shower room right sink	0.123	0.149
SLS - shower room left sink	0.479	0.164
B2CR - bathroom 2 cold right	0.949	1.403
B2CL - bathroom 2 cold left	1.164	1.452
SKD - student kitchen sink D	1.312	0.832
SKF - student kitchen sink F	1.580	0.529
FK - faculty kitchen - A108	0.831	0.120
ARRS - art room right sink - F105	0.424	0.638
WF3 - water fountain 3 - F112 (coral room)	1.773	1.360
WF4 - water fountain 4 - F115W	1.047	0.902
WF5 - water fountain 5 - B103B	0.945	0.374
ABS - auditorium back sink	1.141	1.314
B3LS - bathroom 3 left sink	0.898	0.866
B4 - bathroom 4 - C124G - next to sink 2	1.141	0.868
B5 - bathroom 5 - B103B	0.275	0.216
B6 - bathroom 6 - B124B	1.097	0.819
B7 - bathroom 7 - B112W - staff bathroom	0.649	0.617
B8 - bathroom 8 - C112W - staff bathroom	0.697	0.646
B9 - bathroom 9 - A108M - in office	0.142	0.105

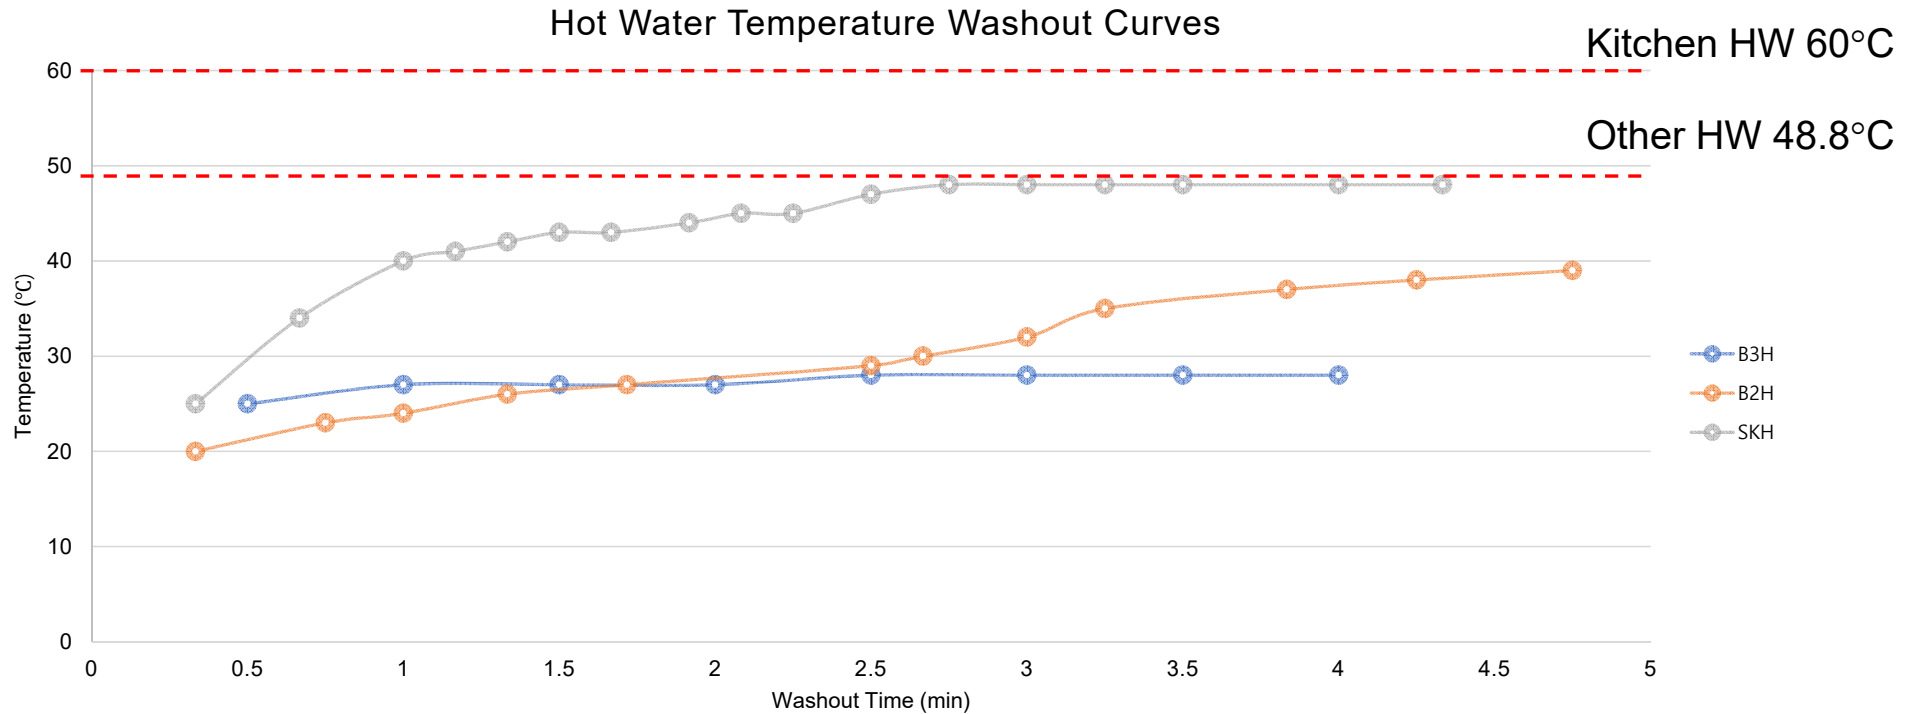
Delivery length		Return length
AM to B3H	509.97 ft	B3H to HWRC	496.75 ft
AM to B2H	252.002 ft	B2H to HWRC	215.49 ft
AM to SKH	267.75 ft	SKH to HWRC	282.3 ft
