# Water Chemistry and Microbiology Changes as Plumbing Ages

**By:** Maryam Salehi, Andrew Whelton, Mohammad Abouali,  
Mian Wang, Zhi Zhou, Amir Pouyan Nejadhashemi,  
Jade Mitchell, Stephen Caskey

*Lyles School of Civil Engineering, Division of Ecological and  
Environmental Engineering & School of Mechanical Engineering  
**Purdue University***

**Dec 11<sup>th</sup>, 2017**

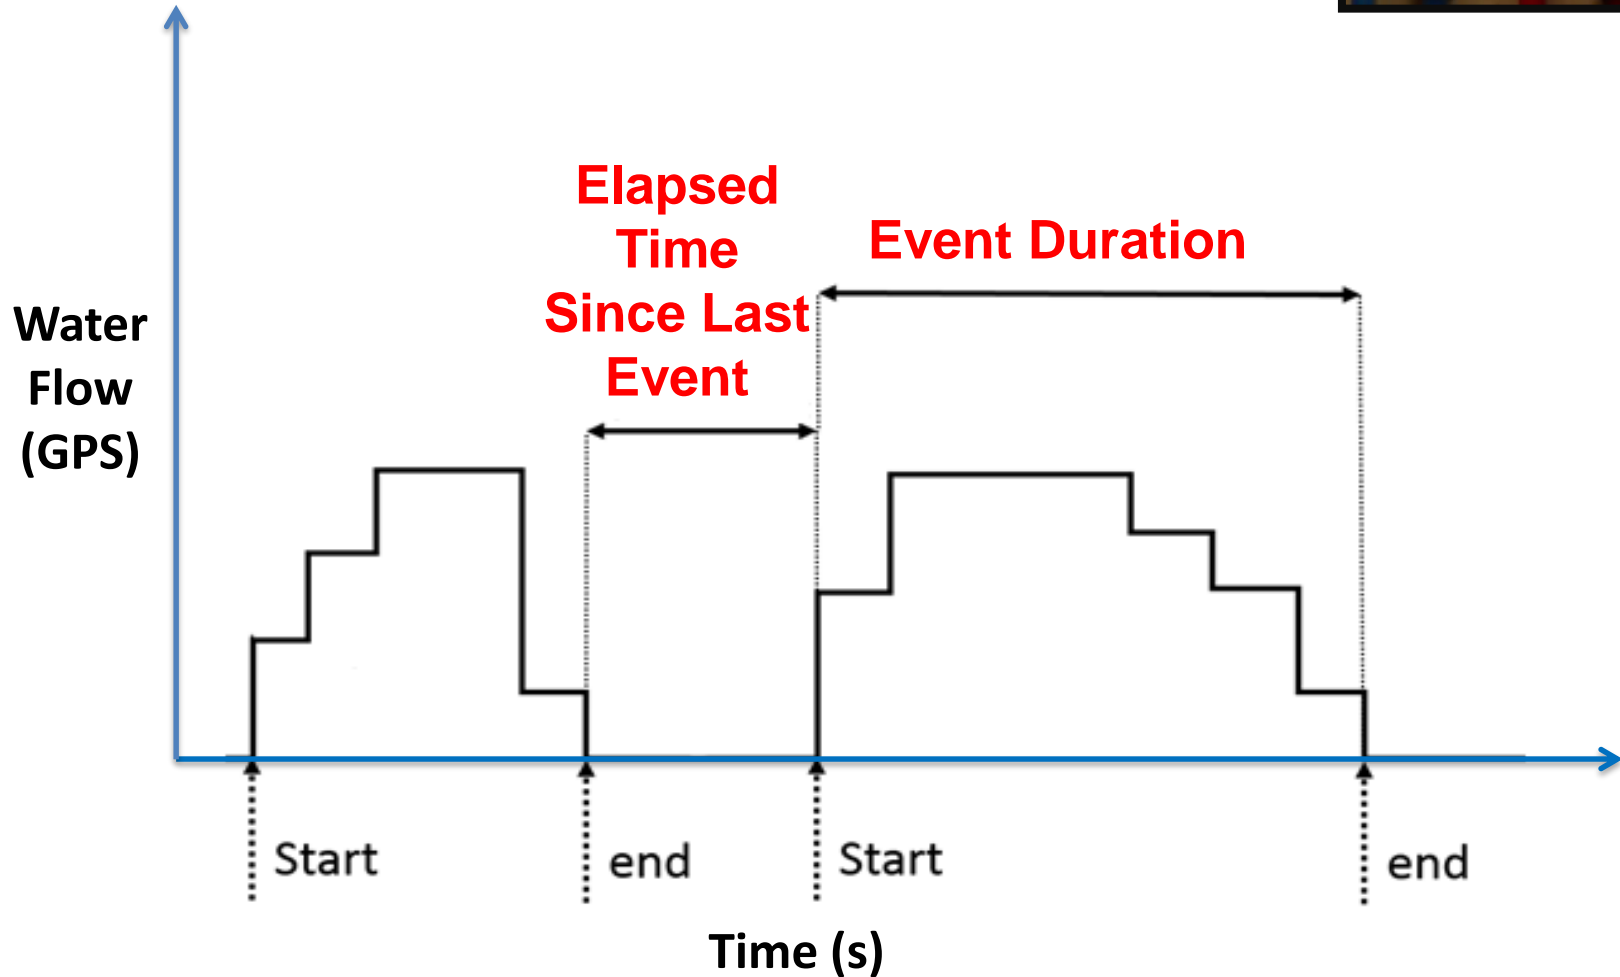
# Water Usage Analysis

**64,891,484 data points**

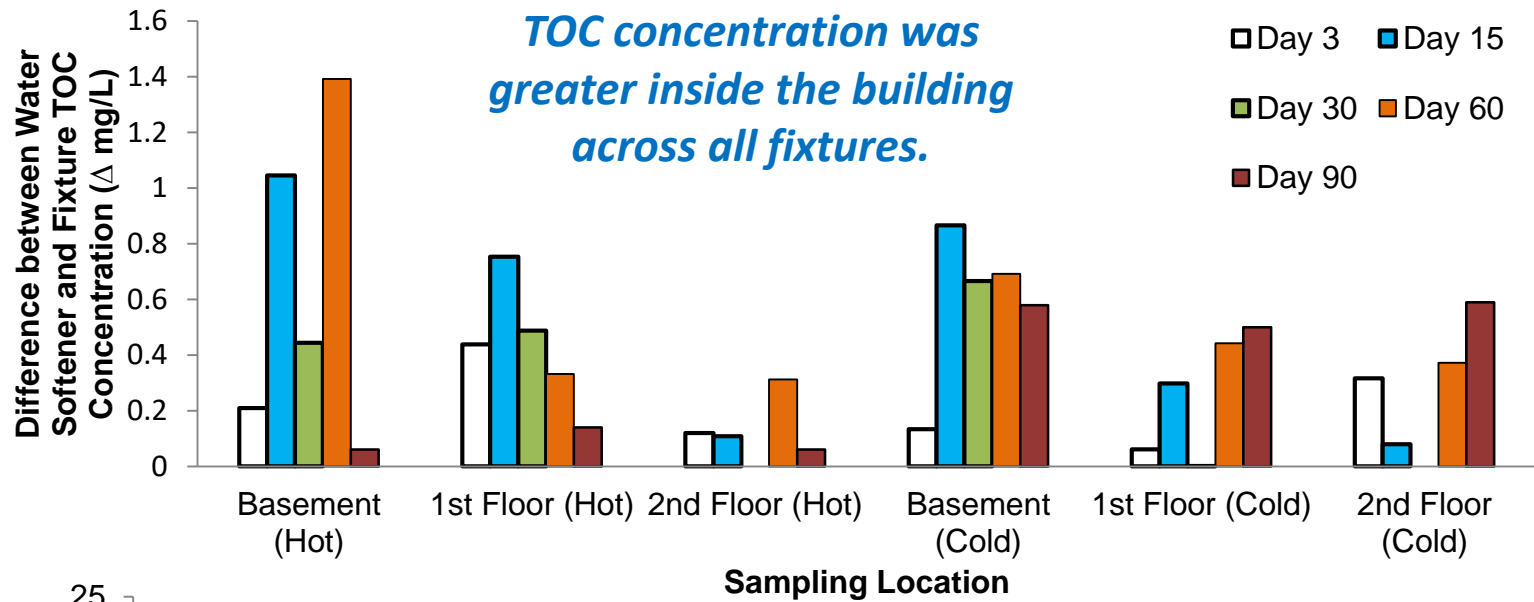
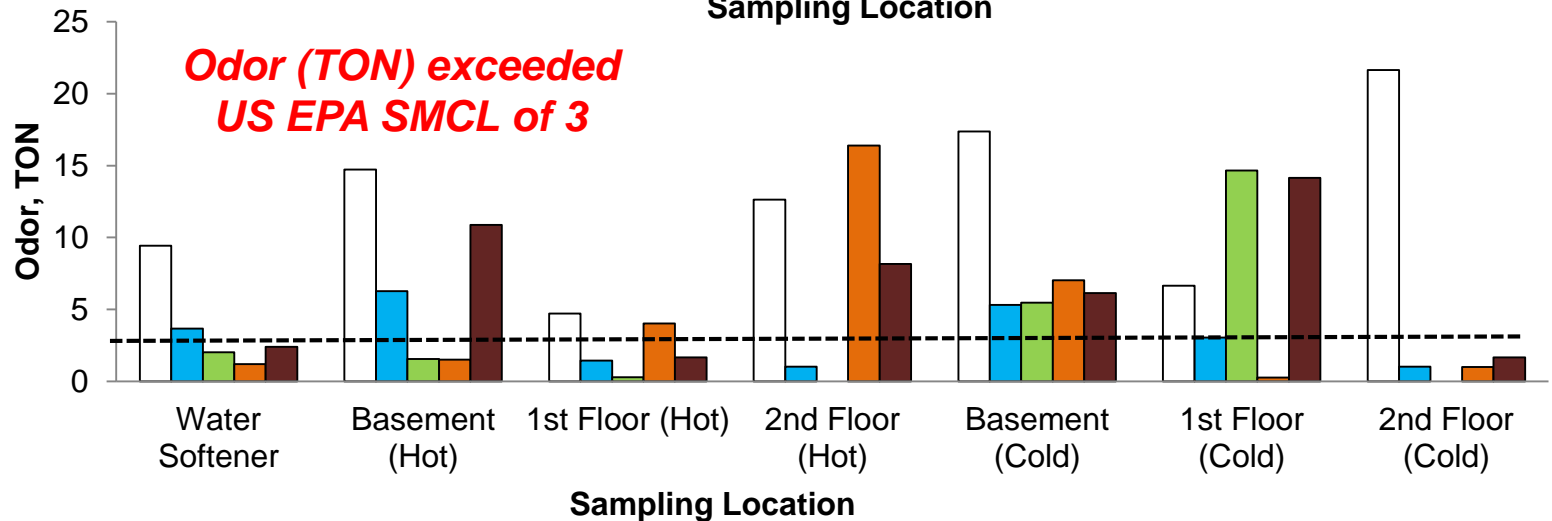
# TOC Concentration Increased Inside the Building

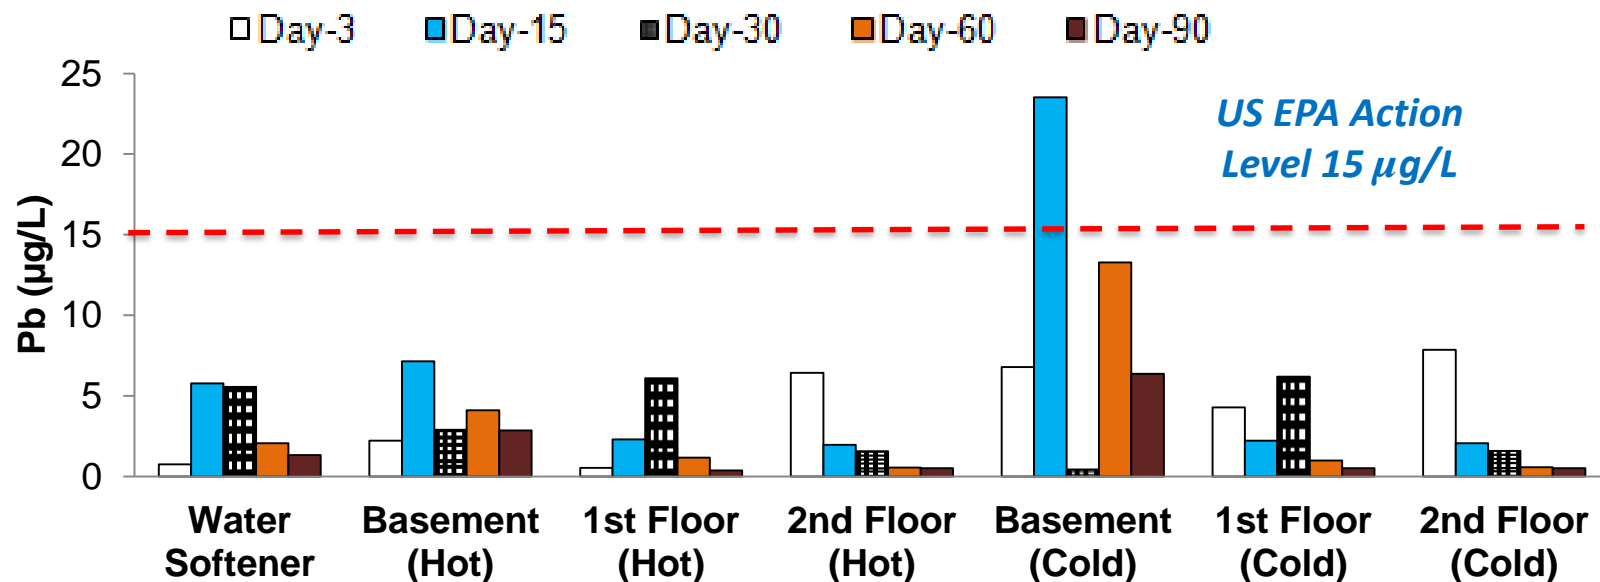
## Several Heavy Metals with Health & Aesthetic Limits were Detected

The **basement fixture brass needle valve** may have caused maximum Zn (5.9 mg/L), Fe (4.1 mg/L), and Pb (23 µg/L) levels compared to other fixture water samples.

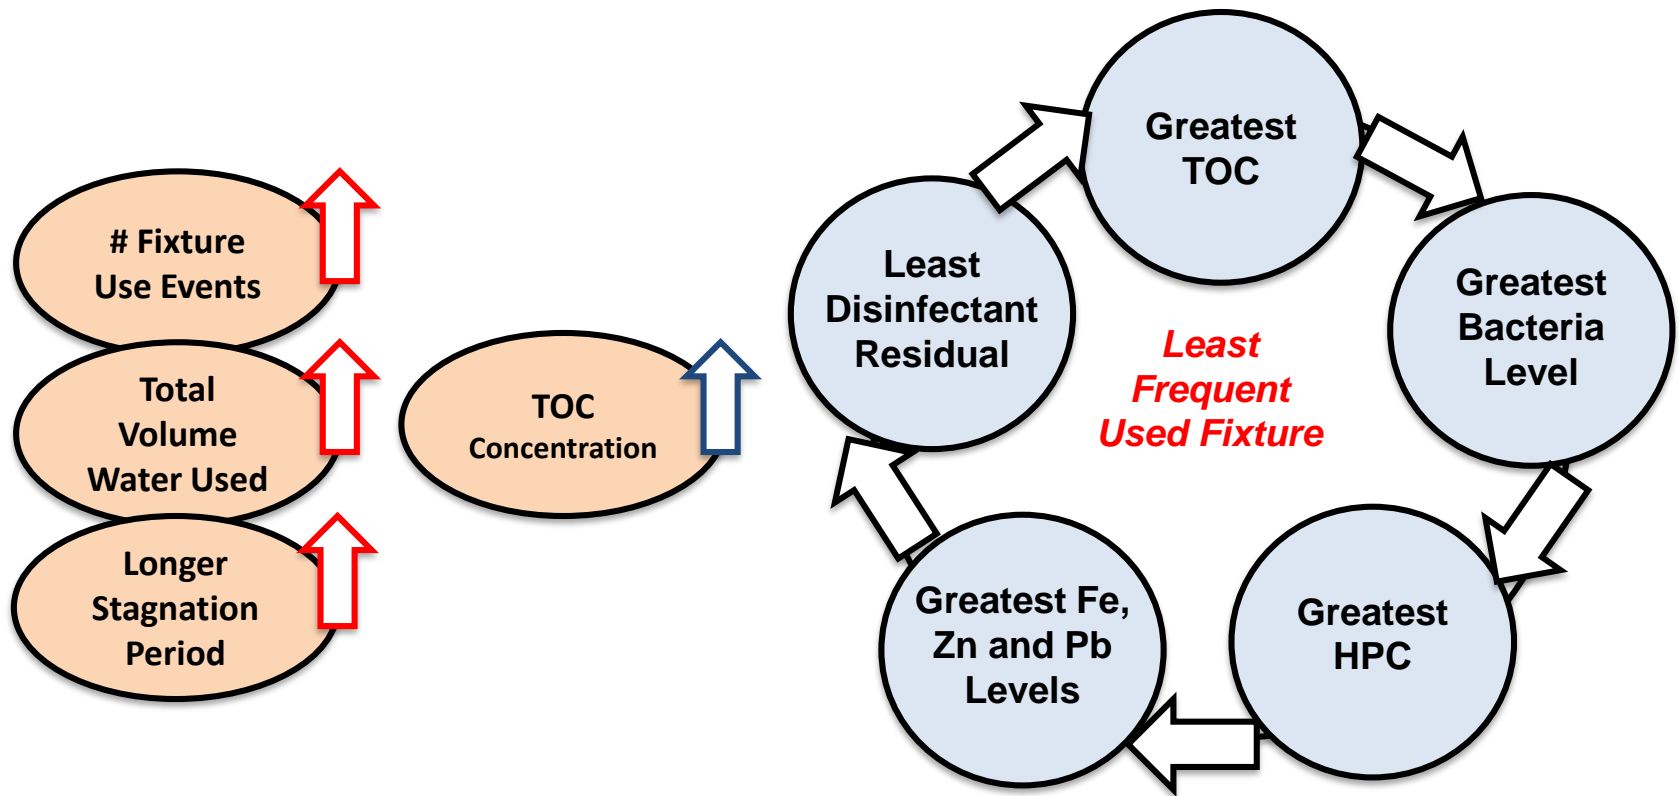
# Water Use Influenced Chemical & Microbial Levels at each Fixture
