Preserving Water Quality in Building Design

November, 2018 Andrew J. Whelton, Ph.D.

Project Goal and Objectives

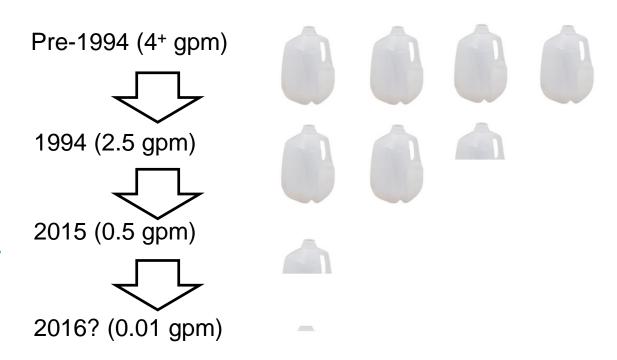
Water Use has **Decreased** From **Lower-Flow Faucets**

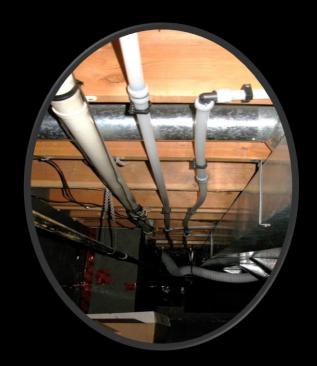
Leaching can provide organisms food, pH affected
Leaching differs across and within pipe brands
No long-term leaching studies
Metal fittings can release heavy metals
Plastics affect lead and copper levels
Compounds causing taste and odors not identified

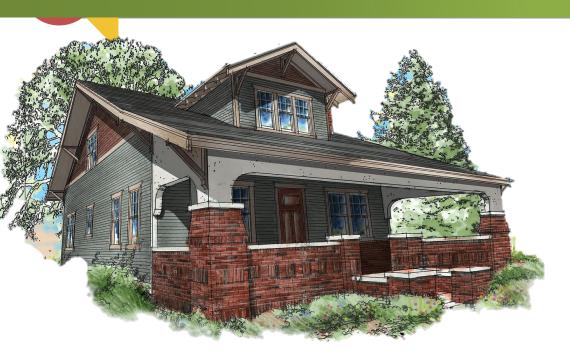
3 Bedroom, 1.5 baths
Renovated 2014
Solar panels
Net-zero waste
Energy efficient appliances
Rainwater catchment
Greywater recycling
Online monitors throughout bldg

ReNEWW House = Retrofit Net Zero Energy, Water, and Waste

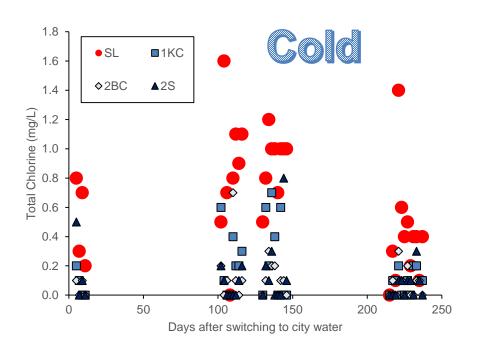
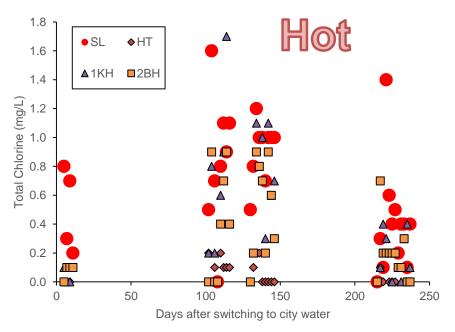
Snapshot of Preliminary Total Chlorine Results

(Service line = red)

not found in more than 50% of water samples exiting the water heater, at the 1st floor kitchen sink cold, 2nd floor bathroom sink cold, and 2nd floor shower

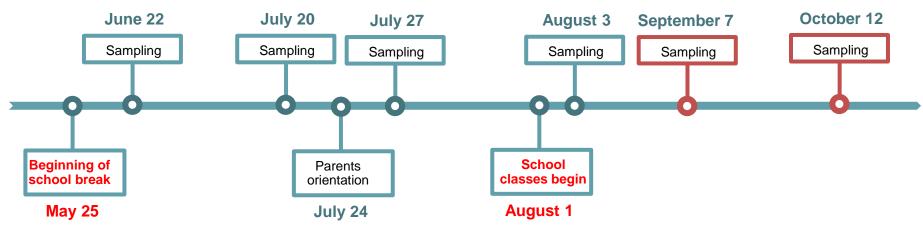
7 year old LEED school receives chloraminated water from a public water system; Copper plumbing, water softener, hot water recirculation system - 4 zones.

Service line, staff kitchens, bathrooms, showers, classroom, water bubblers

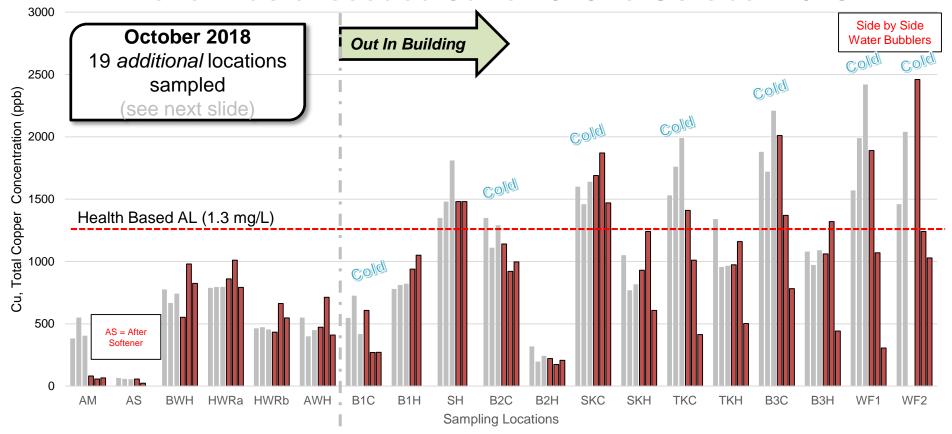
More than 4,500 tests: Copper drinking water action level was exceeded June 2018 to October 2018

Routine Sampling	1 st grab	2 nd grab	Our Experience with Locations		New Sampling Locations in October	1 st grab (mg/L)	2 nd grab (mg/L)
Locations in October	(mg/L)	(mg/L)			SRS - shower room right sink	0.123	0.149
B2C	0.996	1.470	3 of 7 prior samples exceeded the AL		SLS - shower room left sink	0.479	0.164
				3	B2CR - bathroom 2 cold right	0.949	1.403
					B2CL - bathroom 2 cold left	1.164	1.452
SKC	1.470	0.561	7 of 7 prior samples exceeded the AL	3	SKD - student kitchen sink D	1.32	0.832
					SKF - student kitchen sink F	1.58	0.529
None of our other routine locations exceeded the copper AL FK - faculty kitchen - A108						0.831	0.120
during the October sampling event					ARRS - art room right sink - F105	0.424	0.638
WF3 - water fountain 3 - F112						1.773	1.360
of 19 Routine Sampling Locations					WF4 - water fountain 4 - F115W	1.047	0.902
					WF5 - water fountain 5 - B103B	0.945	0.374
					ABS - auditorium back sink	1.141	1.314

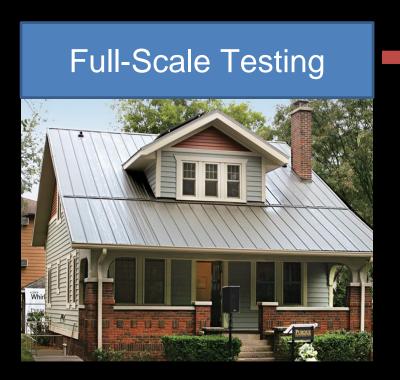
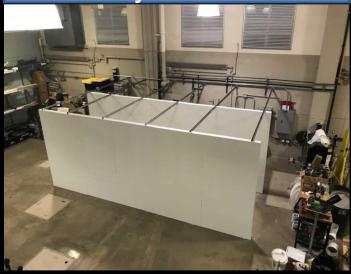
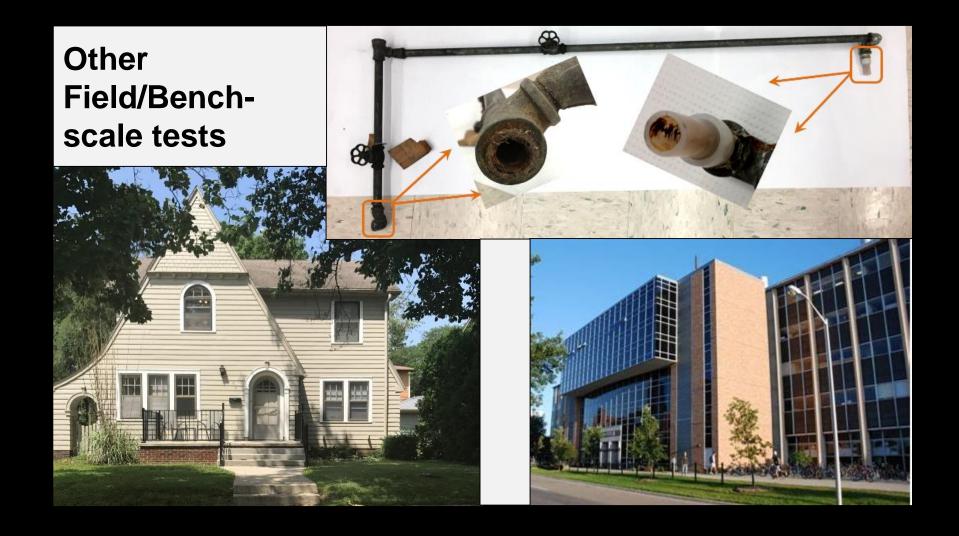
Our Plumbing Testing Facility is Ready: Plumbing, Water Use, and Water Quality Relationships
