### **Application of TDR Cables for Landslide Monitoring**

Miau-Bin Su and Chien-Hsin Liao

A landslide site in central Taiwan was studied using TDR technology. It is a part of the Li-Shan landslide remediation project conducted for the last 15 years. Total affected area for this landslide was estimated larger than 2 kilometers square and has a major central cross-island road passing through it.

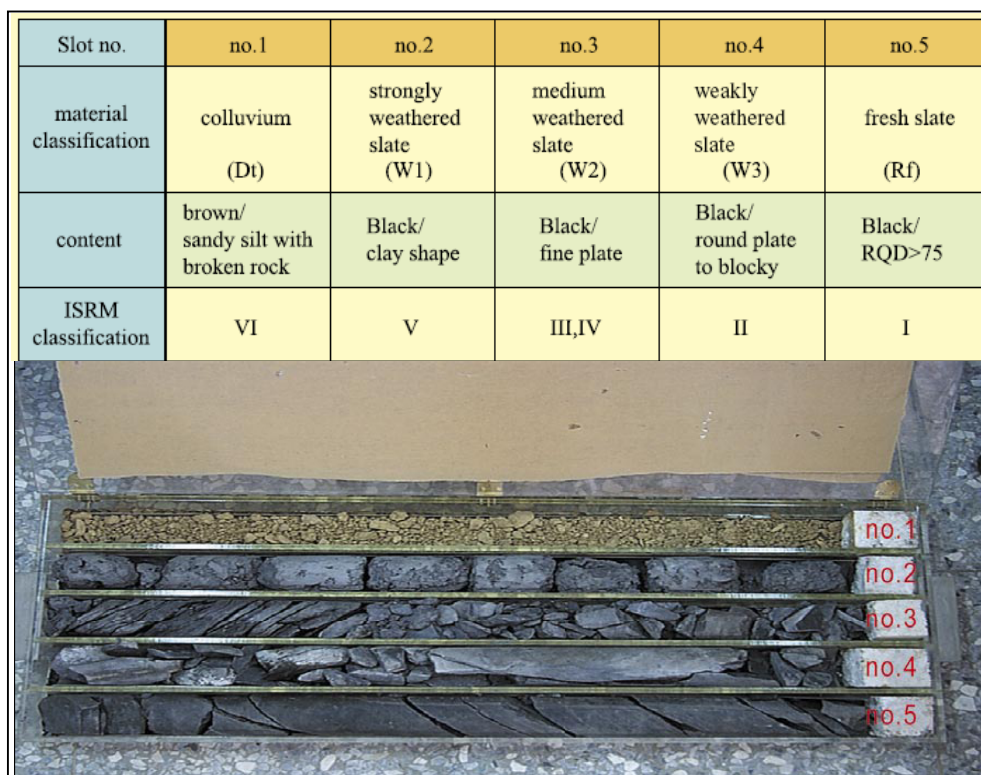
Due to the high precipitation, the erosion rate in this area is high. Therefore there are different extent weathered slate formations covering the slope surfaces. For the purpose of stability study, rock are classified into 5 types, namely colluvium, strongly weathered slate, medium weathered slate, weakly weathered slate, and fresh slate. Fig.2 gives a picture of the geo-materials.

Fig. 2 Classification of Geo-materials

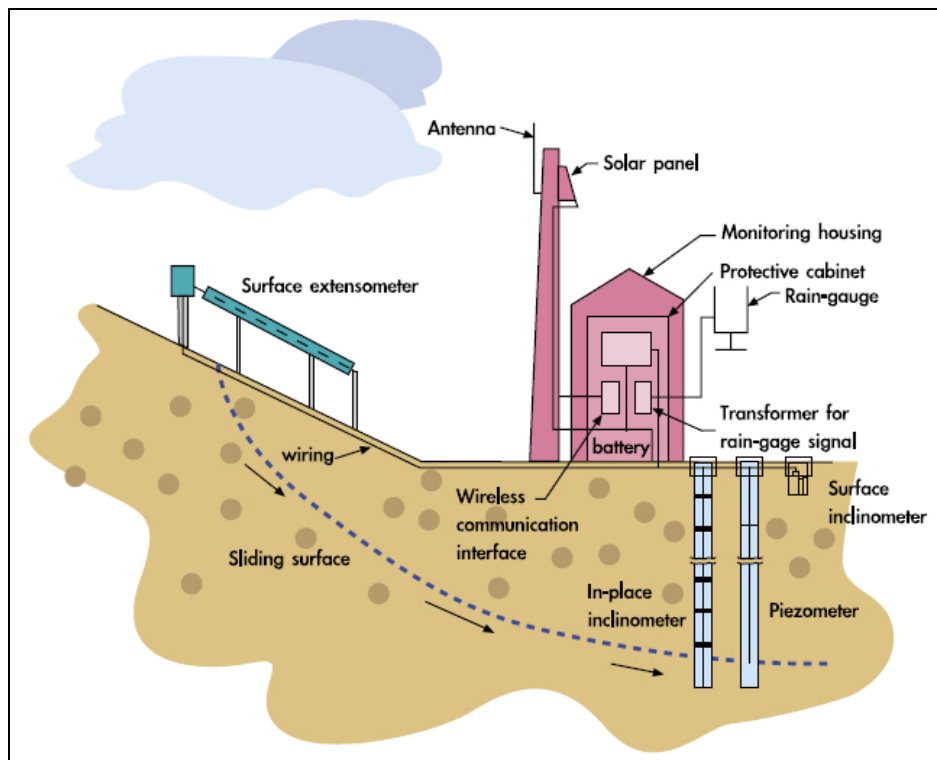
Eight monitoring stations were set up in this area. Each station was equipped with facilities such as the piezometer for measuring the groundwater level, the inclinometer for monitoring the ground deformation, and the extensometer for detecting the surface movement. A picture of schematic of automatic monitoring system is given in Fig. 3.

Fig. 3 Schematic of automatic monitoring system applied in Li-shan landslide area

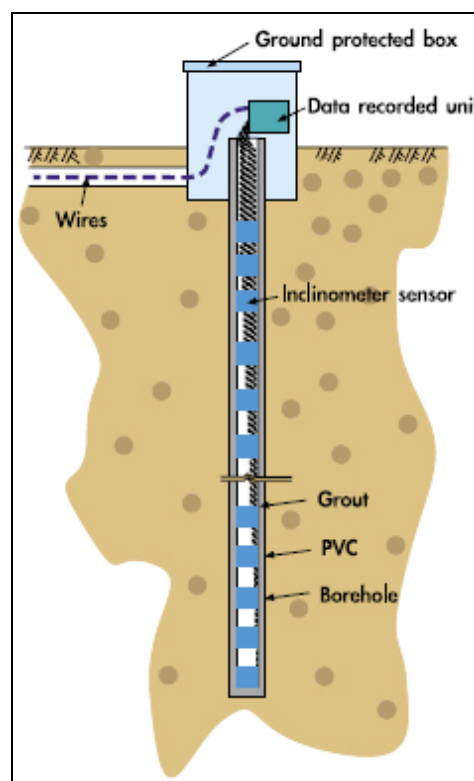
The sensor packages are spaced along a standard grooved inclinometer as shown in Fig.4. The sensors are aligned and secured in the casing by spring-loaded wheels, which fit the casing grooves. Readings could be obtained by measuring the change in tilt of the sensor, and then multiply it with the gauge length or spacing between sensors. The results are expressed as the relative displacement of each sensor; and these relative displacements can be summed to determine the total displacement at each sensor. The maximum deflection range is between  $15^\circ$  and  $30^\circ$ , and the precision is  $0.01^\circ$ .

Fig.4 Setup of probe inclinometer

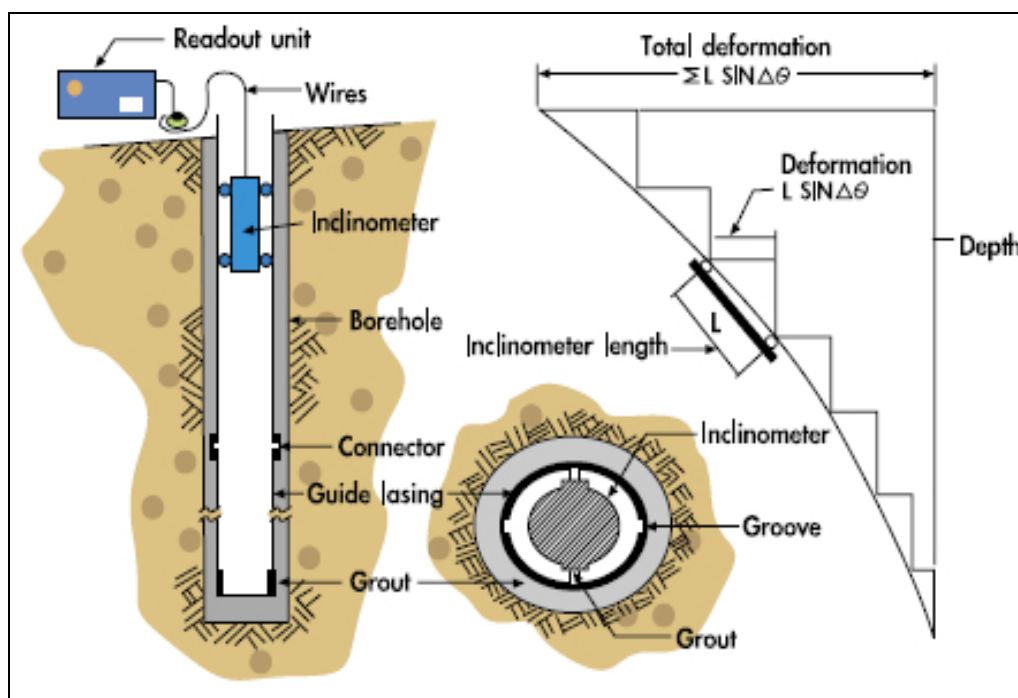
The probe inclinometer consisted of four components, which includes the guide casing, probe sensor, control cable or wire, and the portable control and readout unit as shown in Fig. 5. The probe sensor is lowered on an accurately marked cable, its wheels following the oriented slots of the guide casing. The response to slope changes in the casing could be monitored and recorded on the readout unit manually or automatically.

Fig.5 Sketch of probe inclinometer with manual readout

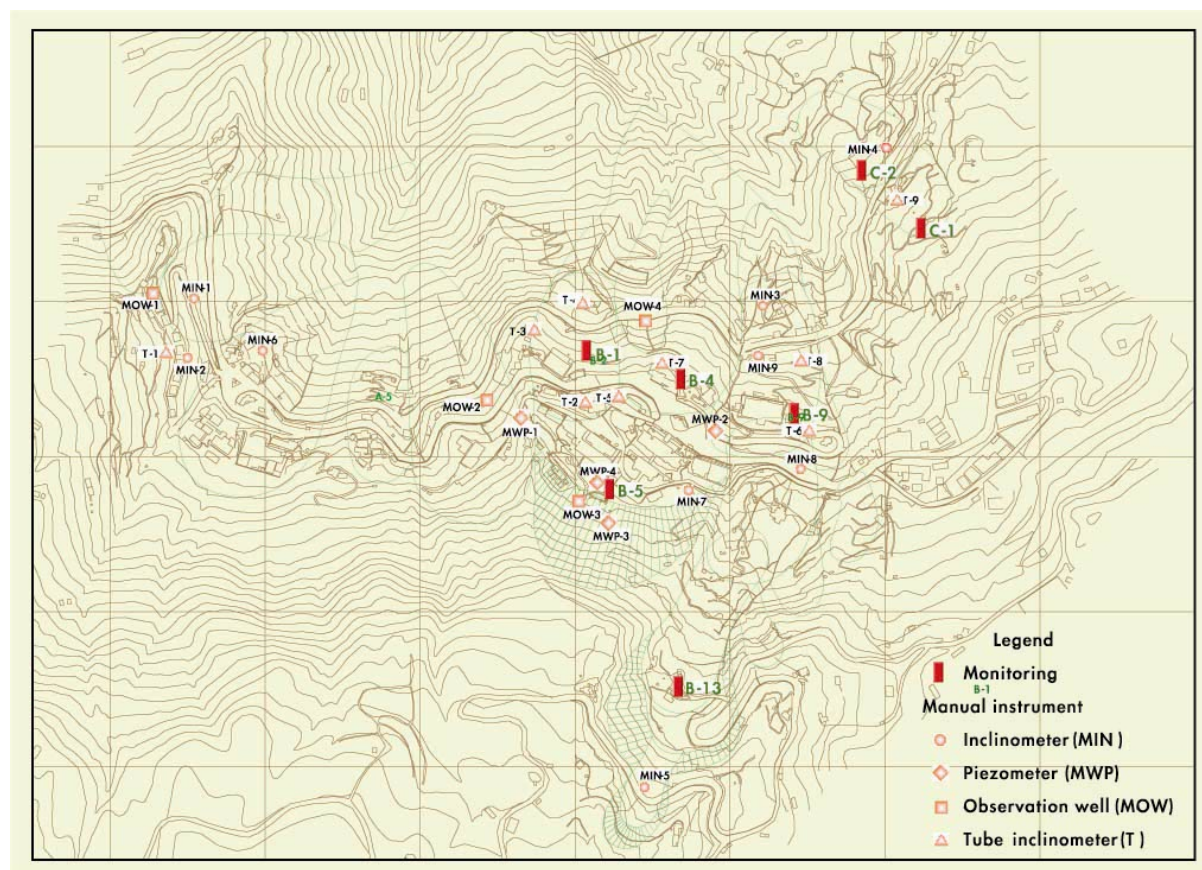
Five TDR coaxial cable were installed in bore-hole in some of the monitoring station. Fig. 6 shows the location for the monitoring stations. Waveforms recorded from 4 stations are presented in here for discussing( see Fig. 7, 8, 9, 10). Cables were grouted within a PVC pipe as the protective sleeves. The PVC pipes had multiple hole predrilled so grout can fill up the space between bore hole and PVC pipe as well as the space between PVC pipe and coaxial cable.

Fig. 6 Location map of monitoring station

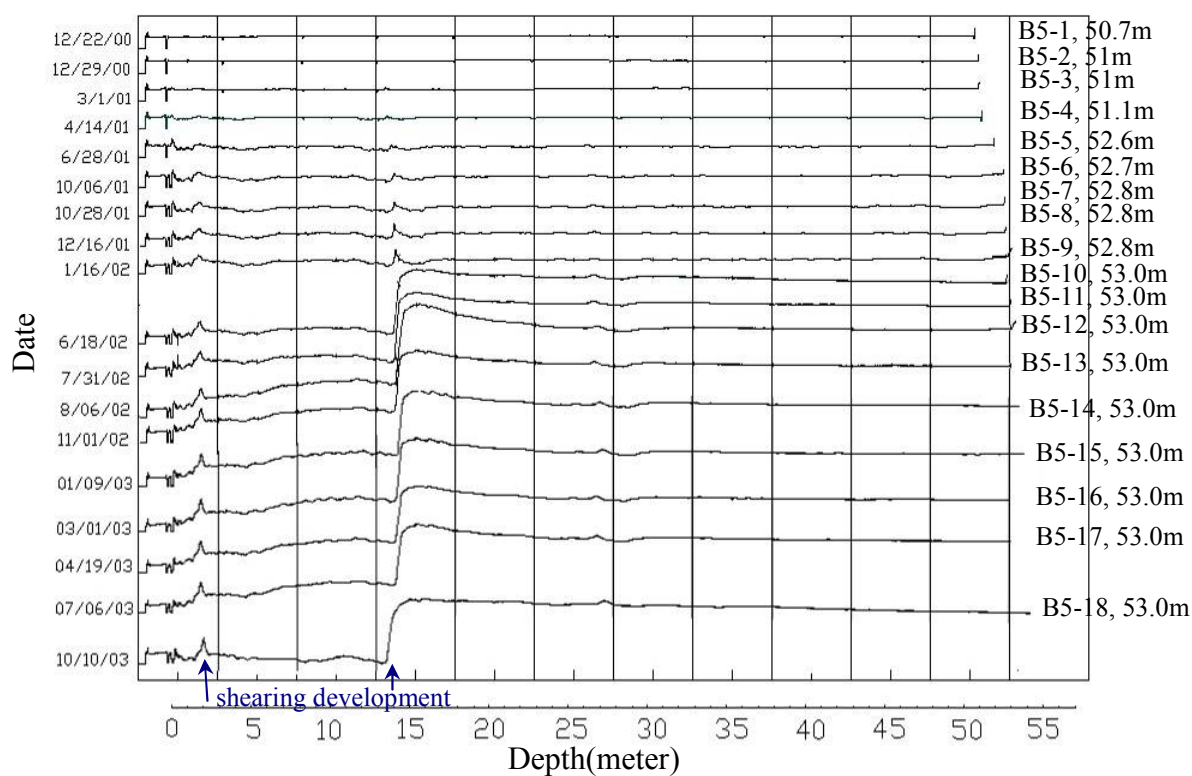
Fig.7 Recorded waveform at B-5 TDR monitoring station

As can be seen from recorded waveforms, shearing development at different depth are quite clear from a small change to total reflection of transmitted wave. Locations of shear plane are compared with boring-log. Highly weathered slate were always presented as the potential sliding surface as in all four record.

As marked at the end of each waveform, length of the waveform presented showed extension of the cable length as shearing occurred. These increase all coming from cable deformation or there's some kind of electrical effect caused by change of cable characteristic impedance after cable deformation.

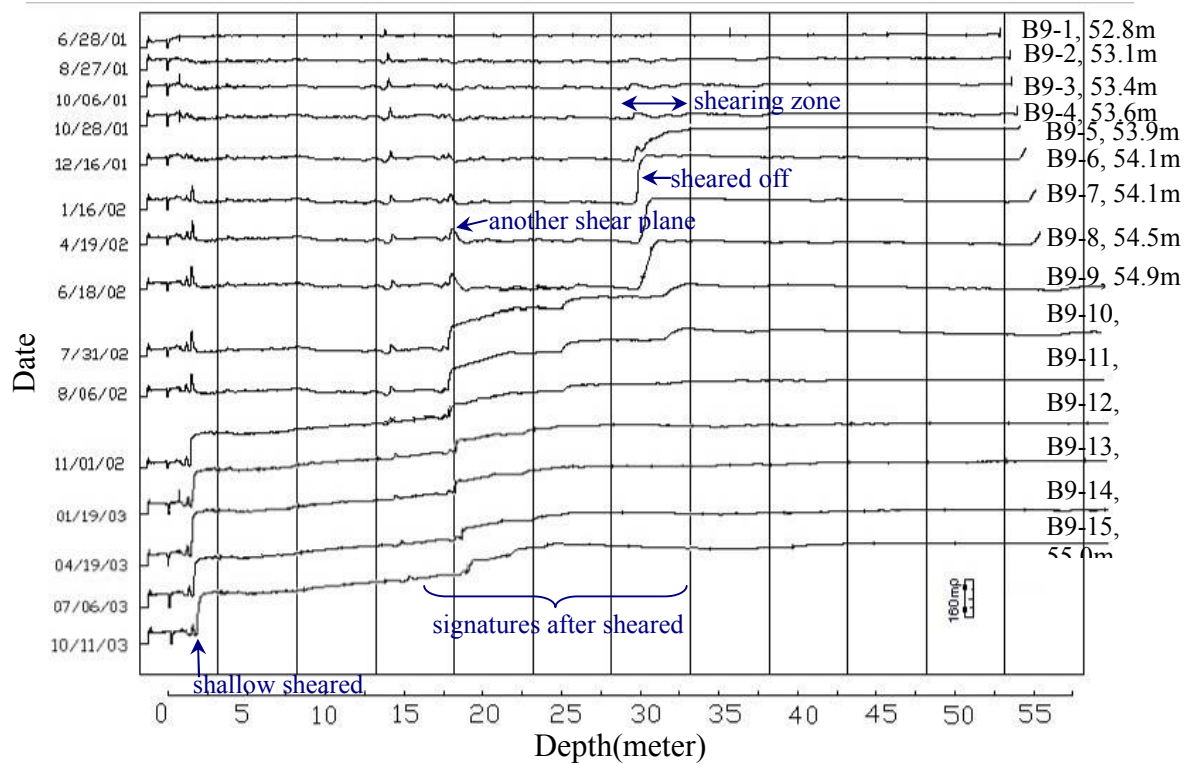
Fig.8 Recorded waveform at B-9 TDR monitoring station

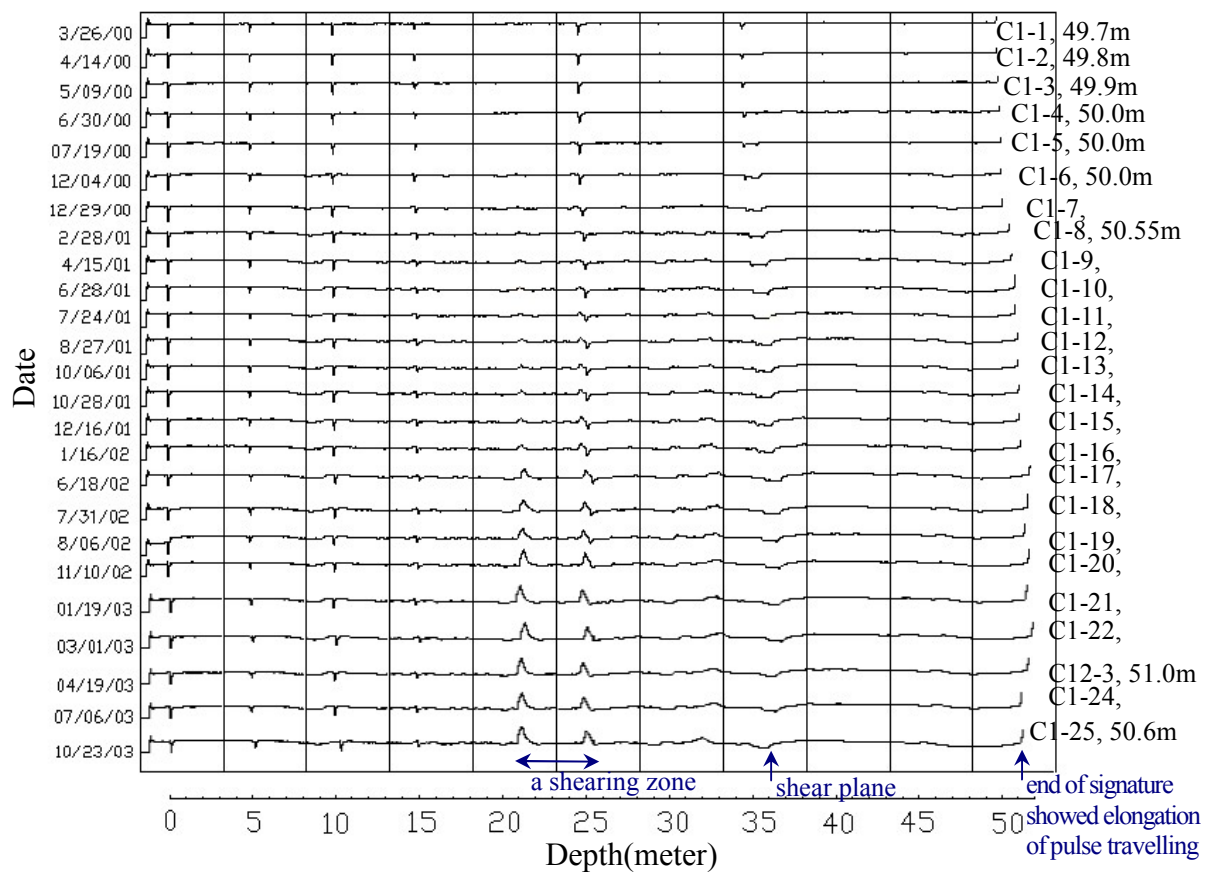
Fig.9 Recorded waveform at C-1 TDR monitoring station

Some special phenomena are observed which are not discussed in previous research. As shown in Fig.9, waveforms show a pair of waveform rise in very close location. By simulating the possible reason for this type of waveform change, it is concluded that it may caused by the bending effect of a section of grouted coaxial cable. Bending causes the cable be teared to break at both upper and lower limit. These damage showed increase in its inductance and caused a spike in the waveform.

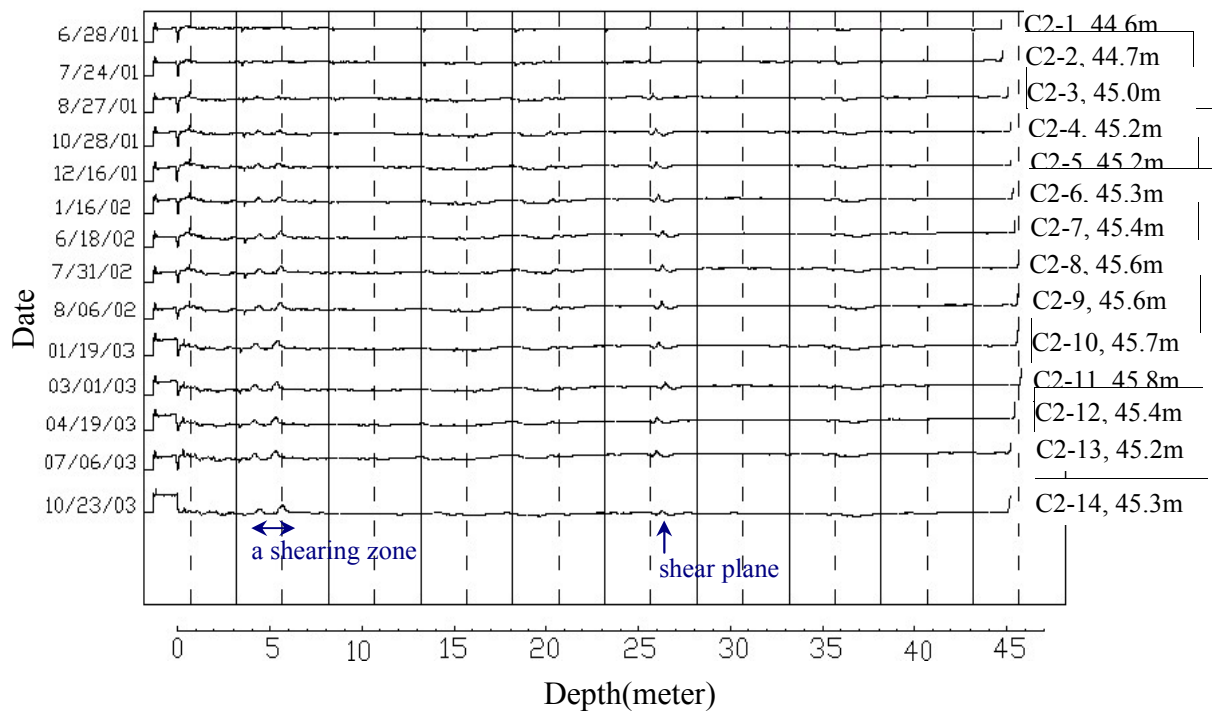
Fig.10 Recorded waveform at C-2 TDR monitoring station

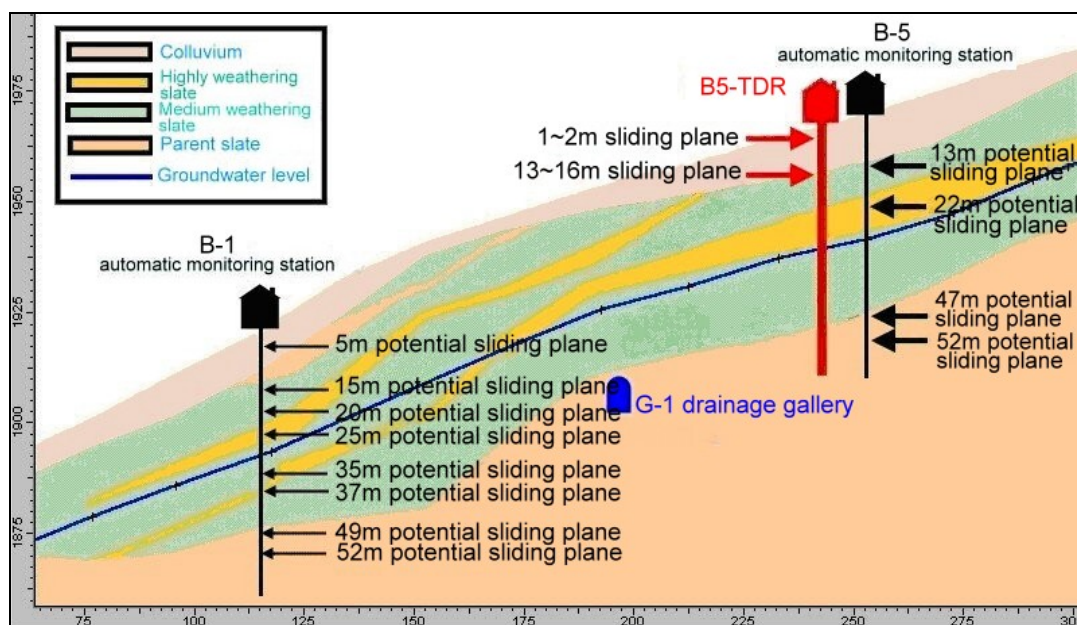
Sliding block B5 monitoring station was located just right above the block B1. Ground water level drops approximately an amount of 15 meters during the construction period of drainage wells, and an extra 28 meters drop was recorded when the underground drainage gallery was excavated and approached to this region. The results also display that little change of surface movement was observed on the wire extensometer, which indicate that the fixed anchoring point of the extensometer might be installed on another sliding block. In Fig. 11, location of monitoring instruments are put together using projected location on the slope profile. Potential sliding planes are judged using the properties of geo-materials.

Fig.11 Profile of slope including B5-TDR cables

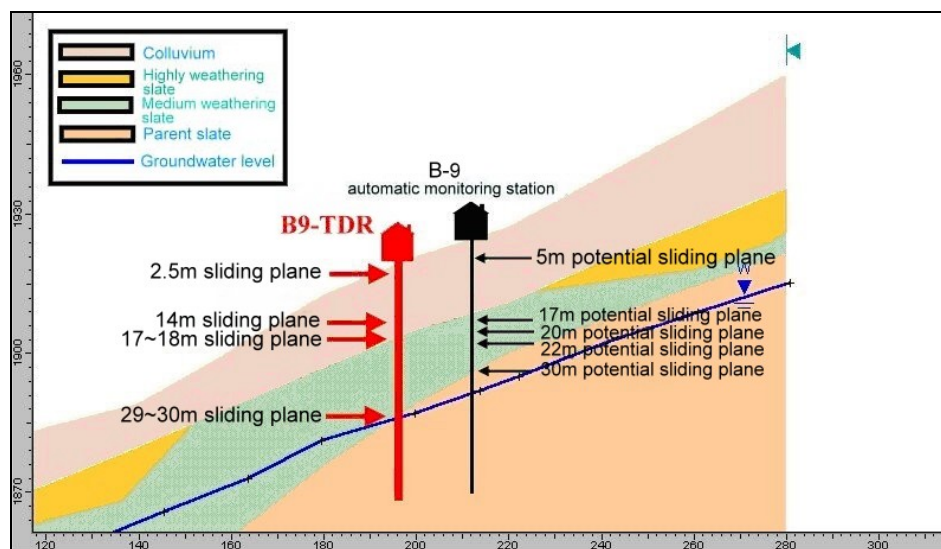
Sliding block B9 monitoring station was located just on the eastern side of the blocks B4 and B5. A huge building of Citizen Hotel was constructed on the top of block B9 in 1970. Unfortunately, it was eventually torn down in 2004 after the malfunctions of the building were evaluated, following the landslide in 1990. Monitored results show that the construction of drainage wells has significant effects on lowering the ground water level. Besides, it could be believed that the stability of this sliding block B9 could be improved after the building of Citizen Hotel was removed. A profile is given in Fig. 12 to compare sliding plane judged from TDR monitoring with potential sliding plane from geo-material.

Fig.12 Profile of slope including B9-TDR cables

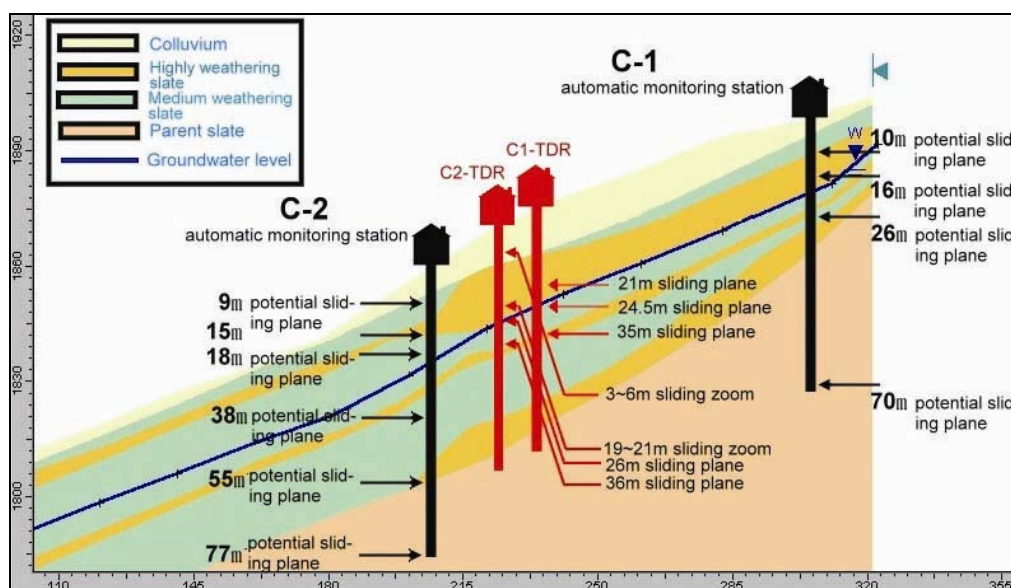
C1 station located at Northeast region. C1 is on uphill of route 7A. Fig. 13 gives the profile of TDR cable installed and monitoring station. As shown in Fig. 14 and 15, date of ground surface deformation showed close relationship with construction work of remedial plan.

Fig. 13 Profile of slope including C1-TDR and C2-TDR cables

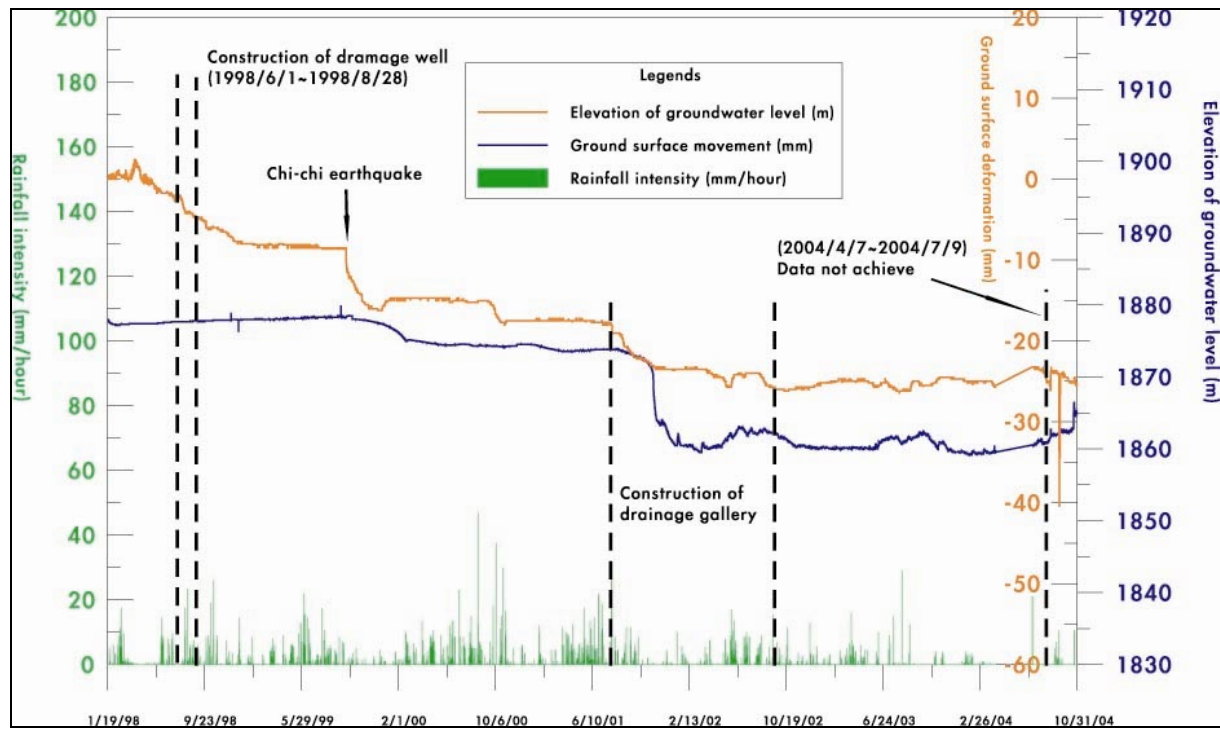
Fig.14 Relation between rainfall intensity, groundwater level and surface deformation in C1 station

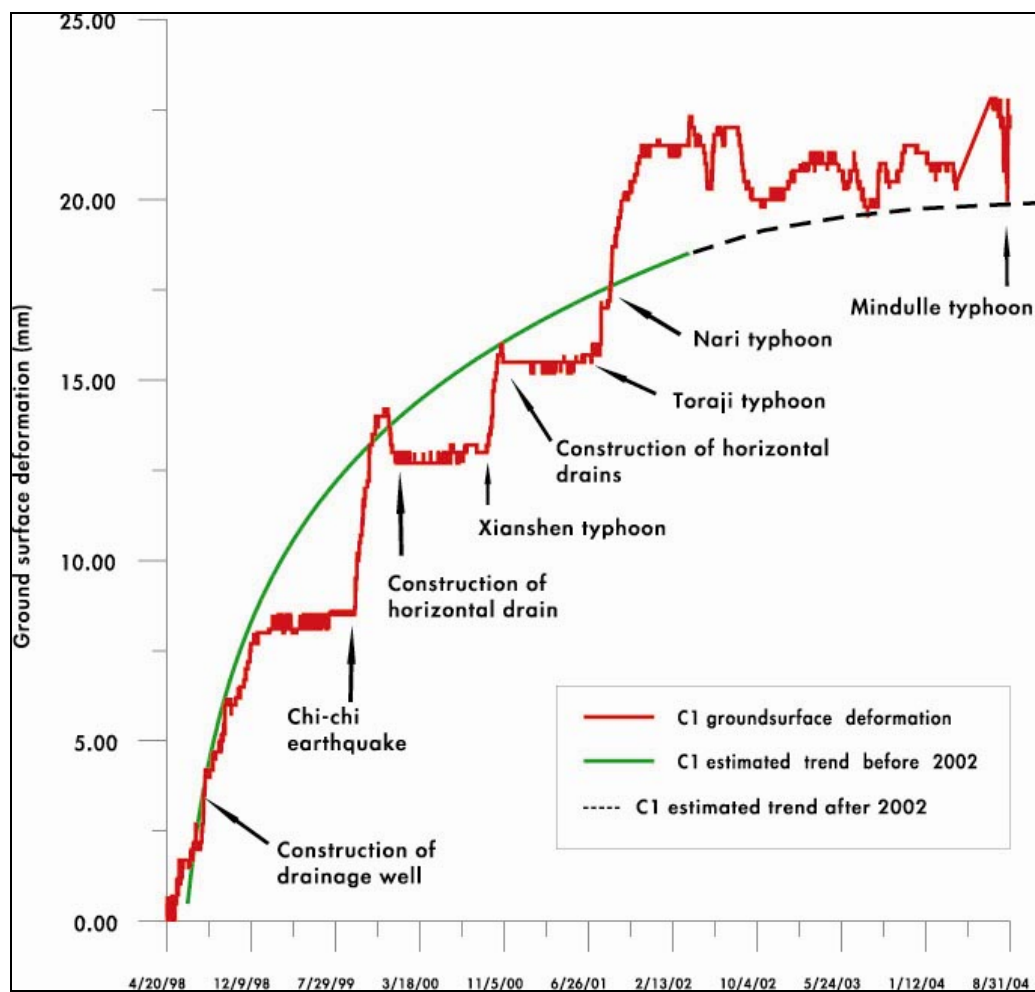
Fig.15 Ground surface deformation and its estimated trend for C1 station
