REHABILITATION OF SHELBY STREET BRIDGE - COMBINING THE “NEW AND THE OLD”

Edward P. Wasserman, P.E.¹, M.ASCE and Joseph J. Pullaro, P.E.², M.ASCE

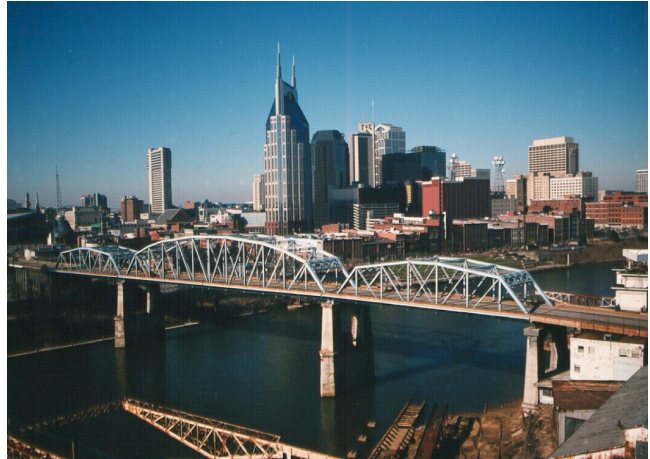
Figure 1: View Looking North

The approach spans were comprised of concrete trestle bents with steel girder spans used over roadways and railroad tracks and closely spaced concrete T-beams with monolithic concrete decks elsewhere. The concrete bents were spaced at 9.14 M (30'-0") center-to-center. The steel girder and truss spans were supported on concrete piers founded on bedrock. (See fig. 1)

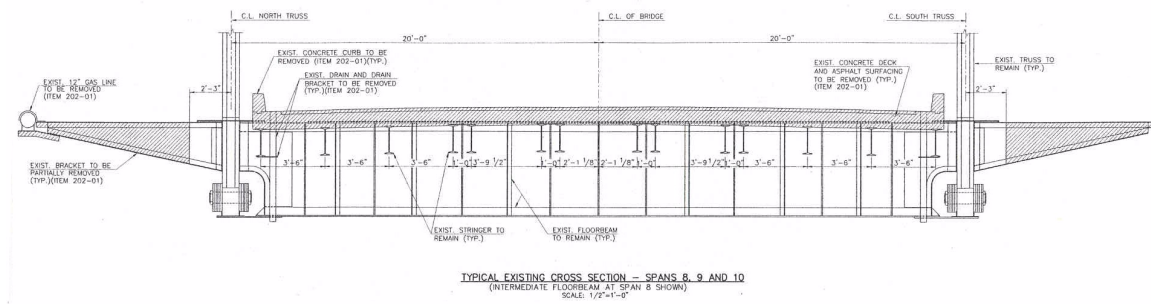
Figure 4: New Cross Section

The fundamental change to the configuration of the existing truss spans, aside from the deck span relocation, was removal of the original sidewalks. The root portion of the cantilever bracket connecting to the floorbeam was retained. The new cross section was to consist of a 4.57 M (15'-0") roadway and two 3.2 M (10'-6") sidewalks. The dead and live loads were significantly reduced and would largely eliminate any requirements for strengthening. The minimum design live loads were to be M13.5 (H15) or 4.07 KPA (85 psf), whichever controlled. The floor system framing for the steel trusses was to remain, while the concrete truss floor would be completely replaced. Scenic overlooks were to be placed at both main river piers. Conventional reinforced concrete deck slabs were to be utilized throughout. (See fig 4)

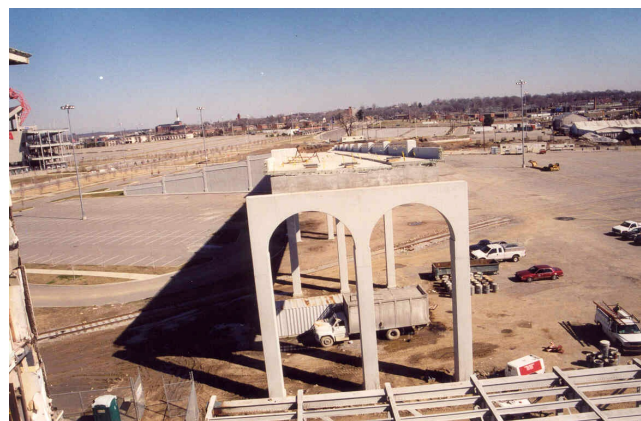
Figure 5: View of approach piers

TDOT elected to replace the approach units with continuous precast, prestressed concrete box girders and composite concrete deck. The newly constructed bents for the approaches used a three column configuration with arched caps to complement and echo the style of the original piers for the truss spans, a feature not present in the tower trestle bents of the original approaches. (See fig's 5 & 6)

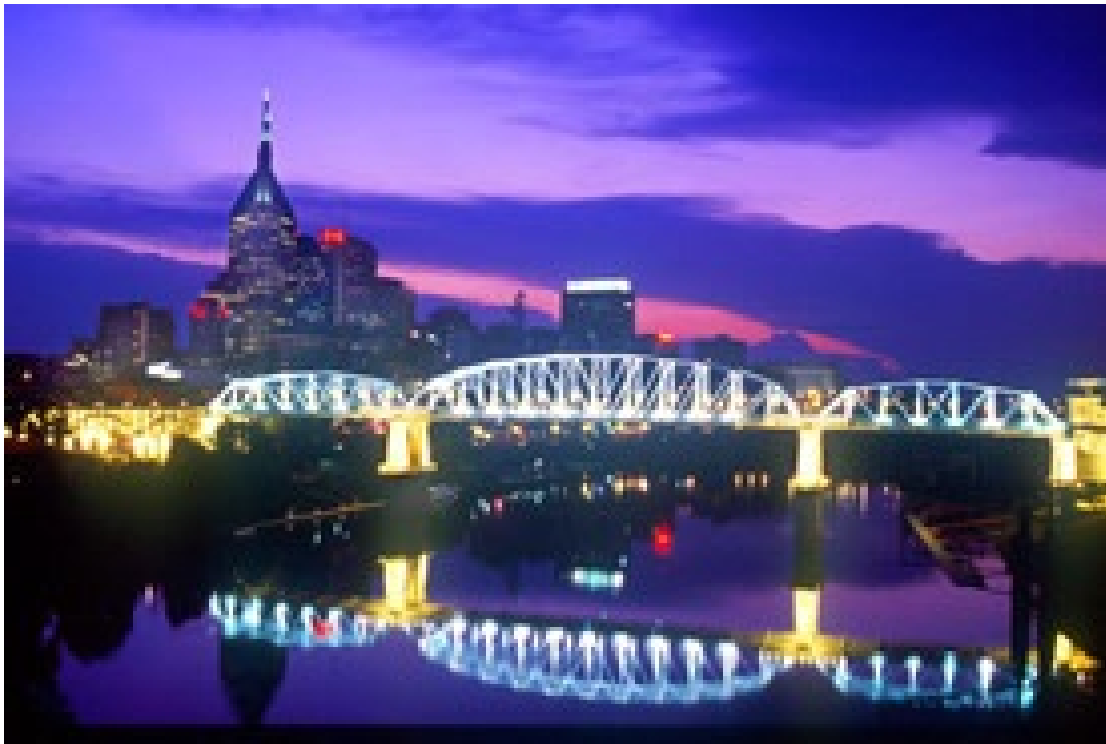
Figure 7: Completed Bridge

The rehabilitation concluded with final painting of the steelwork, installation of the ornamental railings and provision of decorative lighting to accent the bridge structure. (See fig's 7 & 8)
