# Paver Segregation

Tim Aschenbrener  
Colorado DOT

North Central Asphalt  
User Producer Group  
St. Louis, MO  
January 12, 2006

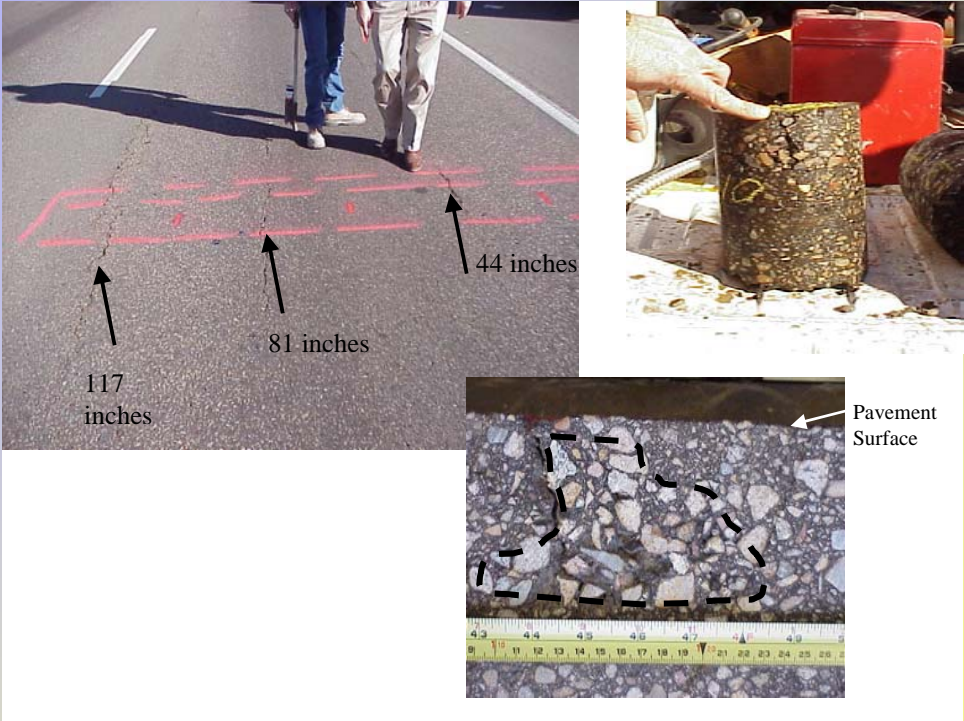
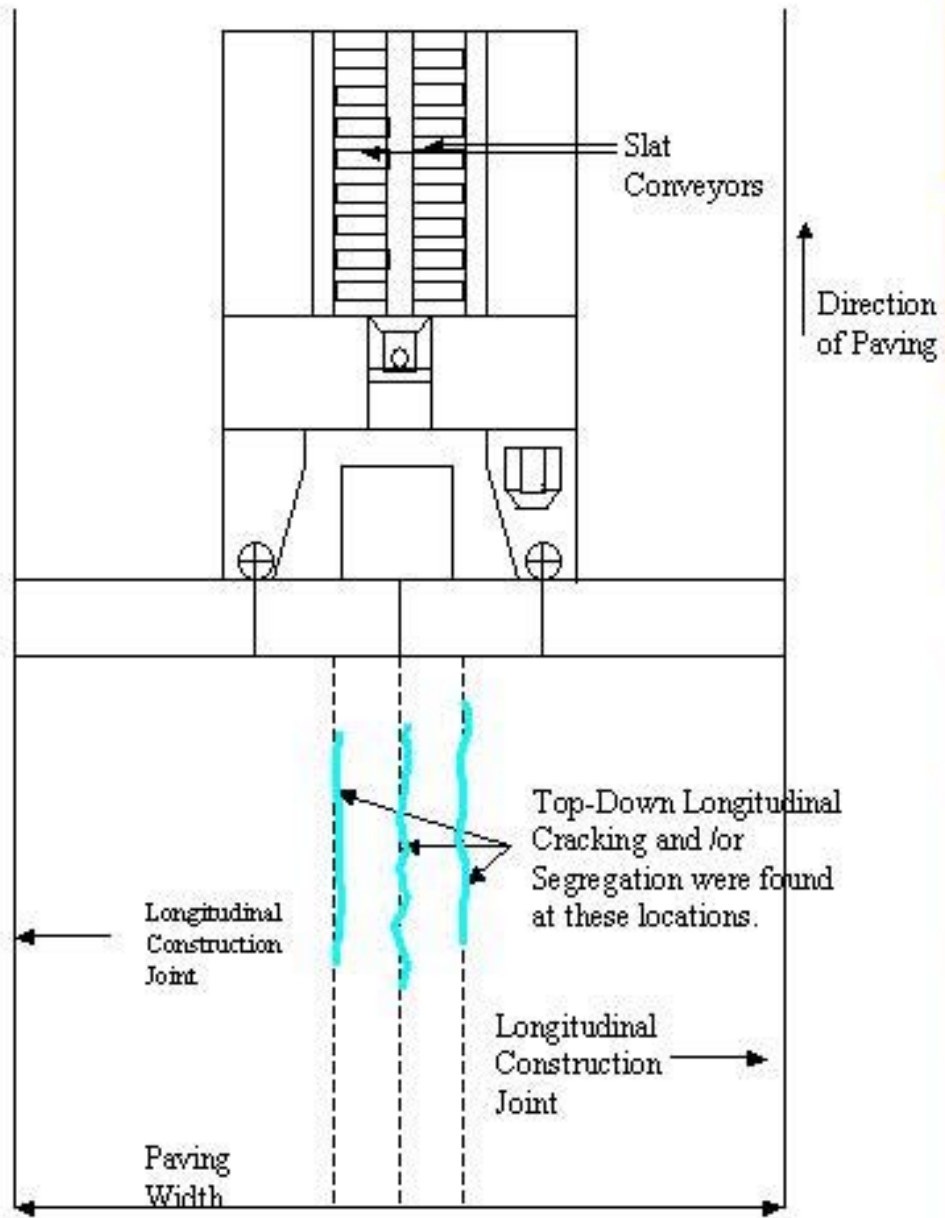
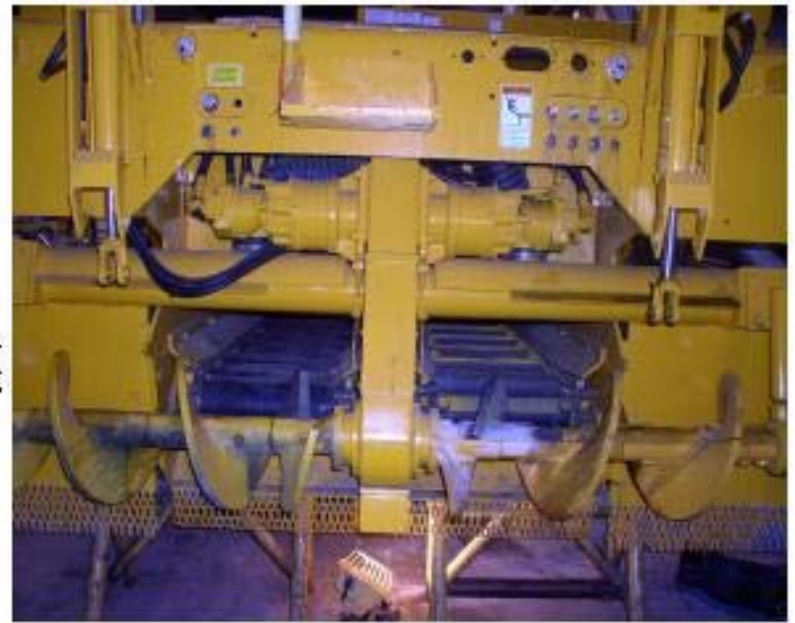
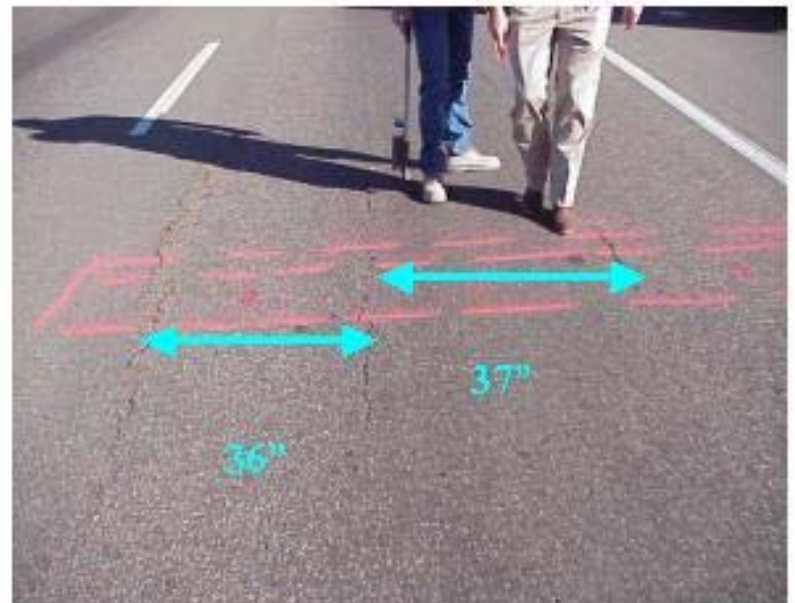
# I-25 Distresses

- Predominantly top-down
- Segregation related
- Induced by paver

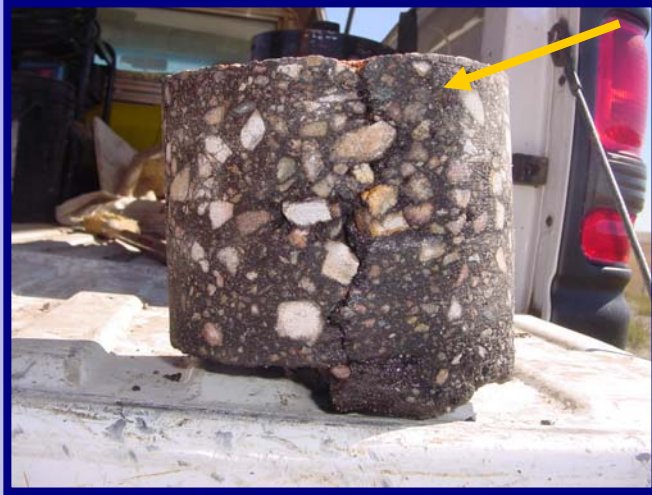
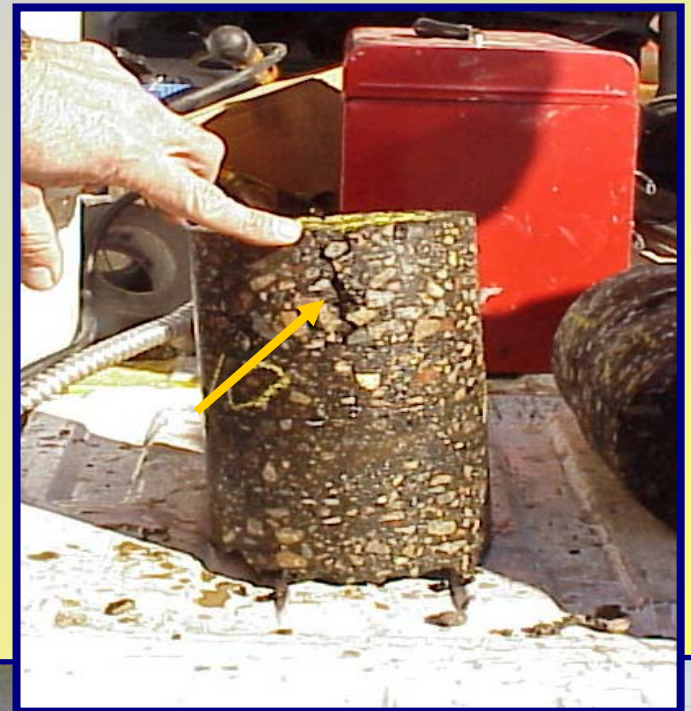
Reflective Crack or

Top-Down Crack?

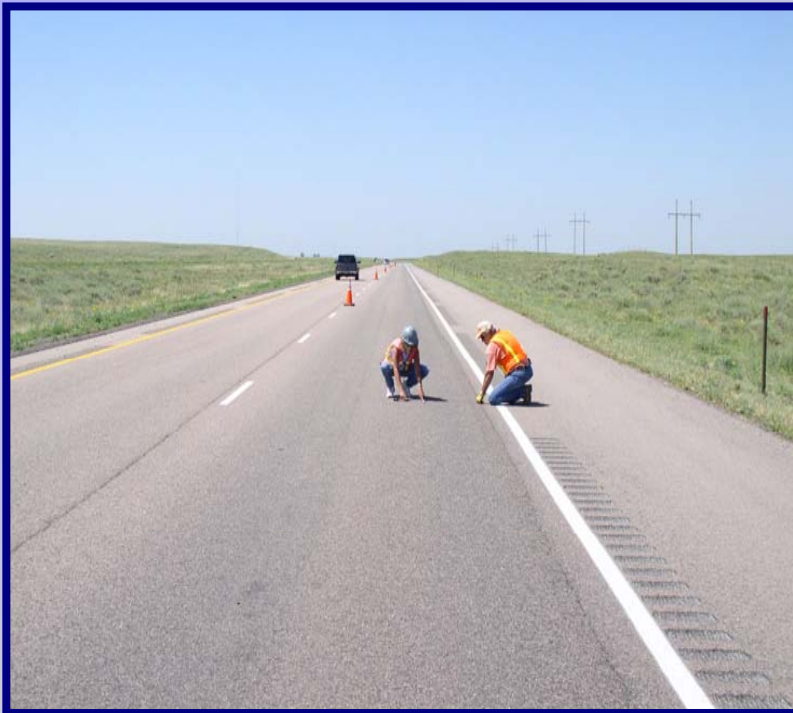
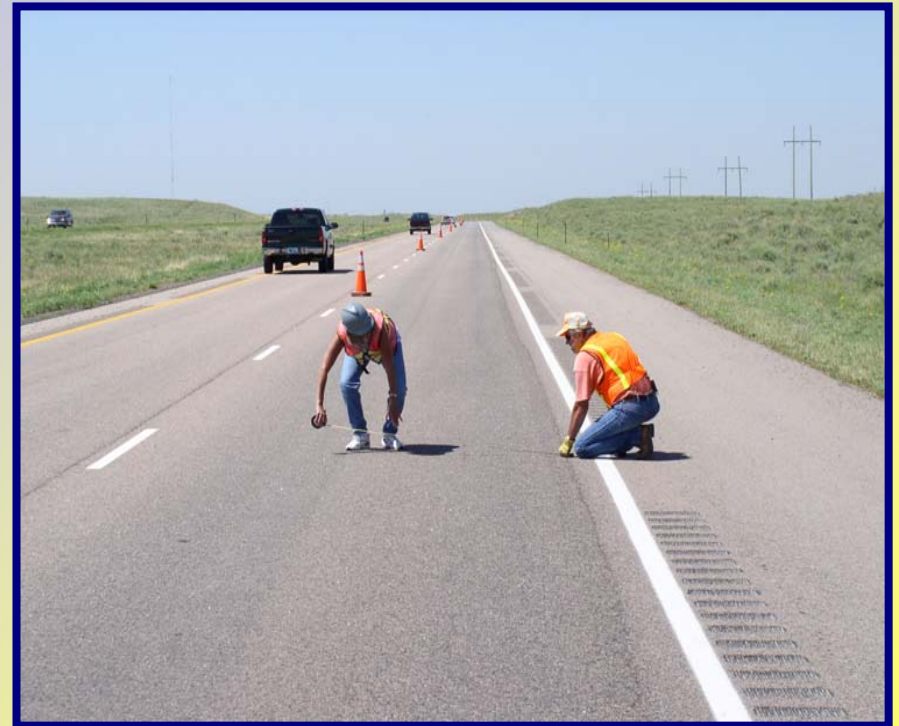
# Measuring Distance from the Joint to the Crack

## Distance from longitudinal Construction Joint

Site No.	Paver Manufacturer/ Model	First Longitudinal crack	Second Longitudinal crack	Third Longitudinal crack
3	1/A	38"	73"	No crack
6	1/B	18"	No crack	102"
13	2/E	37"	No crack	97"
17	1/C	46"	No crack	109"
19	1/D	69"	No crack	128"
20	3/*	58"	87"	No crack
23	2/*	41"	70"	99"
