# Minnesota's Experience With Waste Shingles

February 5, 2009

Roger Olson  
Mn/DOT Research

*Office of Materials and Road Research*

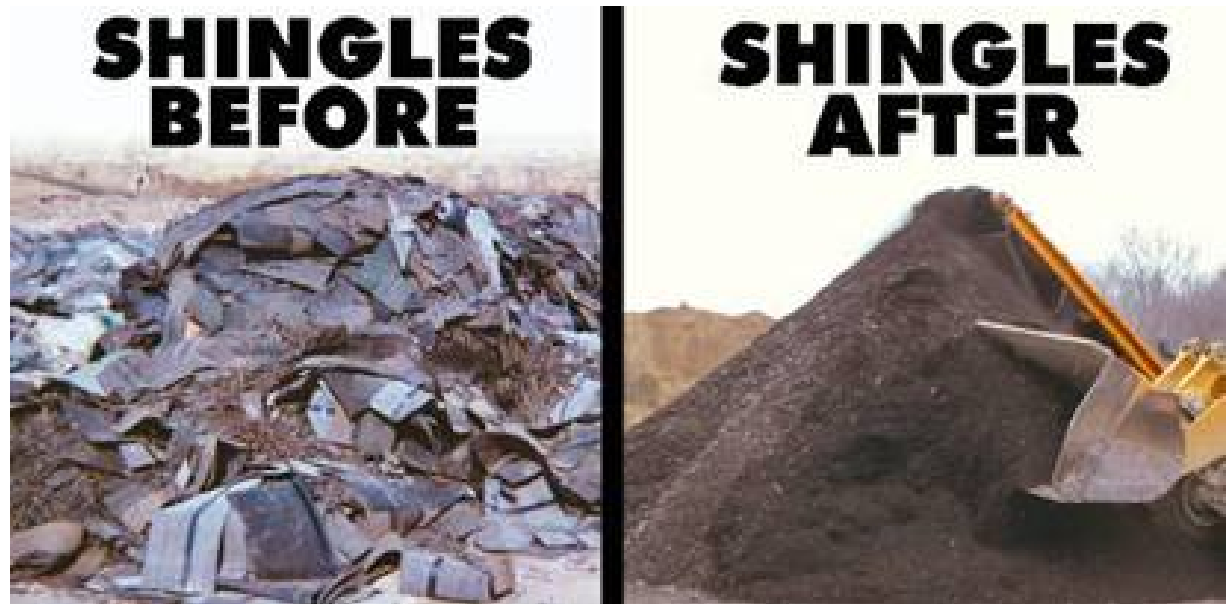
# Shingles

- Tear-off, Manufactured Waste Shingles
- 5% Shingles, No RAP, PG 58-28
- Mainline Shoulders and Transition Areas
