The purpose of this project was to develop a materials failure analysis protocol to identify the root causes of failure in high power battery packs tested at the BIC under accelerated conditions. Plausible mechanisms were identified through examination of electrical measurements taken during charge/discharge cycling and post-test materials characterization. A combined analysis suggests that high charging rates can lead to degradation of the electrolyte which reduces battery lifetime.

This work was sponsored by the Battery Innovation Center.

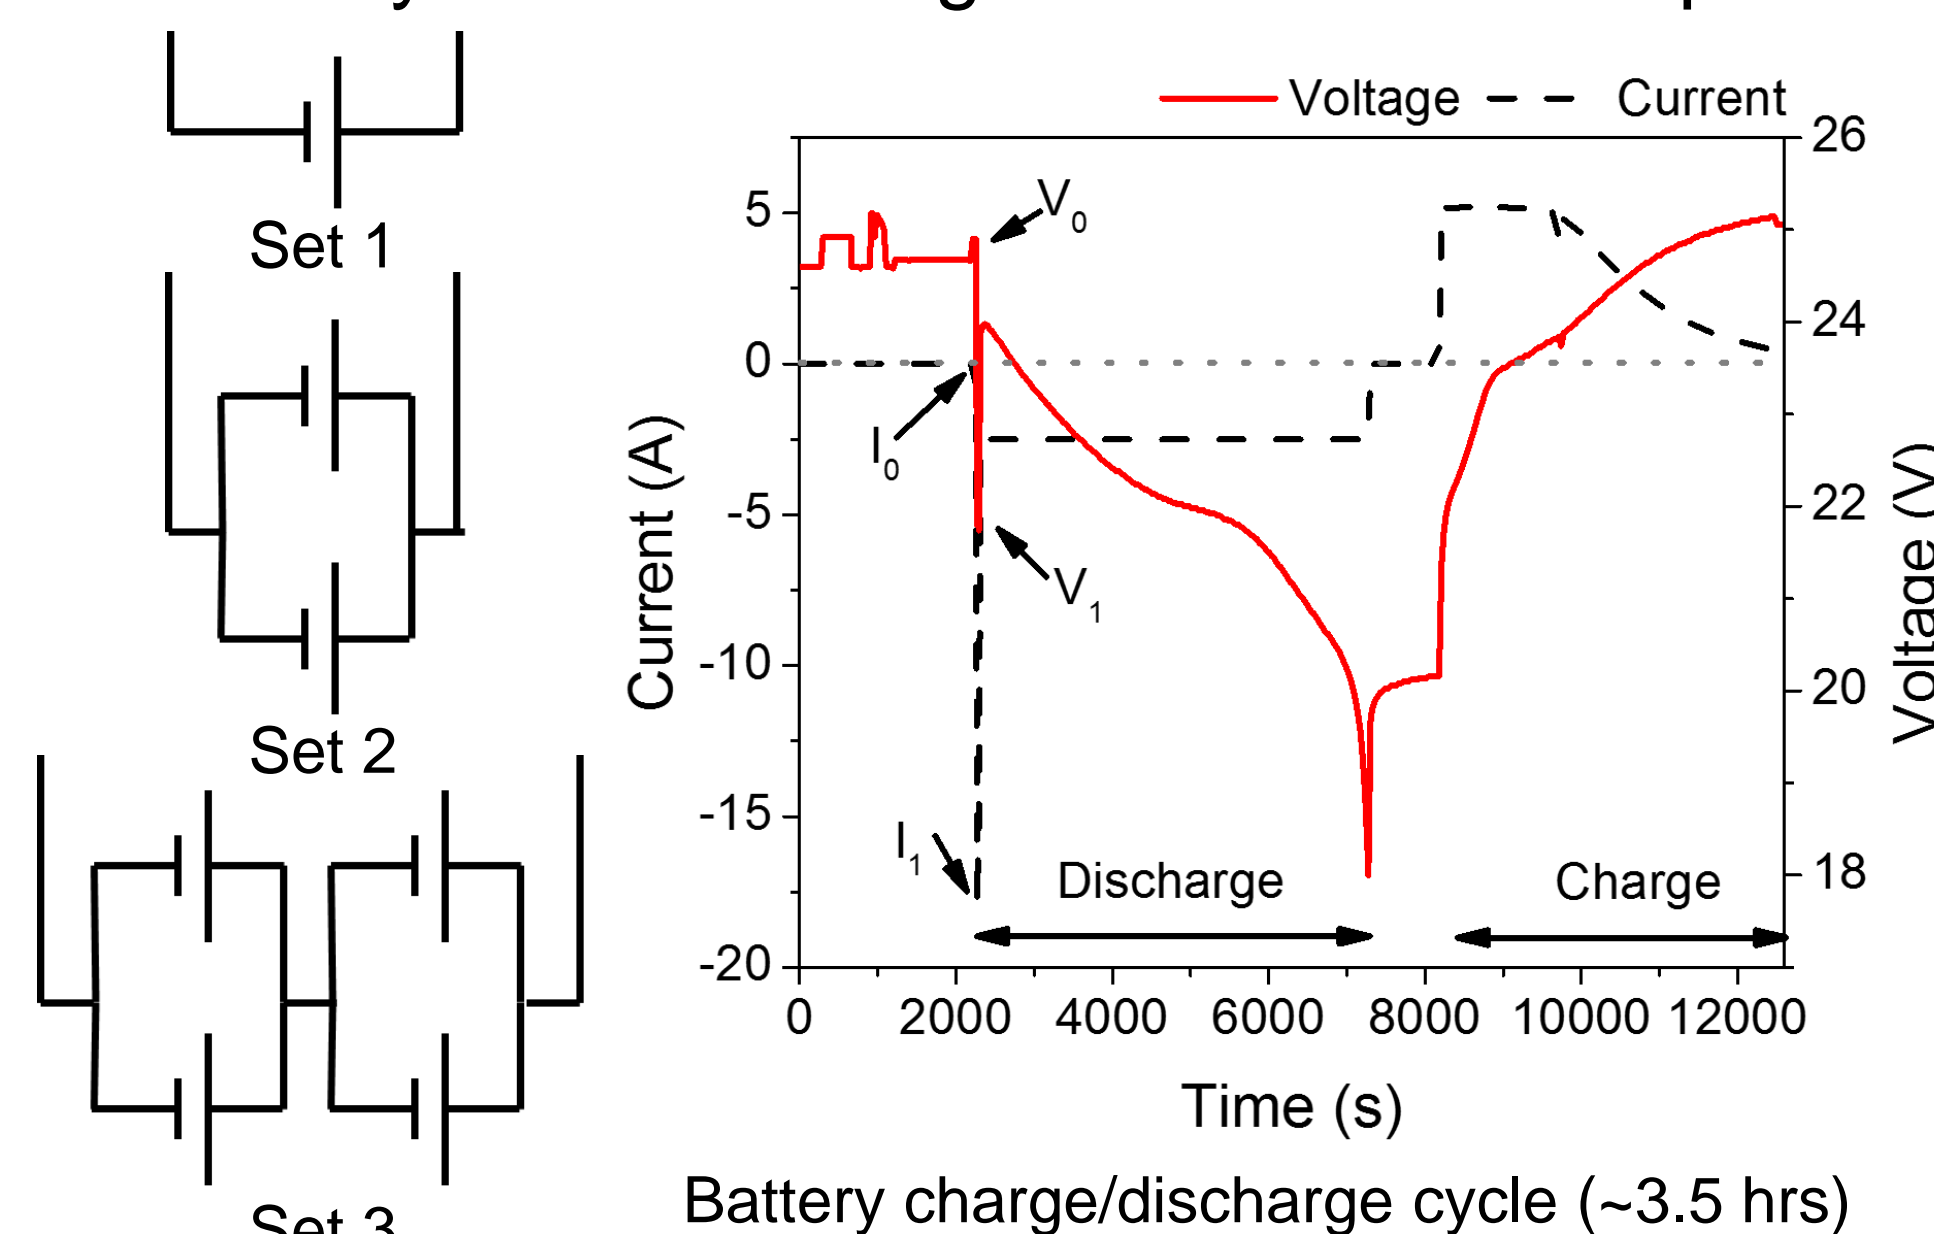
The battery packs consisted of six pairs of pouch batteries wired in series, and the batteries within each pair were wired in parallel. The packs were cycled using a profile provided by the BIC’s customer. Individual pouch cells in different wiring configurations were also cycled according to the customer’s profile.

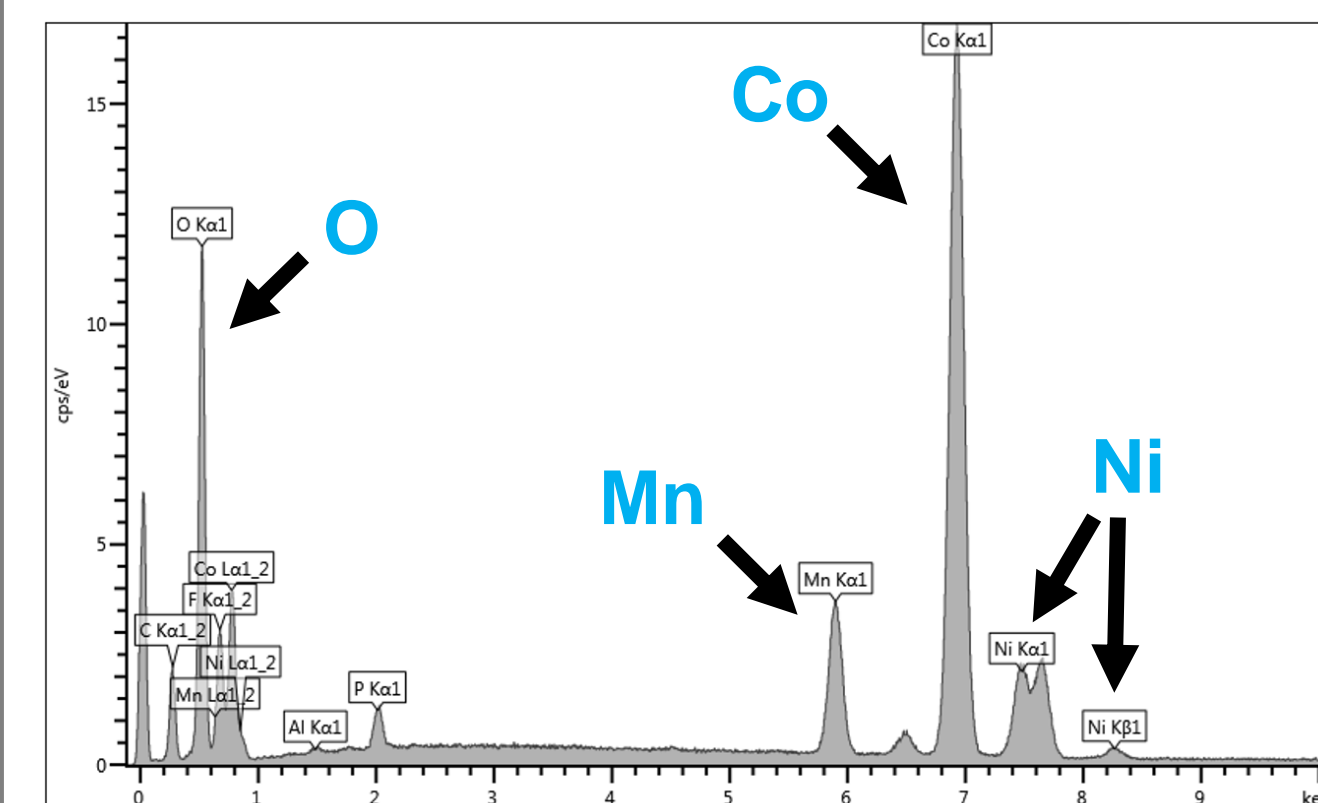
EDS suggests battery chemistry is LiNiMnCoO_2
