The formation of non-transformation products and grinder burn on heat-treated steel gears is a serious problem for John Deere. These defects reduce hardness, residual compressive stresses and fatigue life, increasing scrap costs. John Deere has suggested shot peening as a possible way to restore mechanical properties. Shot peening induces compressive residual stress into the gears, potentially undoing the damage caused by grinder burn. Residual stress, metallography and microhardness measurements were conducted on gear samples provided by John Deere in order to recommend whether or not John Deere should pursue the shot peening approach.

This work is sponsored by John Deere, Waterloo, IA

## Project Background

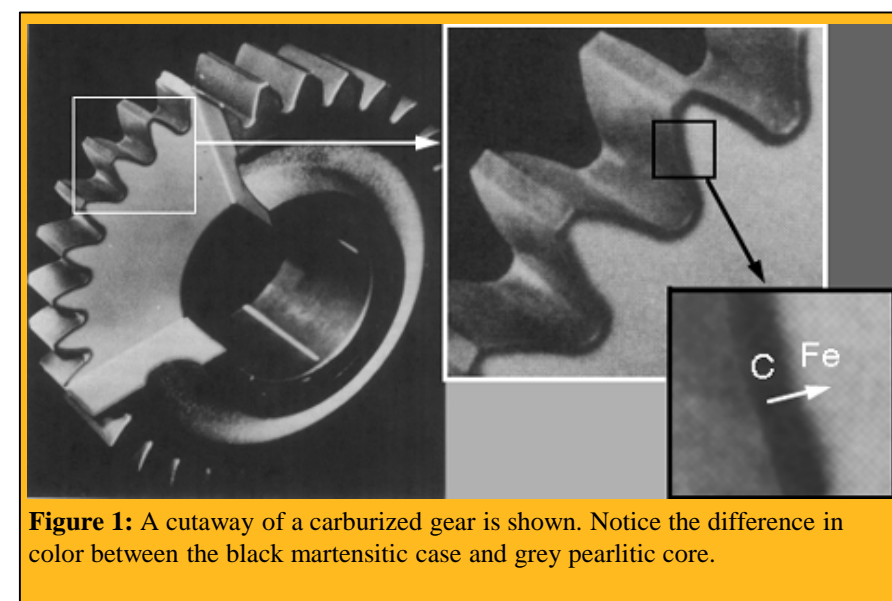
Figure 1: A cross-section of a carburized gear is shown. Notice the difference in color between the black martensitic case and grey pearlitic core.

A carburizing heat treatment is applied to the 8620 steel gears in order to create a hard outer martensitic surface while retaining a tough pearlitic core (Fig. 1). Quenching after carburization produces a compressive residual stress profile that improves fatigue life and minimizes crack propagation.

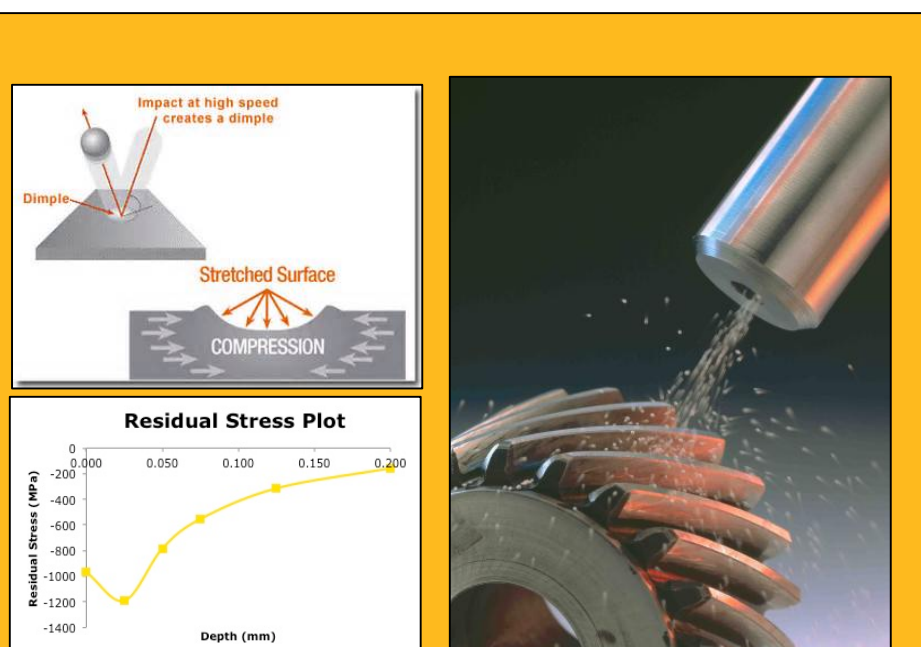
Figure 5: The shot peening process imparts additional compressive stresses into the gear surface. The shot media is usually in the form of small steel balls with a hardness greater than that of the material. A desirable post shot peening stress profile is shown on the left.

Shot peening is being implemented in an attempt to rectify lost residual stress and surface hardness. Shot peening imparts compressive residual stress into the parts by plastically deforming the surface via the shot media impacts.

Our team recommends that John Deere further pursue shot peening as a countermeasure to offset the negative effects of excessive surface NTP and grinder burn. Additionally, we suggest more testing to be done to establish a correlation between residual stress recovery and a non-destructive testing method such as Barkhausen Noise.

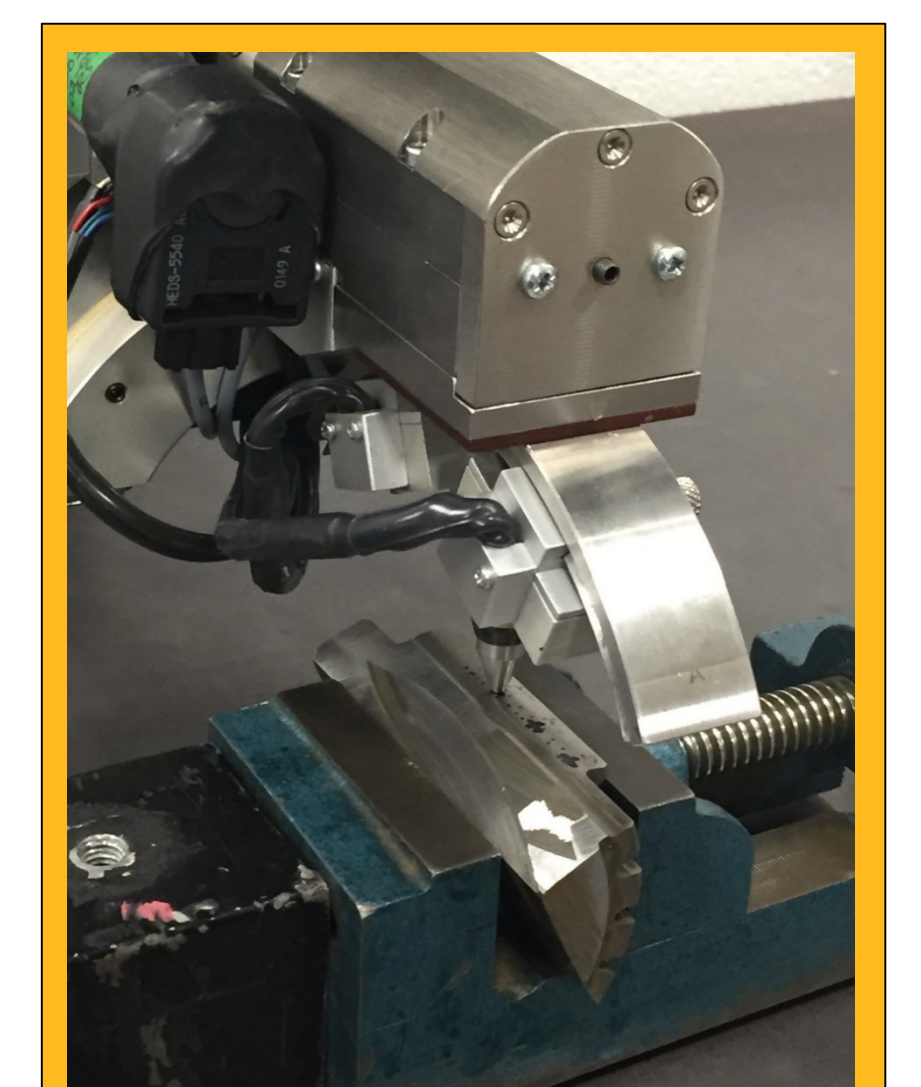
Figure 6: XRD residual stress machine at American Stress Technologies taking surface stress measurements on a burned gear tooth.

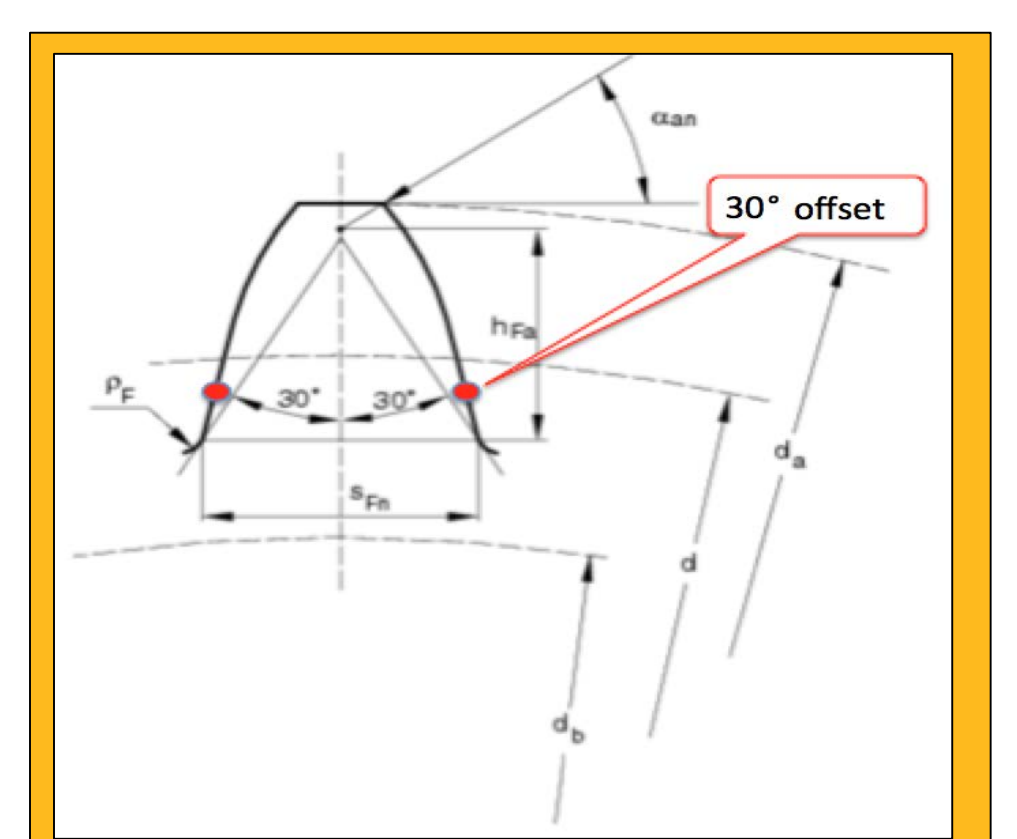
Figure 7: The 30 degree offset location on gear tooth profile according to AGMA standards.

A depth profile was taken from 0-200  $\mu\text{m}$  depth at the 30 degree offset location (Fig. 7) of the NTP and subsequently shot peened part.

Optical microscopy and residual stress and hardness measurements were performed on a set of shot peened and non-shot peened poor microstructure gears. As shown in Fig. 8, the greatest amount of NTP was found near the 30 degree offset location (Fig. 7).
