6th Purdue Geotechnical Society
Workshop – April 18, 2008

***Fast-Track Emergency
Replacement of Collapsed Sewer
by Tunneling in Miocene Clay***

David Chapman
Lachel Felice & Associates, Inc.
Morristown, NJ

Battery Park Sewer – Richmond, VA

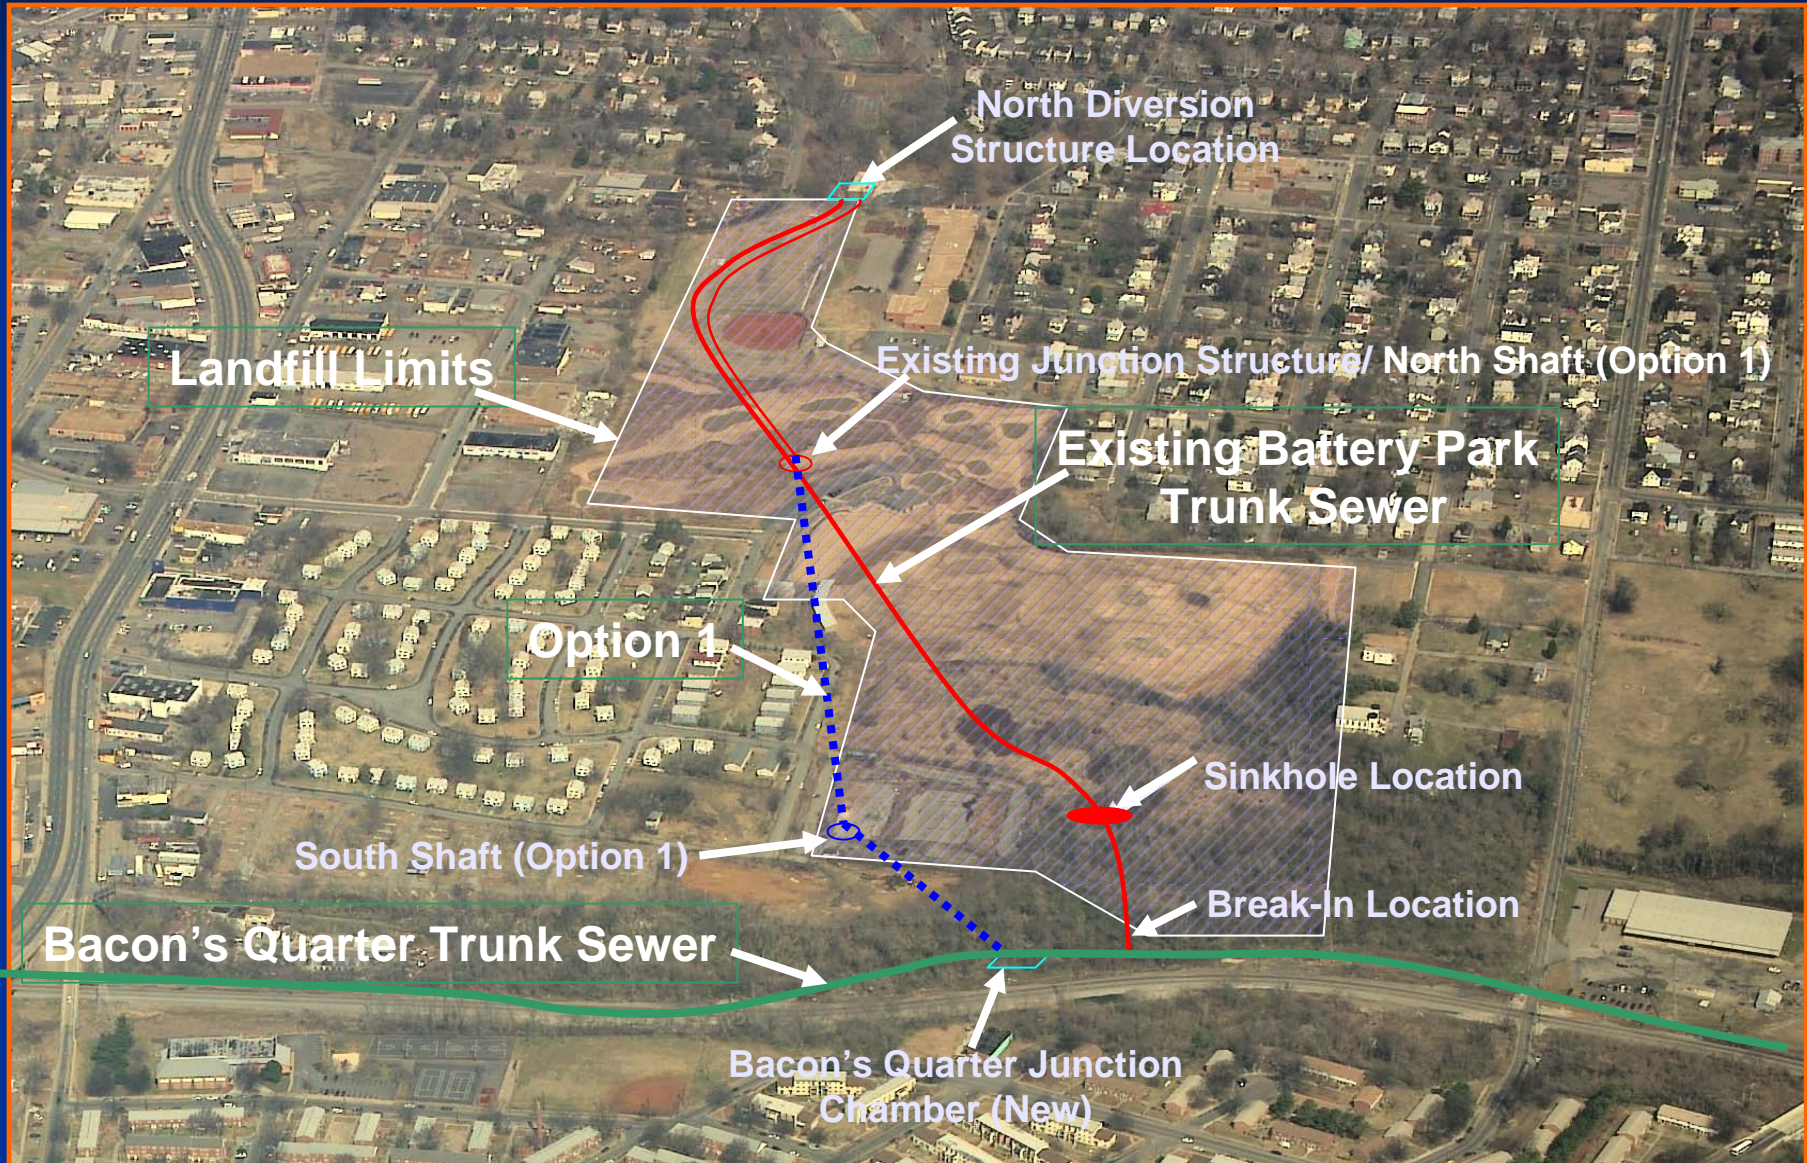
Battery Park Area

- Pro
 - Skip repair – construct bypass tunnel – 1,750 ft
 - Shortest time to eliminate flooding and health risks
- Con
 - Existing North Junction Chamber in MSW
 - 250 ft tunneling required in MSW
 - Additional vulnerable old sewers below landfill upstream of junction chamber
- Half a solution! Risk not eliminated.
