# Performance of School Buildings in Turkey during the 1999 Düzce and the 2003 Bingöl Earthquakes

Several school buildings were surveyed in the disaster areas of the Marmara (1999,  $M_w=7.4$ ), Düzce (1999,  $M_w=7.2$ ) and Bingöl (2003,  $M_w=6.4$ ) earthquakes in Turkey. Among them, 21 reinforced concrete buildings were found to have an identical floor plan. Lateral load resisting structural system consisted of reinforced concrete frames (moment-resisting frame) in 16 of the buildings and structural concrete walls integrated with the moment-resisting frame (dual system) in the remaining five buildings. The number of stories above ground in these buildings ranged from 2 to 4. These school buildings provide a nearly ideal test of the effect of a single important structural characteristic on the performance of buildings with structural designs that are uniform in all other respects. Our observation is that the presence of structural walls improves the behavior of reinforced concrete systems drastically.

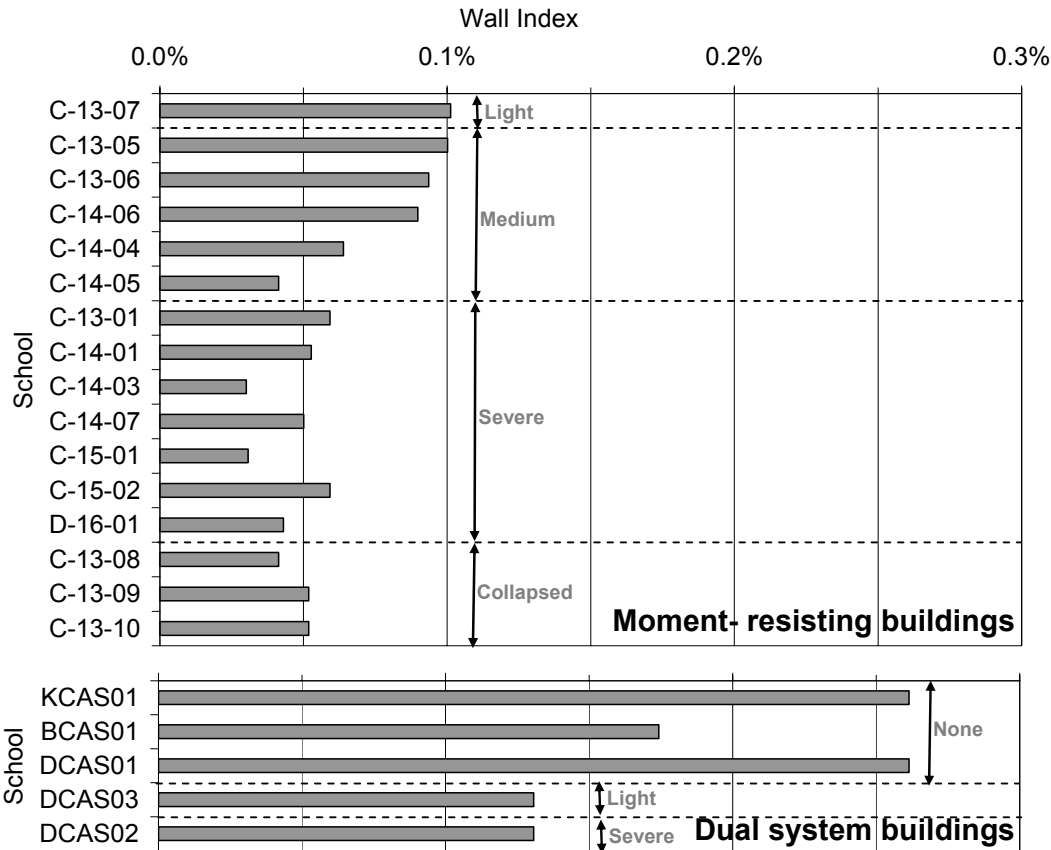
**Figure 16.** Correlation between the structural performance and the wall index defined by Hassan (1997).

The effect of reinforced concrete walls on the structural performance is presented graphically in Fig. 16. The buildings were grouped in the graph according to their damage levels. The horizontal axis shows the wall index for each building. It is clear from Fig. 16 that the buildings with higher wall index performed better as indicated by the level of damage observed during the earthquakes.
