Theresa Ingermann (ENRE), Billy Sipes (ENRE), Maiqi Zhang (AE)

Title: NC-1 Nature Conservancy Pond-Stream Rehabilitation Project

The landowners, the Cotners', and The Nature Conservancy need a solution to reduce the erosion occurring on the bank between the Cotners' pond and the adjacent stream in Kokomo, IN.

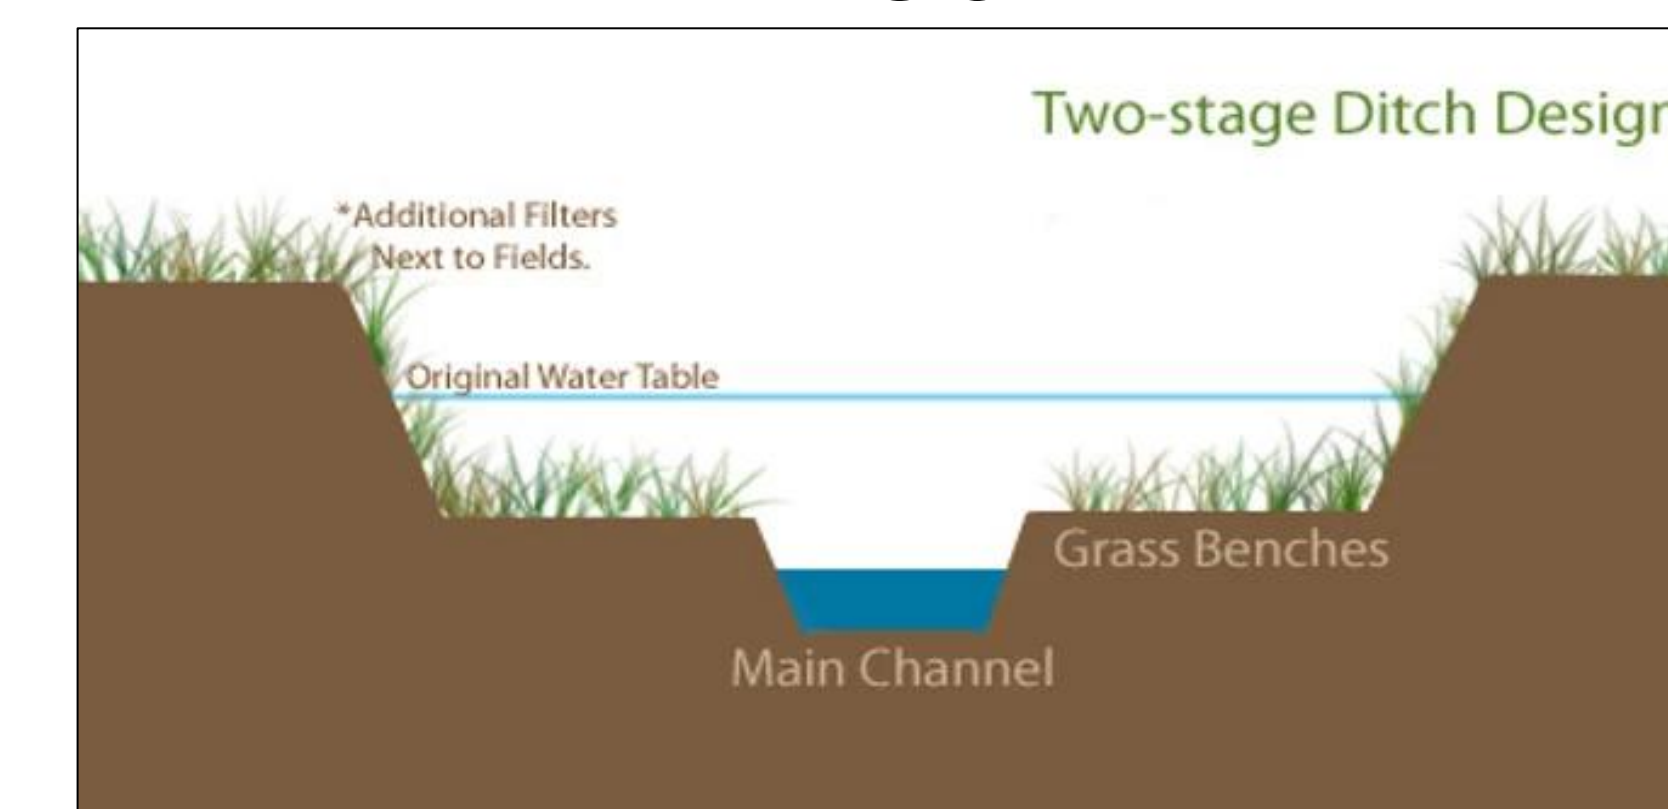
Area 2

Only Applied to Left Bank (facing downstream)
Grass Bench Elevation: 757 feet
Grass Bench Width: 21.5 feet
Upper Channel Bank Slope: 1V:2H
Cut Volume: 1977 cubic feet
Vegetation:

- Sideflowering Aster
- Gray Sedge
- Common Wood Sedge
- Fowl Manna Grass
