Drinking Water Pipe Repairs with Coatings and Liners: Experience and Knowledge-Gaps

May 2, 2017, City of Cambridge, Mass

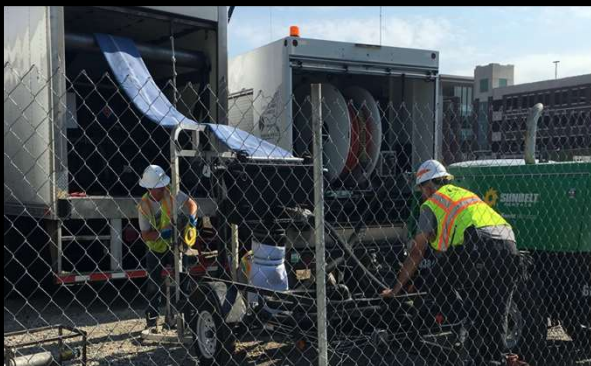
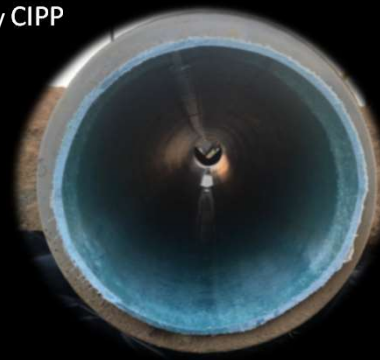
Cured-in-Place-Pipe (CIPP): Chemical Manufacture of a New Plastic Pipe Inside an Existing Pipe

Resin impregnated tube hardened inside a broken pipe

Curing methods: Hot water, Steam, UV light

Deliberate curing time: Hours to many days

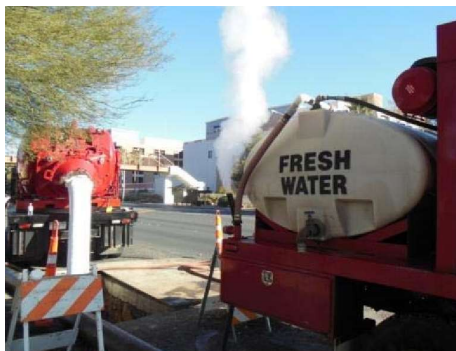
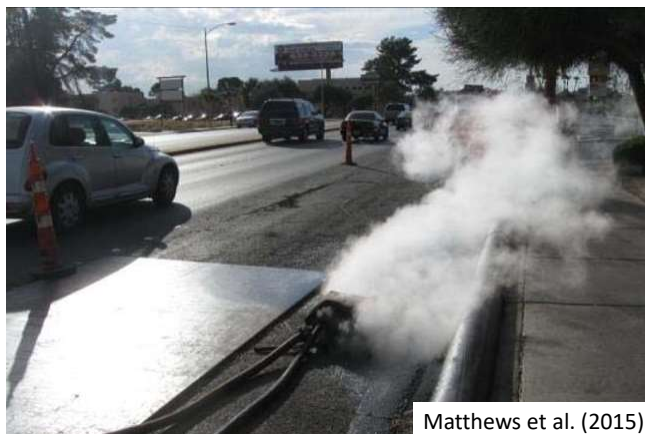
Matthews et al. (2015)

For a drinking water pipe, the epoxy resin tube is inserted, steam is injected at 10 psi, 180 to 210°F to facilitate chemical reactions (curing). *(other curing methods are available)*
