# New Research on Plastic Water Pipes: Water Quality and Air Quality Challenges

*Andrew J. Whelton*

November 2, 2016

Webinar: Florida AWWA Section

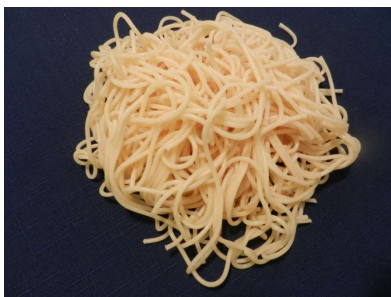
## How to Make Plastics (*Think Spaghetti*)

Straighten the spaghetti strands

Not crosslinked

HDPE,  
PVC, etc.

Bond the spaghetti strands

Crosslinked

CIPP,  
gaskets,  
coatings,  
PEX

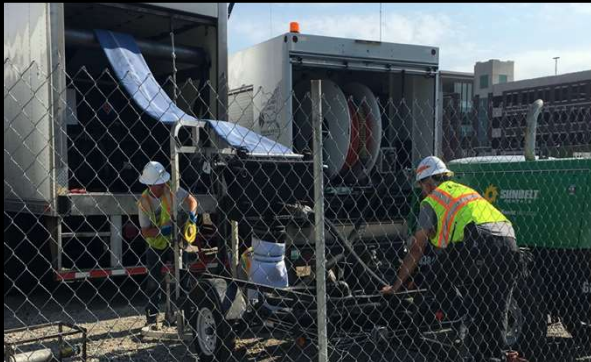
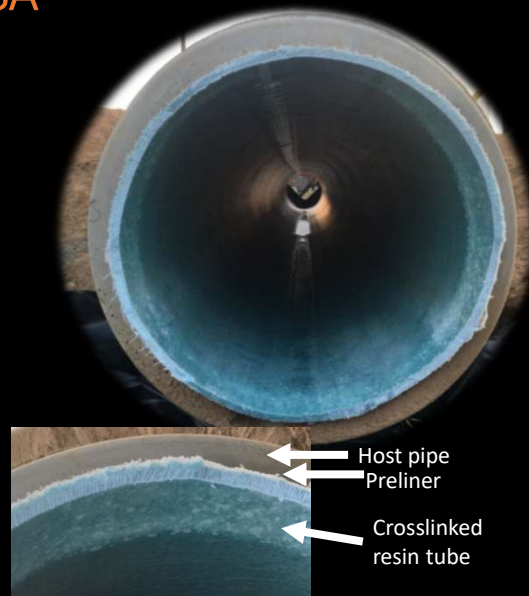
## Today, Cured-in-Place-Pipe (CIPP) is used to repair 50% of all water pipes in the USA

Trenchless technology: "No Dig" "No Excavation"

Resin impregnated tube hardened in a broken pipe

Curing method: Hot water, Steam, UV light

Deliberate curing time: Hours to many days

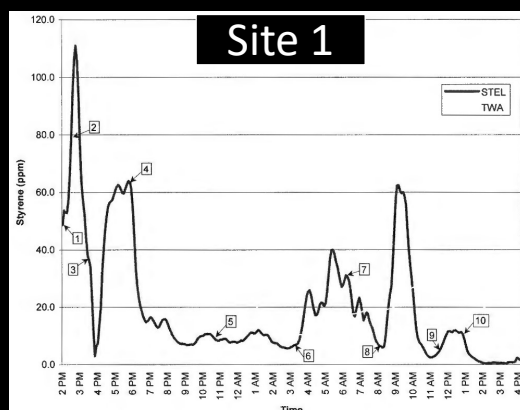
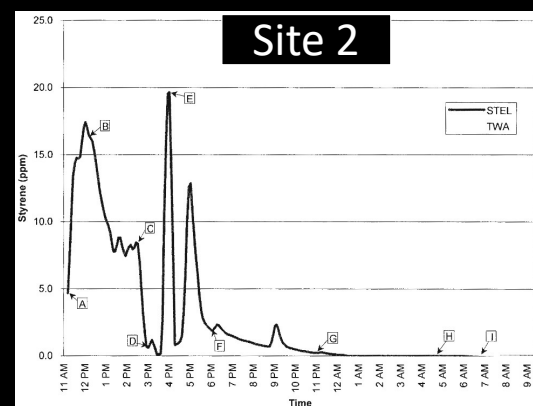
## In 2004, CIPP PID Air Testing Study was conducted in Canada

Bauer & McCartney. 2004. Proc. No-Dig.

PID set for styrene

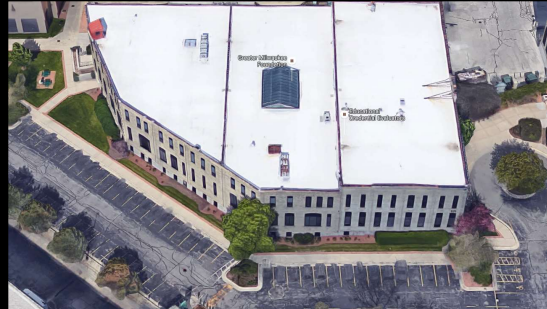
## In 2005, ATSDR Found CIPP Styrene and Other VOCs Entered Office Building through the Foundation, Chemicals Lingered for Months

Date	Total VOC, ppm	Styrene, ppm
12/10	Evacuation	Evacuation
12/13	Evacuation	Evacuation
12/13-22	nd – 1.45	Not tested
12/22	nd – 199.0	Not tested
1/12	0.5 – 30.0 <sup>+</sup>	Not tested
1/13	nd – 1.77	nd – 0.30
1/18	nd – 1.60	Not tested
1/21	nd – 0.86	nd – 0.22
2/4	nd – 0.21	nd – 0.15
2/7	nd – 0.57	nd – 0.04
3/28	nd – 0.22	nd – 0.01

*"...past conditions at the site are classified as a public health hazard."*

Styrene odor threshold < 0.1 ppm

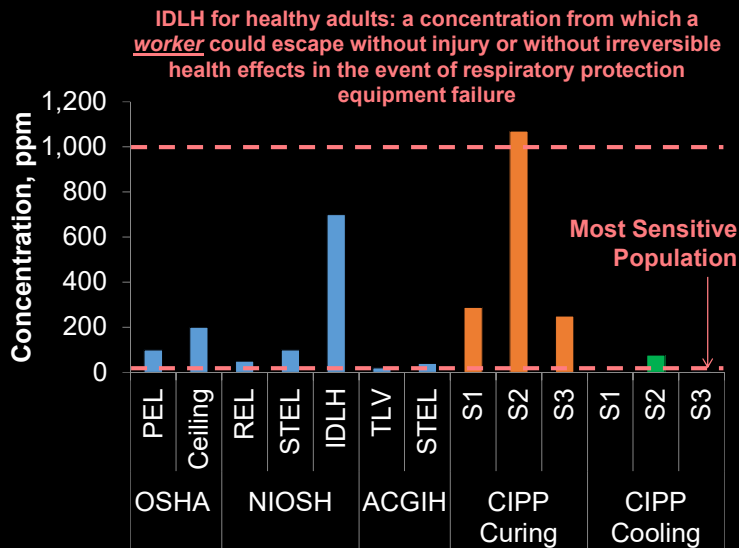
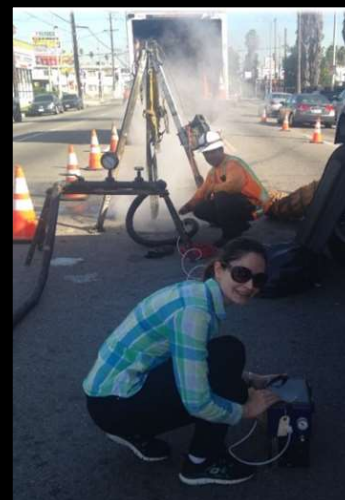
## 2015, Styrene Reported Exiting Sewer Manhole Exceeded the NIOSH IDLH

Adjari (2016)

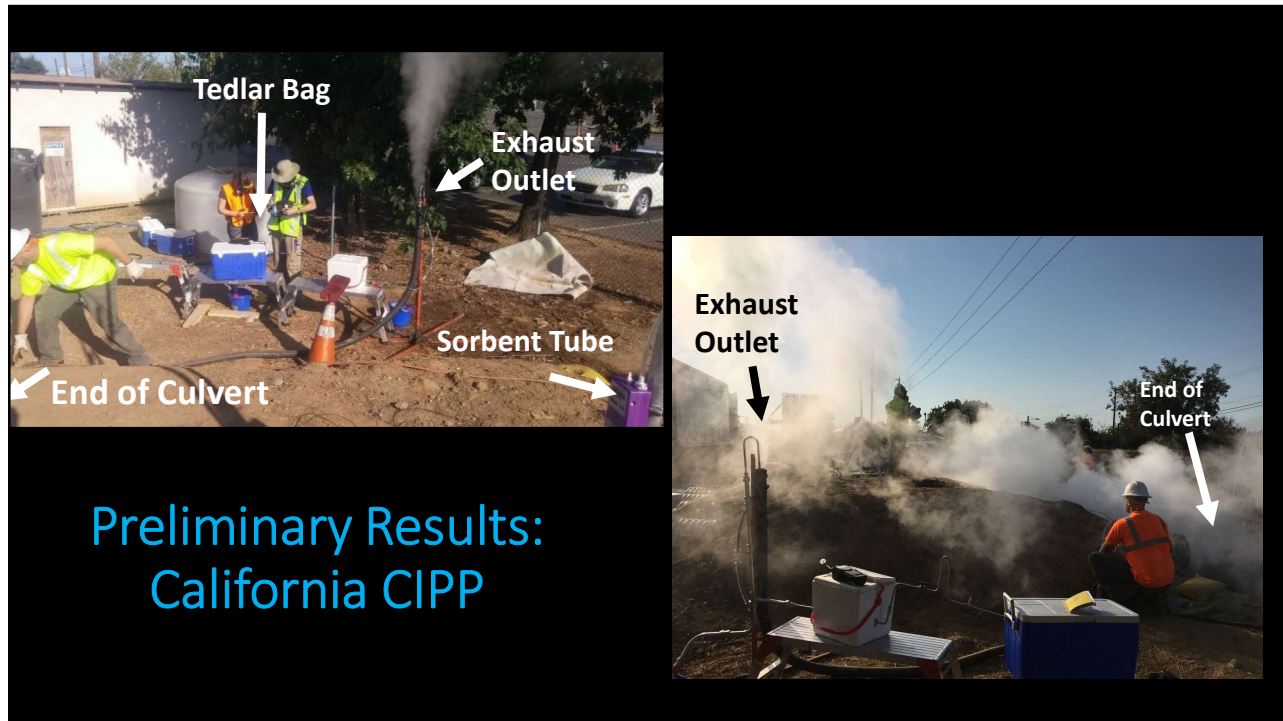
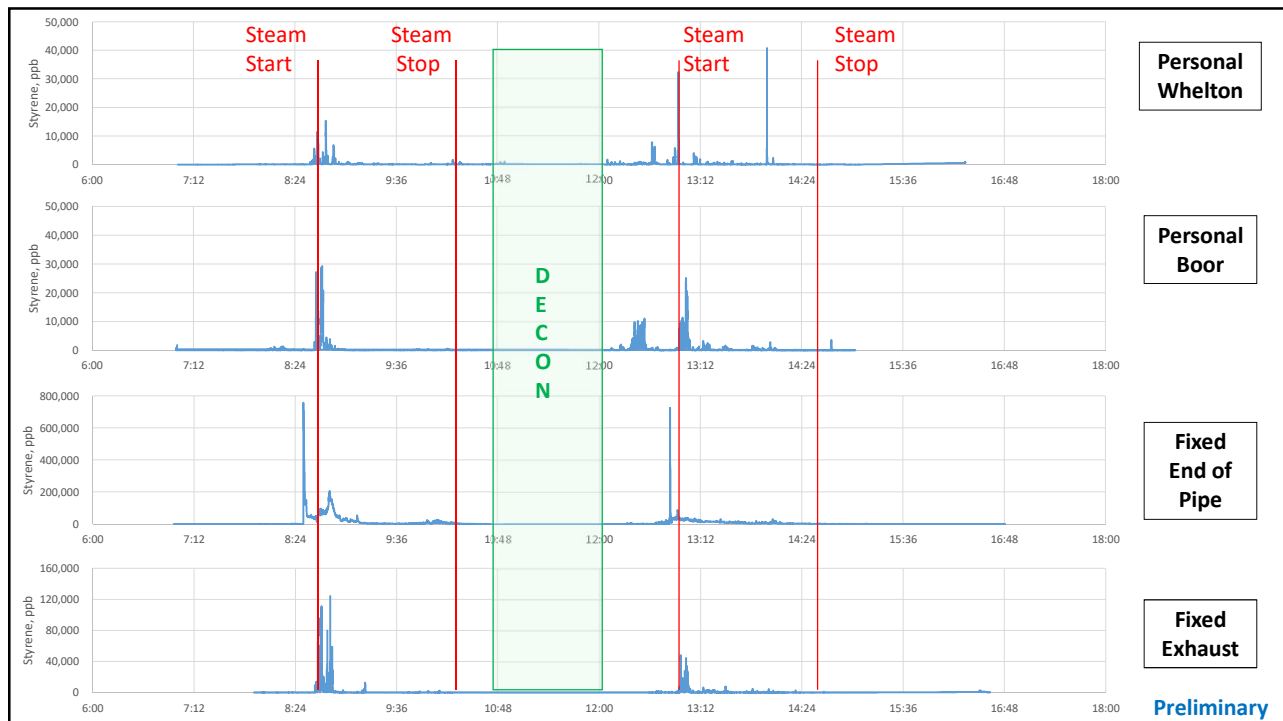
### Preliminary Results: California CIPP

Site	Host Pipe	Pulled Separate Preliner	Resin Type	Cooldown Method	Insertion Method
1	CSP	Yes, 1	A	Ambient air	Air inversion
2	CSP	No, 0	B	None	Air inversion
3	CSP	Yes, 2	A	Hot air	Air inversion
4	RCP	Yes, 1	A	None	Air inversion
5	CSP	No	A	None	Pull-in

We are still analyzing  
and interpreting CIPP air study data.
