# Maximizing the Benefits of Culvert Lining By Minimizing Chemical Emission

Andrew Whelton, Ph.D.  
Lyles School of Civil Engineering  
Environmental & Ecological Engineering  
[awhelton@purdue.edu](mailto:awhelton@purdue.edu)

Jan 5, 2019

*Session 1178      TRB Ann. Meeting*

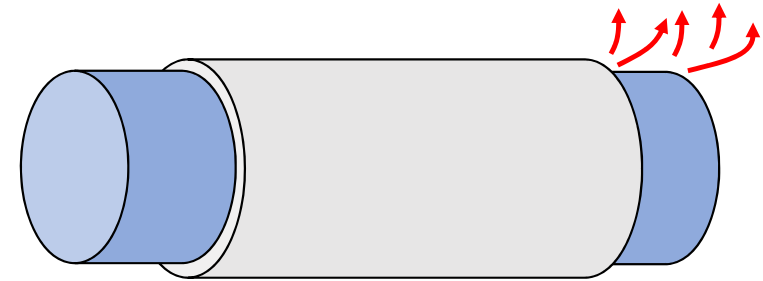
Uncured **RESIN** tube inflated  
with air inside host pipe

**“Curing (Hardening) Method”**  
Hot Water or Steam or UV Light

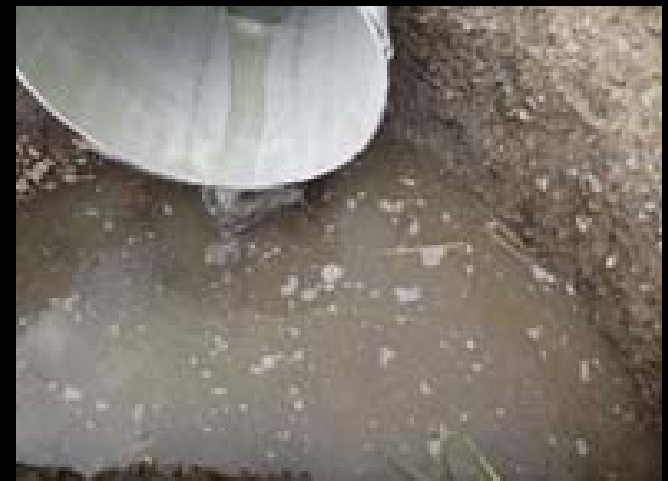
**Pinch of salt = 148 mg**

**Pinch of CIPP dust = 100 mg caused 4-16 mg/L styrene in water in 24 hr**

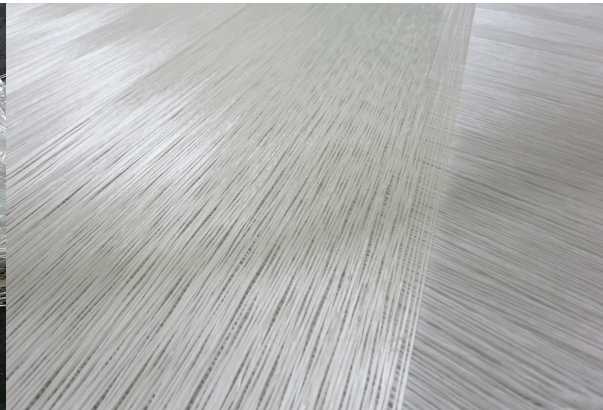
## Glass Fiber

- Advantages: Low cost, High strength, Moderate stiffness,
- Disadvantage: High density, Low fatigue resistance, Stress corrosion, brittle

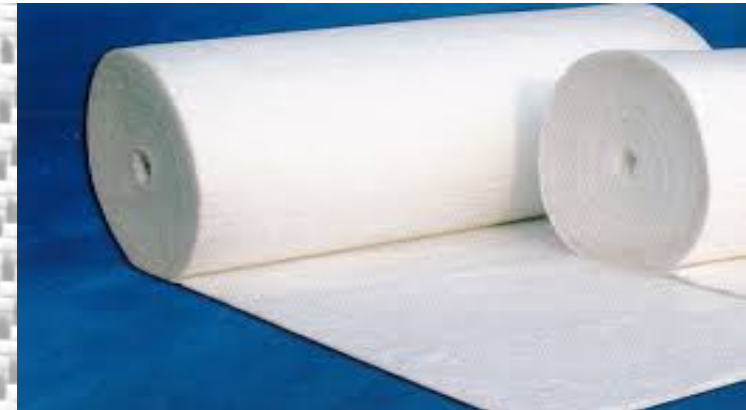
Fiberglass represents > 90% of the reinforcements used in infrastructure applications

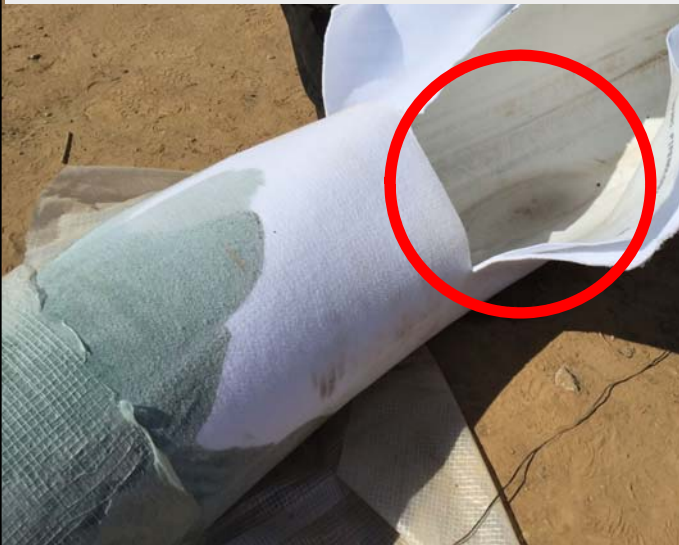
Chemical release potential:  
Condensate

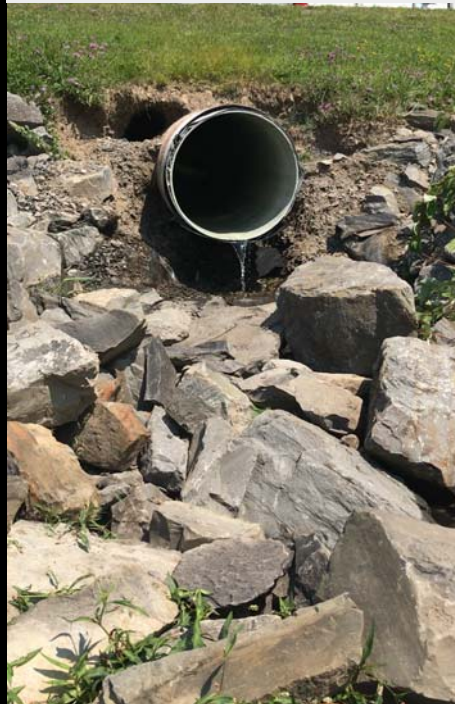
Do not permit rinse  
water to enter the  
environment

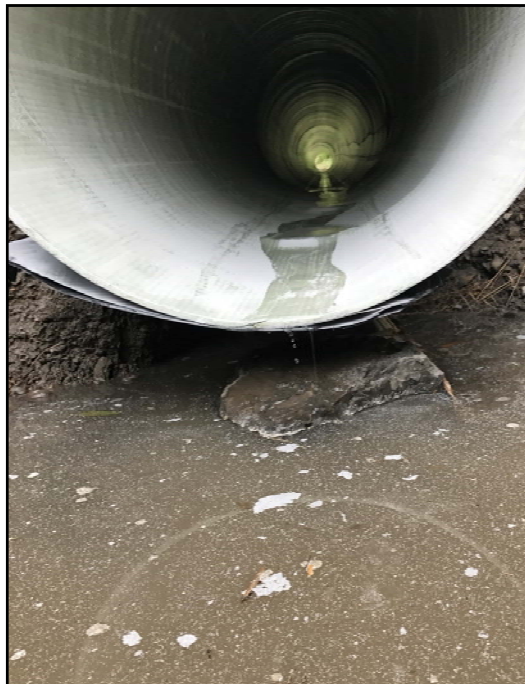
Chemical release potential:  
Blisters with bubbling liquid  
can rupture and leak

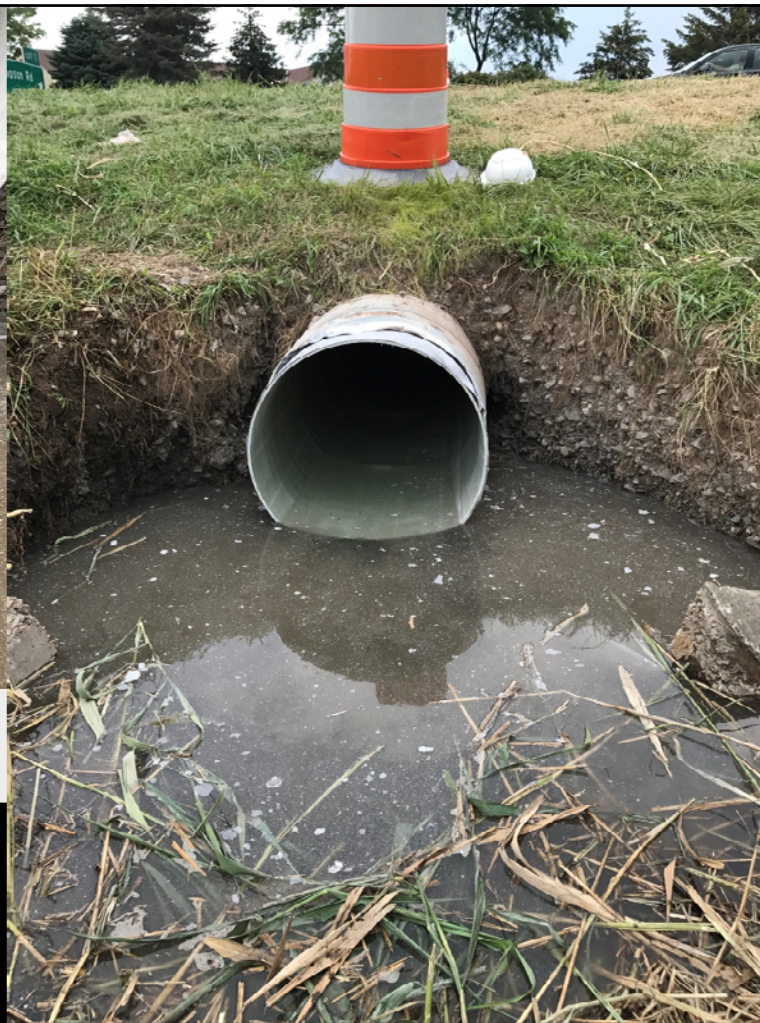
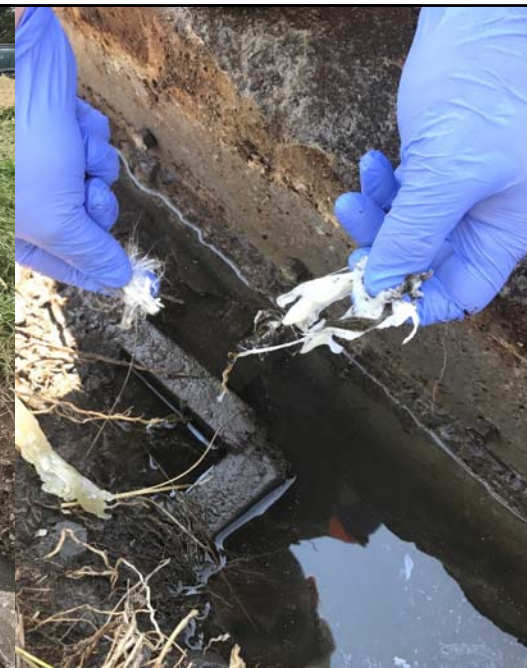
Cutting materials created during new CIPP cutting

Do not let liner materials contact the water
