Pooled Fund Project: TRB Meeting Presentations will be delivered online with Q&A

Maximize the Benefits of Culvert Lining By Minimizing Chemical Emission

Plastics for Infrastructure Rehabilitation: Their Creation, Factors that Can Affect Performance, and Characterizing Product Integrity

POOLED FUND STUDY: Contaminant Release from Storm Water Culvert Rehabilitation Technologies: Understanding Implications to the Environment and Long-Term Material Integrity, 2016-Present

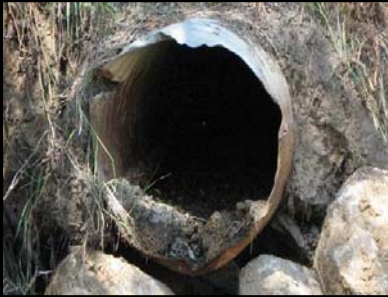
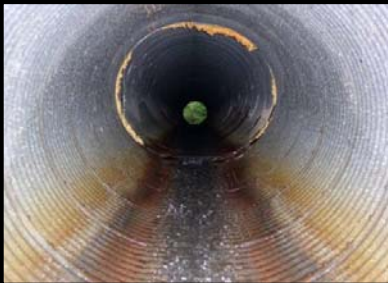
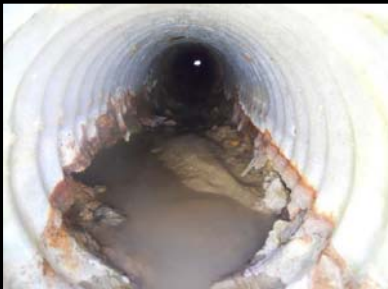
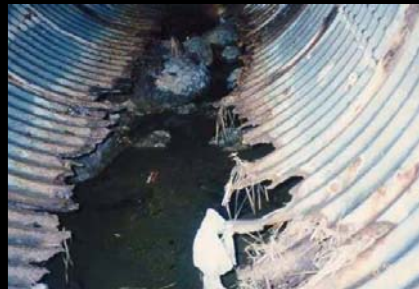
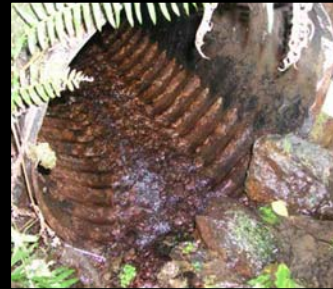
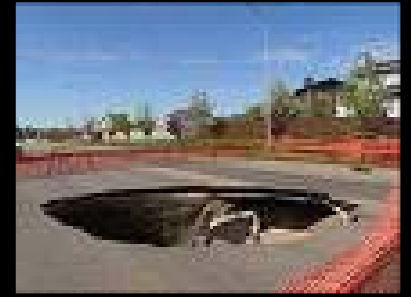
Many culverts require repair

Mechanical failures can be catastrophic
(traffic disruption, public safety)

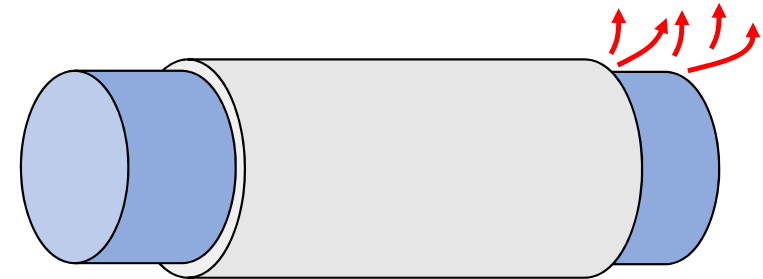
“Curing (Hardening) Method”
Hot Water or Steam or UV Light

Hard ends are cut off

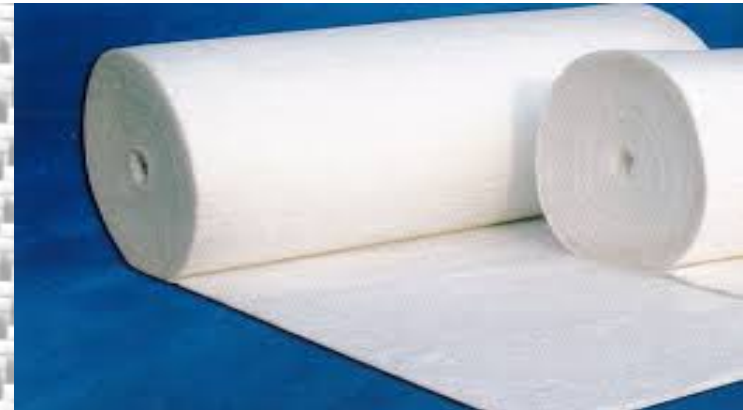
Staple Polymer

- Advantages: Extremely low cost, High toughness, Low density
- Disadvantages: Low stiffness, Low strength, low temp, poor solvent

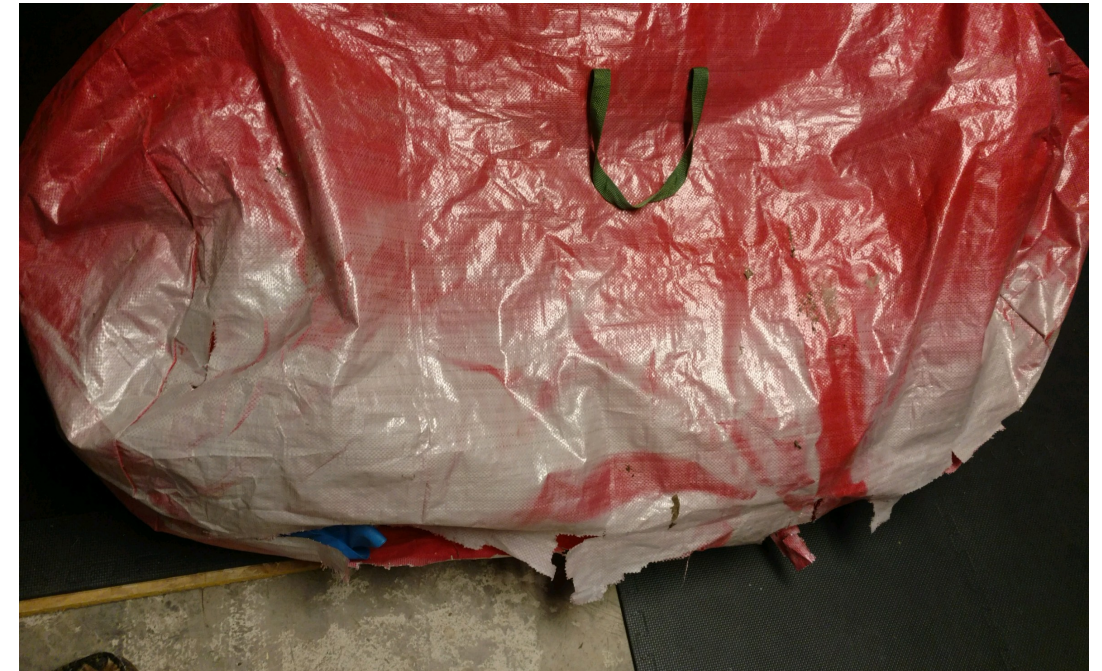
Photo of a Nylon bag under a deck for ½ summer showing light induced aging

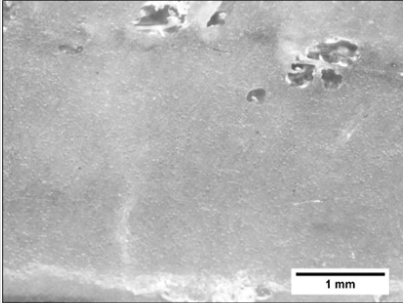
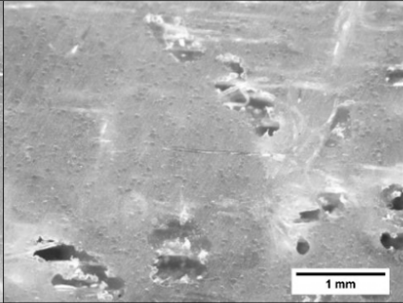
Properties	Inner Layer	Outer Layer
Surface Morphology

Porosity, %	3.41 ± 0.89	8.07 ± 1.32
Density, g/cm ³	1.24 ± 0.02	1.23 ± 0.01
Thickness, mm	2.65 ± 0.05	5.26 ± 0.09

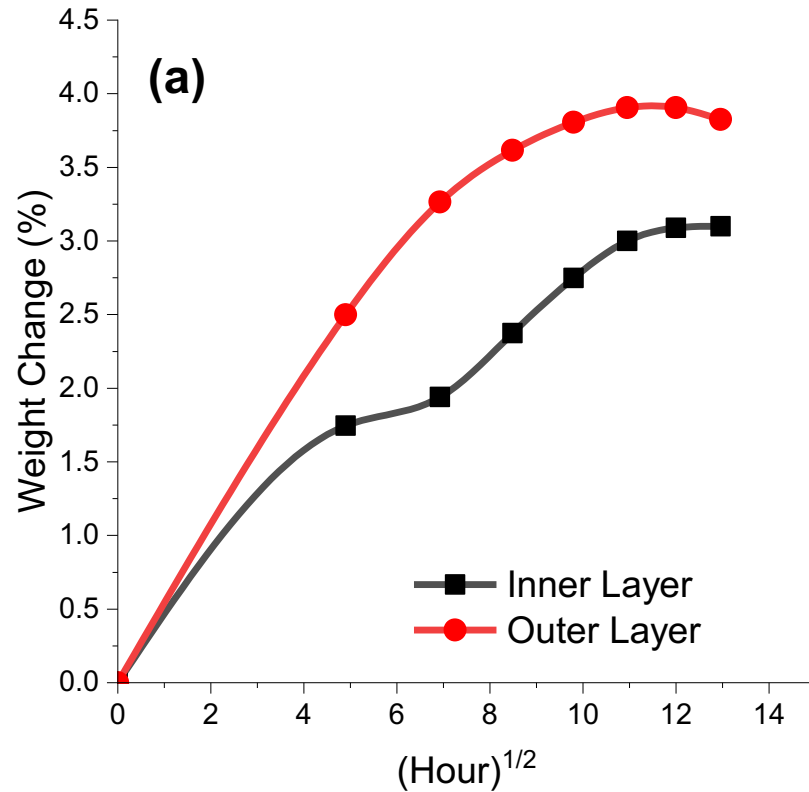
Weight (a) and thickness (b) change of inner and outer layers of CIPP as a function of immersion time in water.

- Outer layer (higher porosity) is able to sorb more water (up to 4% by weight).

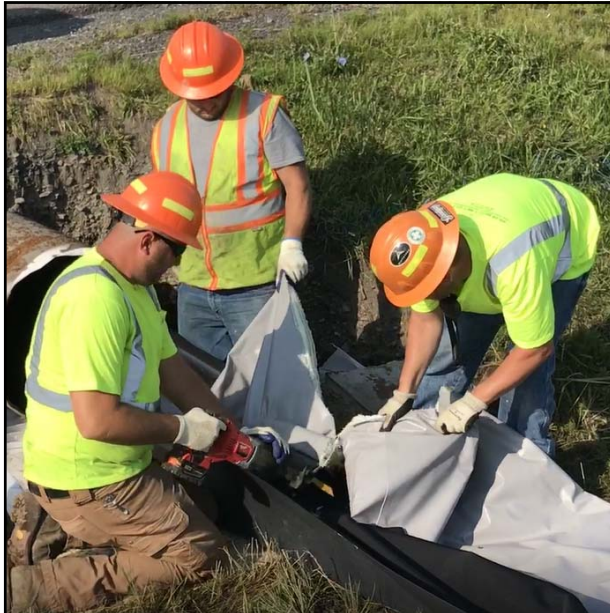
Use glide sheets to avoid uncured resin tube contact with the ground and water

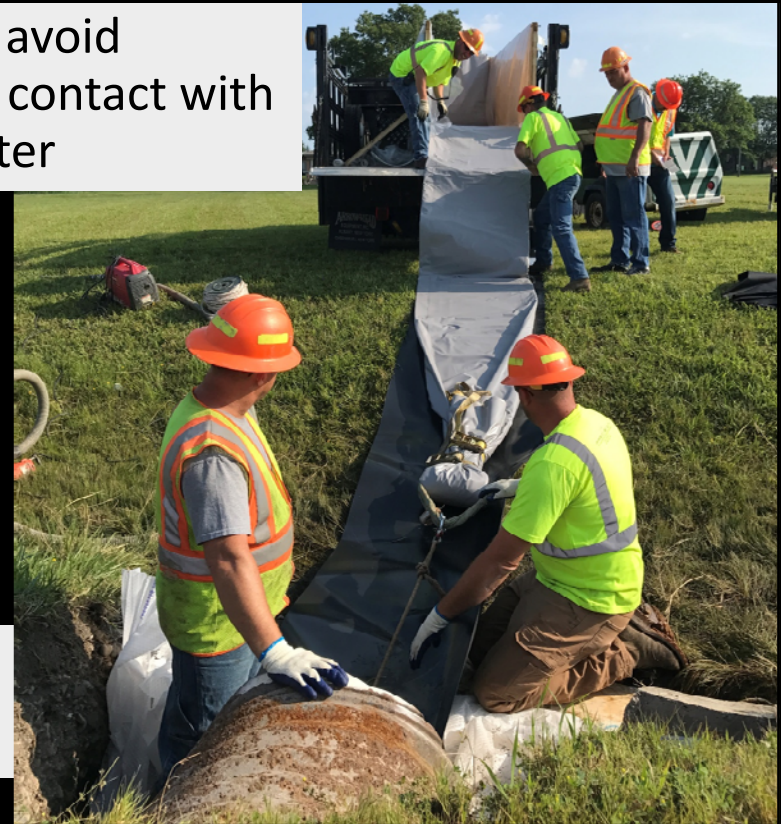
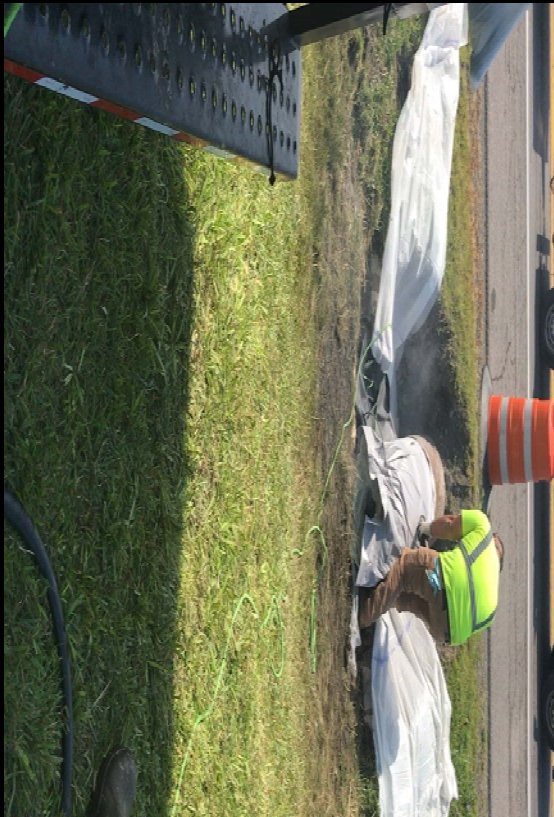
Cutting a UV uncured resin tube exposes raw chemicals to the environment

Workers can spread contamination: Do not contact PPE (boots, gloves, etc.) and then contact other materials

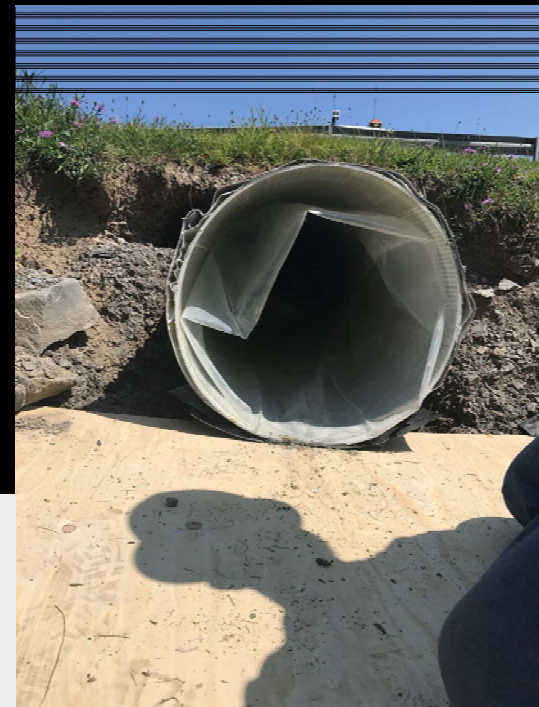
Plywood prevented the uncured resin tube from contacting standing water

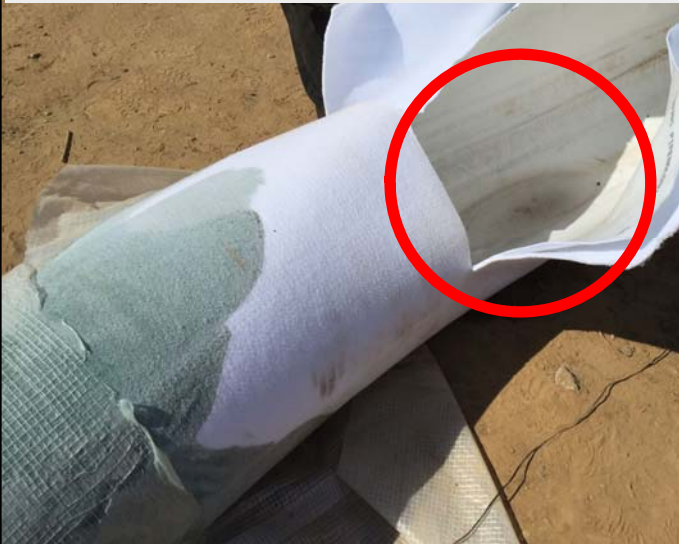
Chemical release potential:
Condensate

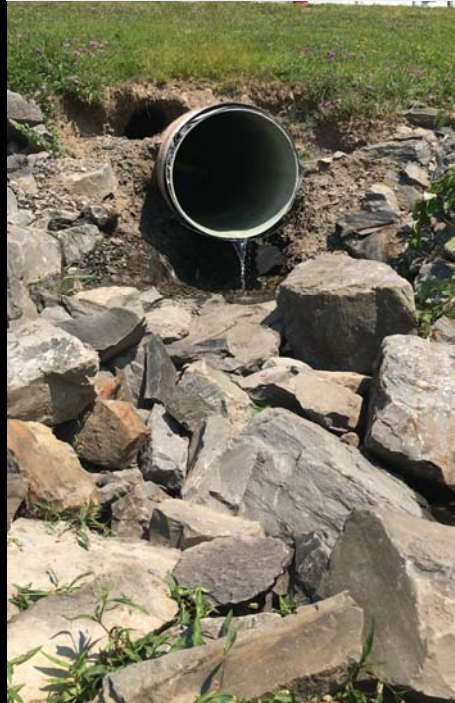
Do not permit rinse
water to enter the
environment

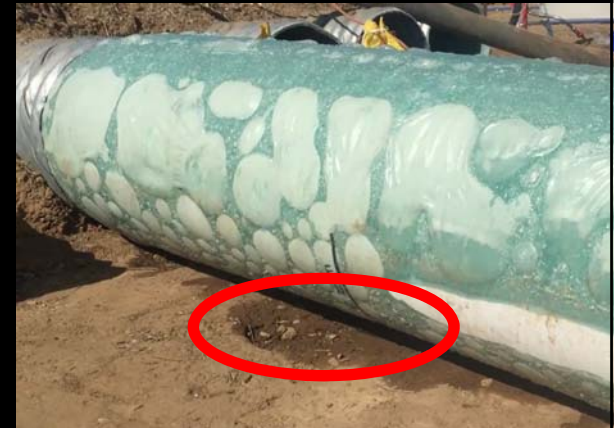
Do not permit discharge
to the environment to
include curing water,
wastewater, rinsewater,
condensate, particulates

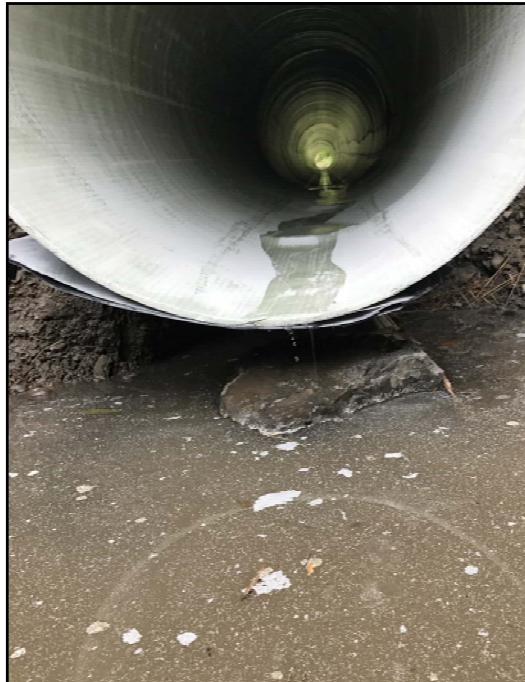
Chemical release potential:
Blisters with bubbling liquid
can rupture and leak

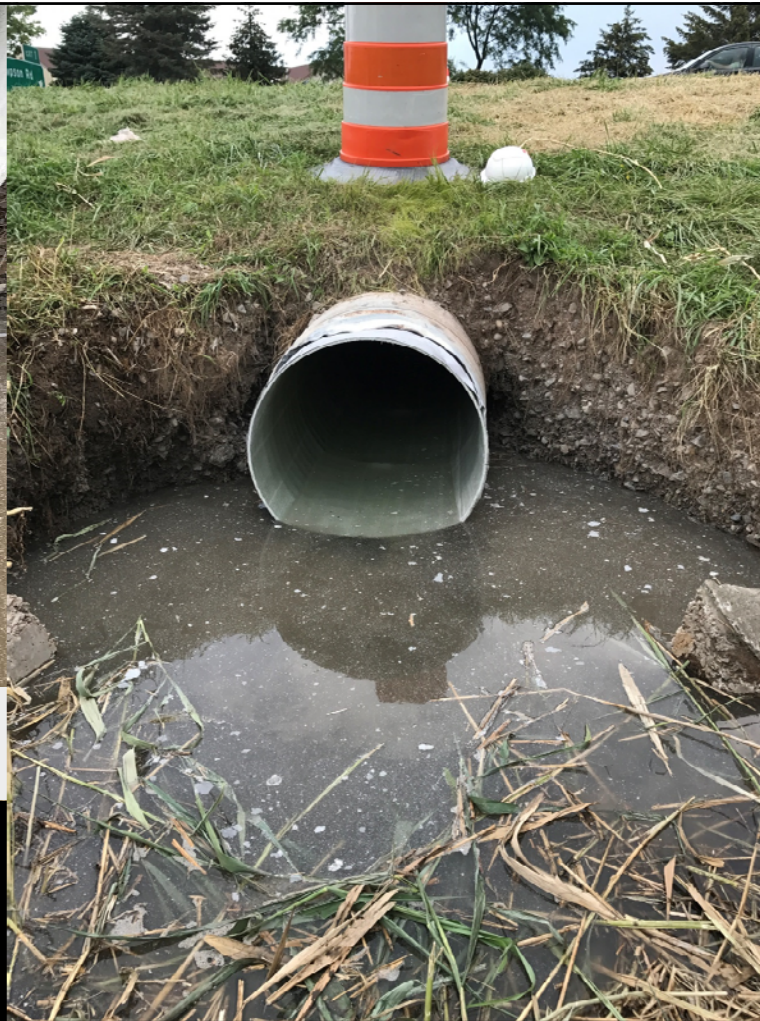
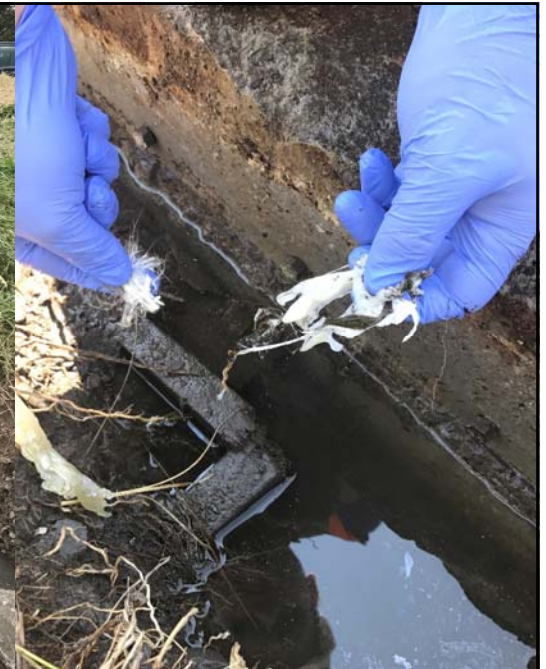
Cutting materials created during new CIPP cutting

Do not let liner materials contact the water

Chemical release potential: Dust released when cutting new CIPP

Less than a pinch of CIPP dust released 16 mg/L styrene into water in the lab in only 24 hours
