New scientific discoveries have made reducing environmental, occupational, and public health risks for polymer composite sewer pipe repairs possible

Andrew Whelton, Ph.D. Lyles School of Civil Engineering Div. of Environ. and Eco. Engineering

What is cured-in-place-pipe (CIPP)?

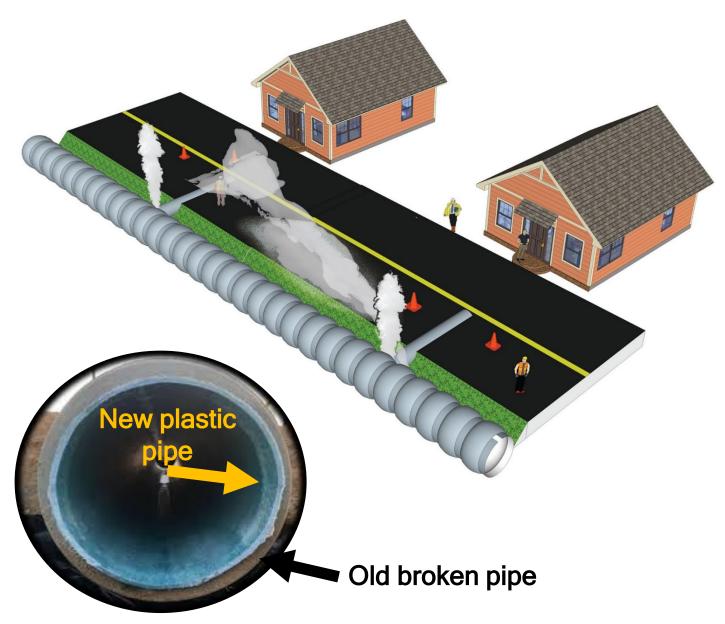
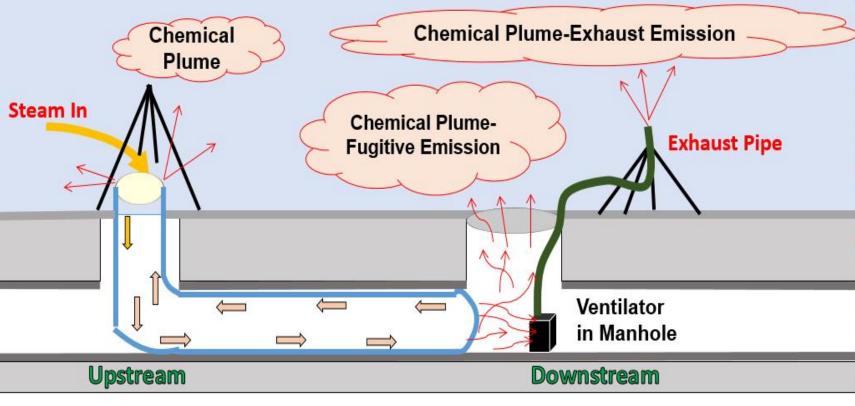
"Trenchless" pipe repair method preferred by communities nationwide

Sanitary sewer, storm sewer, drinking water pipes (4-100" diam.)

Pipes can be typically repaired in 1-3 hours instead of days or weeks

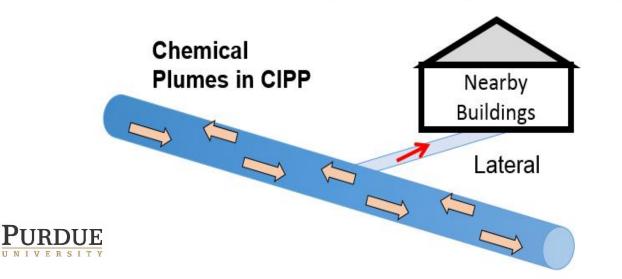
Chemical Plumes Generated by CIPP can Escape the Pipe Being Repaired

Chemical plumes can be discharged into nearby areas

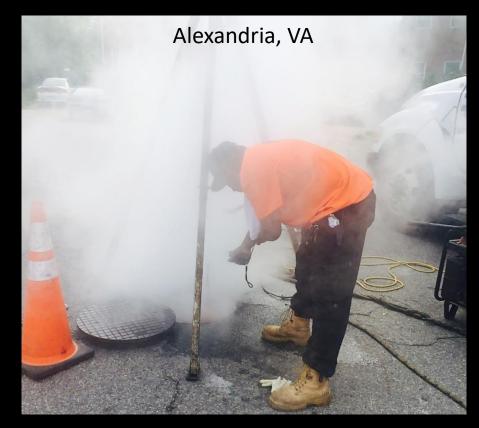
Common in the US

No waste capture No formal setback distances No formal respiratory protection No formal air monitoring

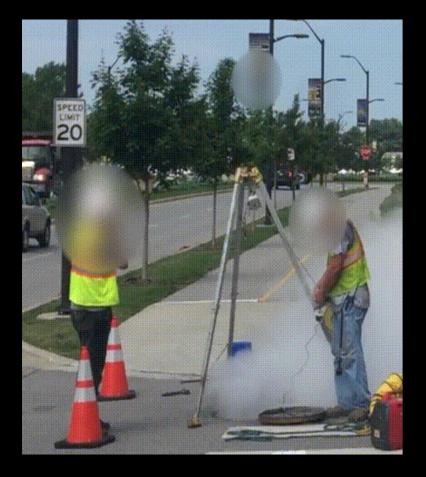
NSF RAPID Study: The plastic manufacturing waste was a multiphase chemical mixture, <u>NOT</u> Steam (vapors, particulates, droplets, partially cured resin, etc.)

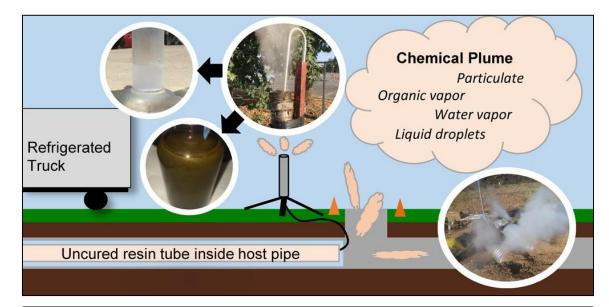
Exhaust is a multi-phase mixture, not steam

1,800 to 4,300 ppm (total) styrene in condensed material + other carcinogens and EDCs

Acute toxicity differed by worksite to mouse lung cells

Some workers were handling resin with barehands and had no respiratory protection

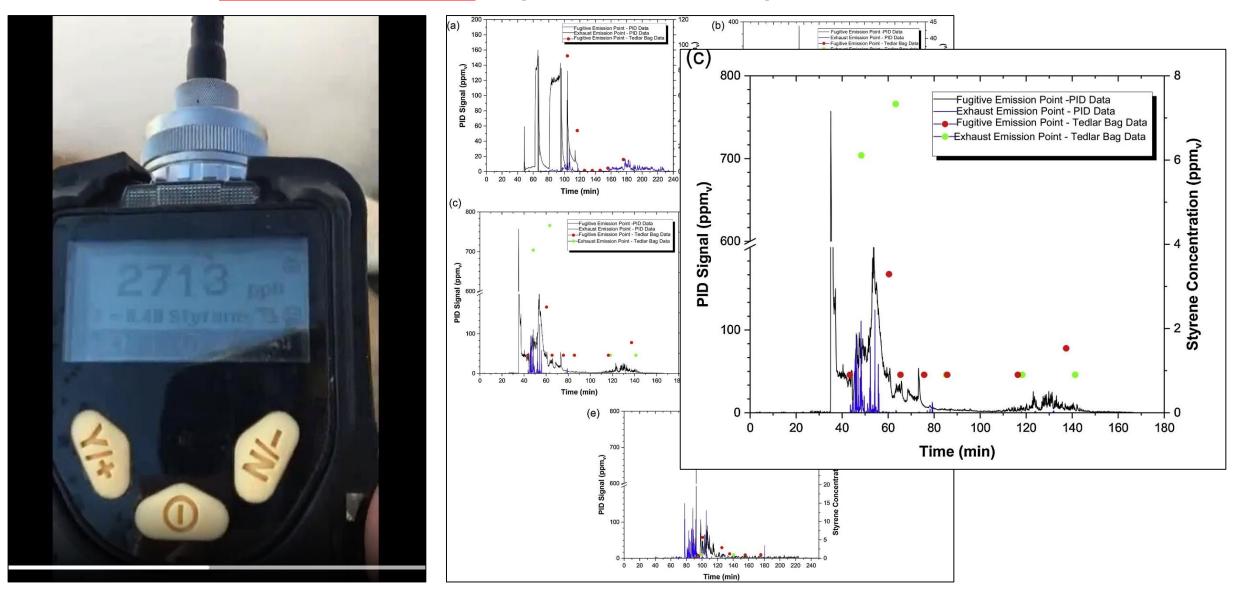
Calibrated PIDs at CIPP worksites <u>underestimated</u> and <u>overestimated</u> styrene levels by 10x to 1000x

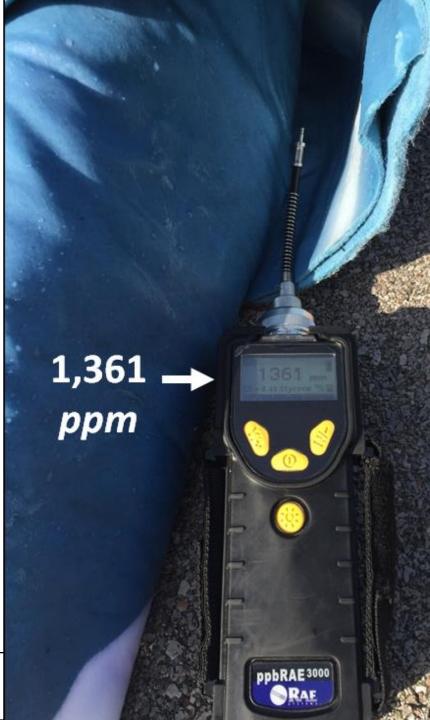
Vapors found: Styrene (>86 ppm), methylene chloride (>1.5 ppm), phenol

Many people using PIDs, but styrene vapor by PID can have 10x to 1000x error on worksite! - Unreliable.

1 to 2 wt% of final CIPP is VOC residual

Many VOCs and SVOCs in the new CIPP.

Workers contaminated non-styrene CIPP with styrene.

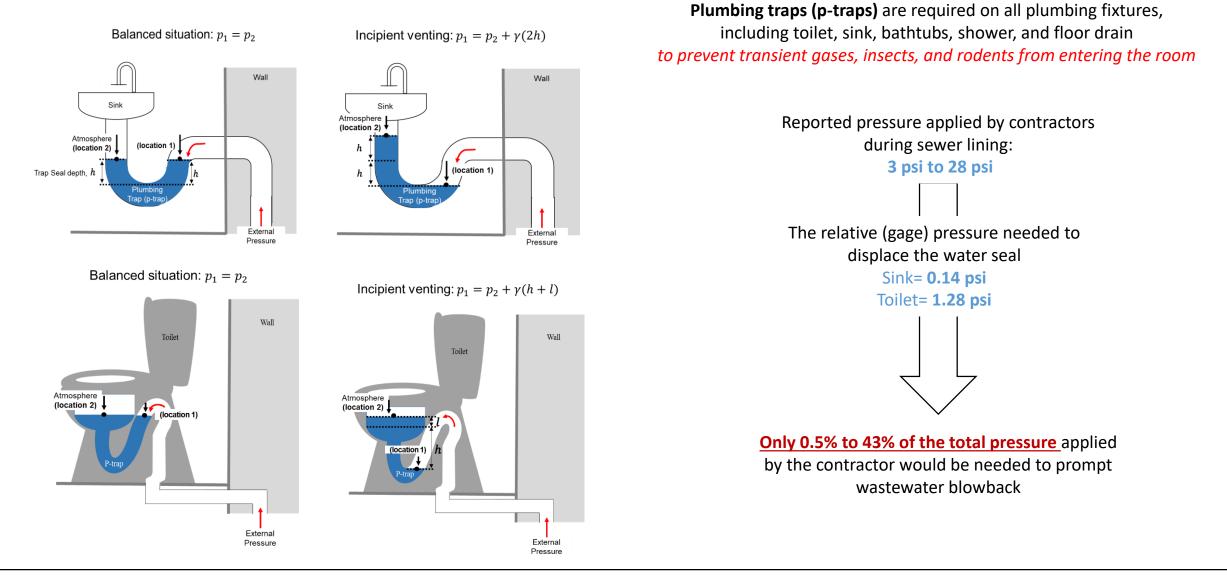
Emergency responder and public health considerations for plastic sewer lining chemical waste exposures in indoor environments

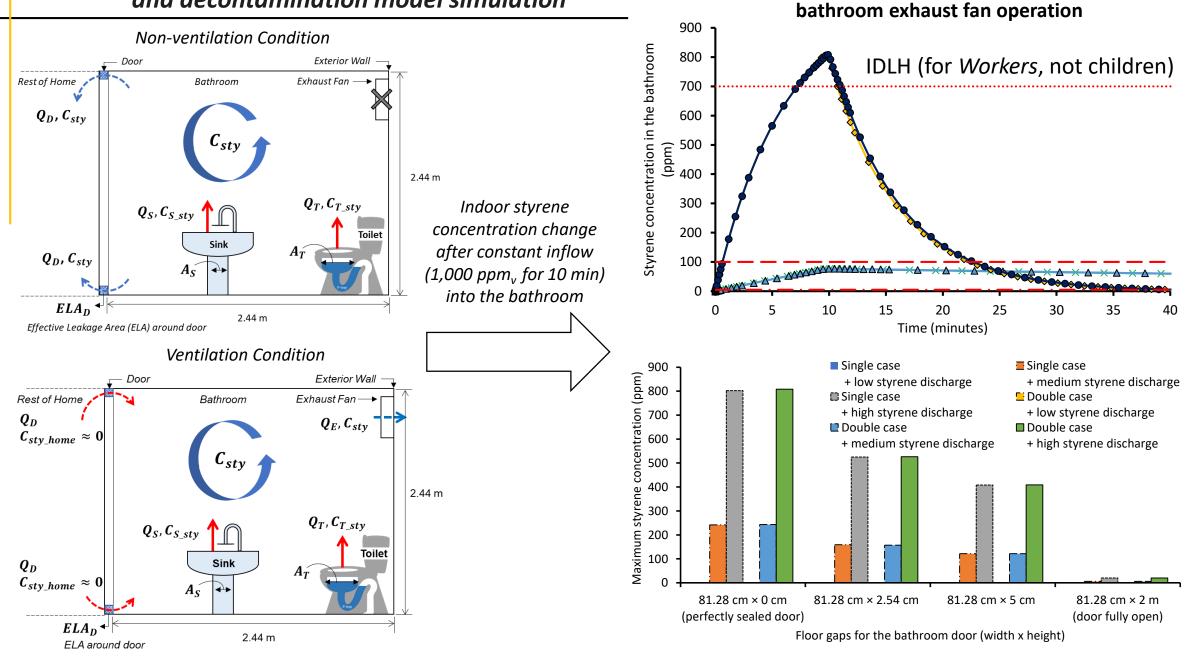
Bathroom chemical air contamination and decontamination model simulation

The bathroom air styrene concentration was influenced by

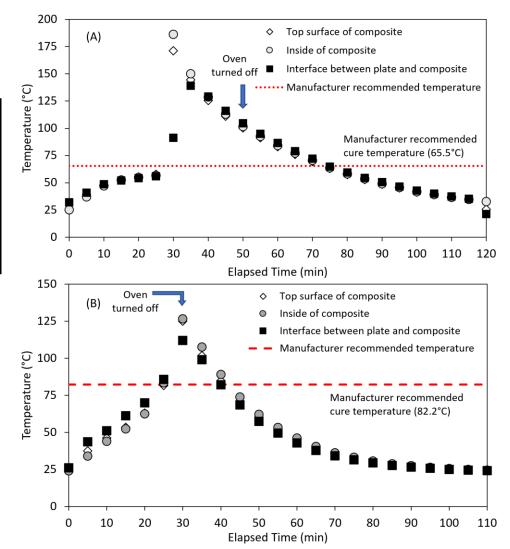
Styrene resin (39% VOC) vs. Nonstyrene resin (4% VOC)

Resin manufacturer contaminated their Nonstyrene resin with a Styrene resin (Companies do not test before installation)

By increasing the initiator loading we reduced styrene (-42%) and styrene oxide (-32%) residuals.

Only 2 compounds listed on material SDS, but 8 identified

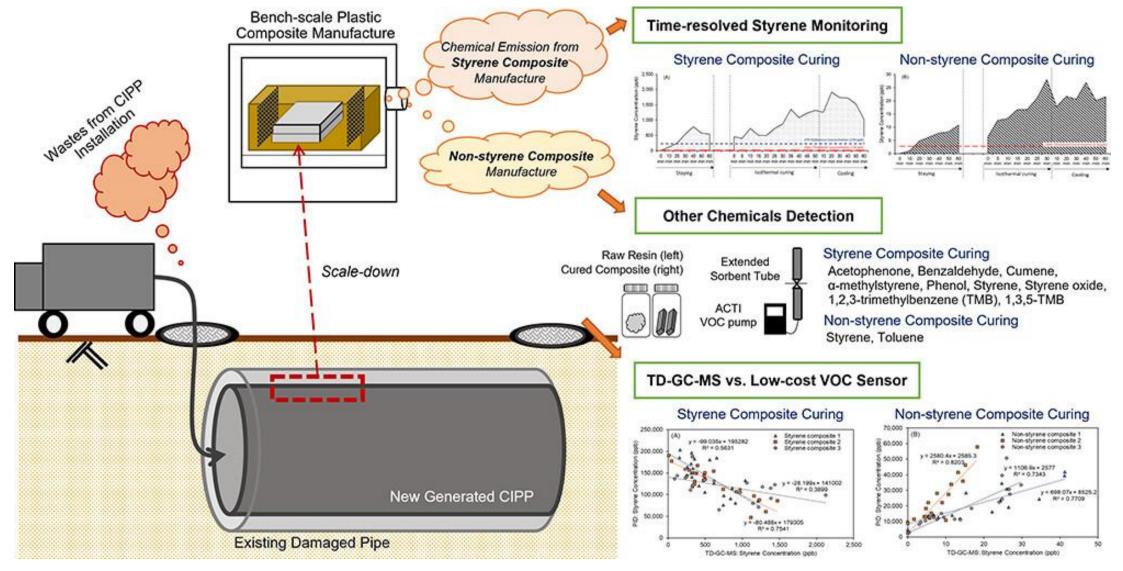
Regulatory Significance of Plastic Manufacturing Air Pollution Discharged into Terrestrial Environments and Real-Time Sensing Challenges
