Journal of Nuclear Materials 290–293 (2001) 1059–1063

Study of brittle destruction and erosion mechanisms of carbon-based materials during plasma instabilities

T. Burtseva^{a,*}, A. Hassanein^b, I. Ovchinnikov^a, V. Titov^a^a STC SINTEZ D.V., Efremov Institute of Electrophysical Apparatus, 189 631, St. Petersburg 196641, Russian Federation^b Argonne National Laboratory, Argonne, IL 60439, USA

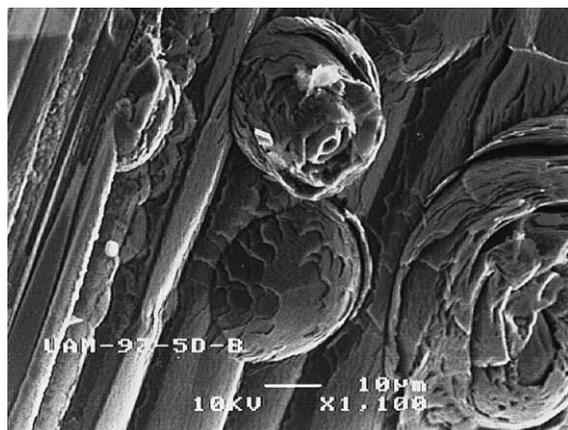
Fig. 4. Surface recrystallization and new structure formation for CFC materials during plasma irradiation.

SEM investigation demonstrated a considerable evolution of surface recrystallization processes, especially for preheated CFC materials. Surface modification with intensive formation of high porosity and cracks in all C–C composites with and without doping are shown in Fig. 2. The primary observation from surface microstructure is that all of the CFC composites eroded in a similar and very uniform manner. Cracking of C–C fiber composites usually occurs in the direction parallel to the fibers (see Fig. 3) and cracking of fibers occurs only occasionally (also, recrystallization processes can be partially responsible for crack formation; see Fig. 4).
