Maintenance Actions to Address Fatigue Cracking in Steel Bridge Structures

PROPOSED GUIDELINES AND COMMENTARY

NCHRP Transportation Research Board of
The National Academies

Robert J. Connor and Jason B. Lloyd
Purdue University
West Lafayette, Indiana

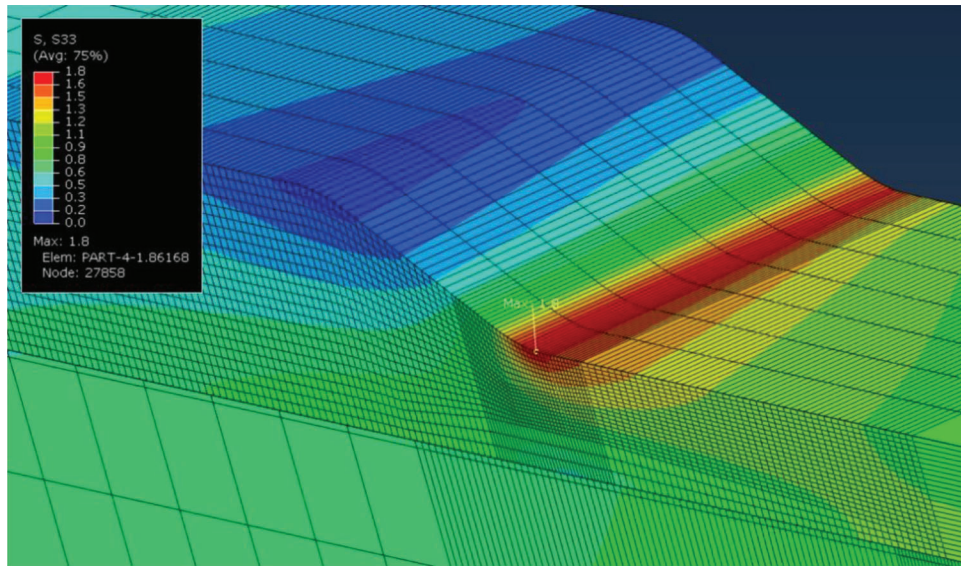
Figure 3.1 Stress concentration at a finite element model flange thickness transition.

A discontinuity refers to any interruption to uniform stress flow through a given detail. These can come in the form of drilled or punched holes, copes, thickness transitions, or attachment terminations, such as is illustrated in Figure 3.1 in the red area. However, they can also be introduced into a member through material imperfections and manufacturing processes, such as weld inclusions. Abrupt changes in the stress flow result in stress concentrations, which increase the risk for fracture. Discontinuities can be controlled through appropriate material specification, fabrication processes that utilize extensive quality control measures, and detailing practices that reduce concentrations and promote uninterrupted stress flow. These concepts do not only apply to new design, but also the design and installation of effective retrofits and repairs. In some cases, discontinuities have been introduced into bridges during fatigue or fracture retrofit and repair projects, not only by the design of the repair or retrofit itself, but also by ignorance or negligence.

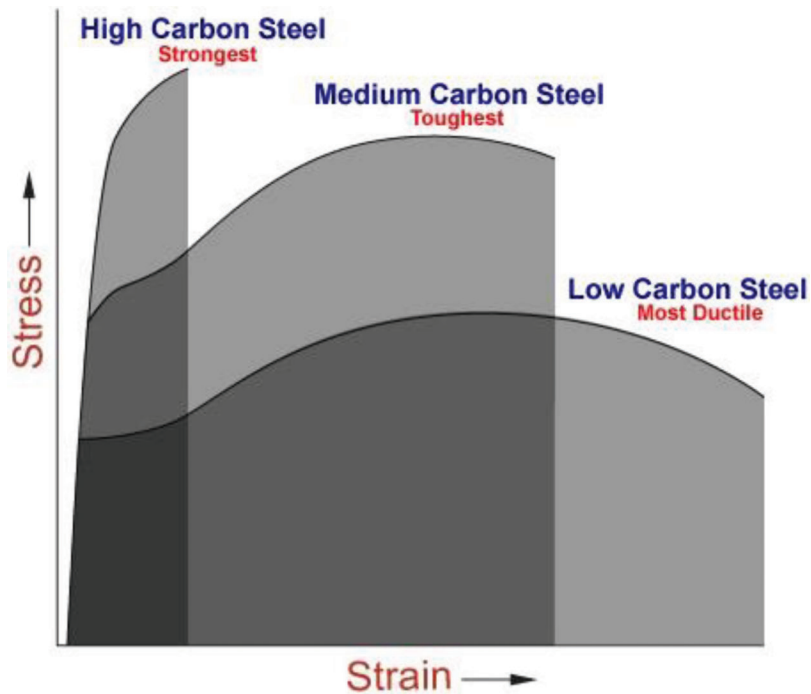
Figure 3.2. Material toughness curves (NDT Resource Center, 2014).

In simplest terms, crack propagation is a release of stored strain energy. If the release of the energy exceeds the ability of a material to absorb energy, then the crack will continue to grow. Toughness is the material property that quantifies the ability of a material to absorb energy, or resist fracture. The amount of energy that can be absorbed relates to the local plastic deformation at the crack tip prior to fracture initiation and throughout fracture propagation. This can be graphically represented by the area under the stress-strain curve. Figure 3.2 qualitatively illustrates this concept with three different types of steel. The first, High Carbon Steel, possesses high strength and low ductility and the lowest toughness. The Low Carbon Steel possesses a lesser strength, higher ductility and a higher toughness than the High Carbon Steel. The final example is the Medium Carbon Steel that fall between the previous types, possessing a compromise of ductility and strength while having the highest level of toughness. In this example, the High Carbon Steel would be expected to behave in a brittle manner. The Medium Carbon Steel better represents a typical High Performance Steel (HPS) where the optimal combination of

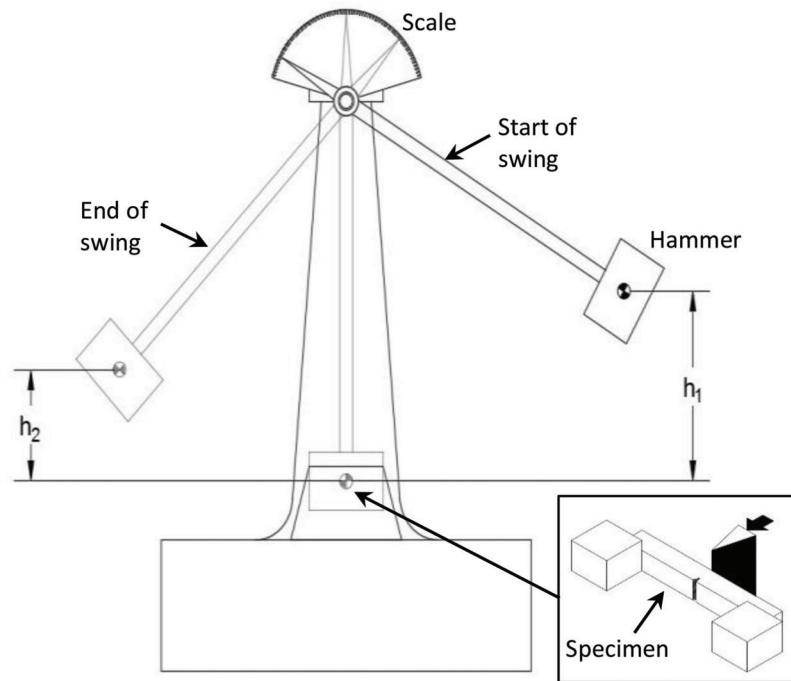
Figure 3.3 Charpy impact test machine.

During the test, a Charpy specimen is cooled to the desired temperature and maintained at that temperature for at least 5 minutes. Tongs, which are also cooled

and maintained at the test temperature, are used to extract the specimen from the cooling bath and place it in the test machine within a specified time limit, so as to minimize any warming of the specimen. Once the specimen is placed, a lever is pulled on the test machine and the hammer swings from a high position impacting the specimen opposite the notch, as shown in Figure 3.3. The energy absorbed by the specimen is measured by knowing the hammer weight, the height of the hammer in the start position (h_1) and the height at the end of the swing (h_2). The difference between these two potential energies is the energy absorbed by the specimen, which is indicated on the calibrated scale. Videos showing CVN Impact testing can be seen here: <https://doi.org/10.4231/R7H41PC8> and <https://doi.org/10.4231/R74T6G98>.

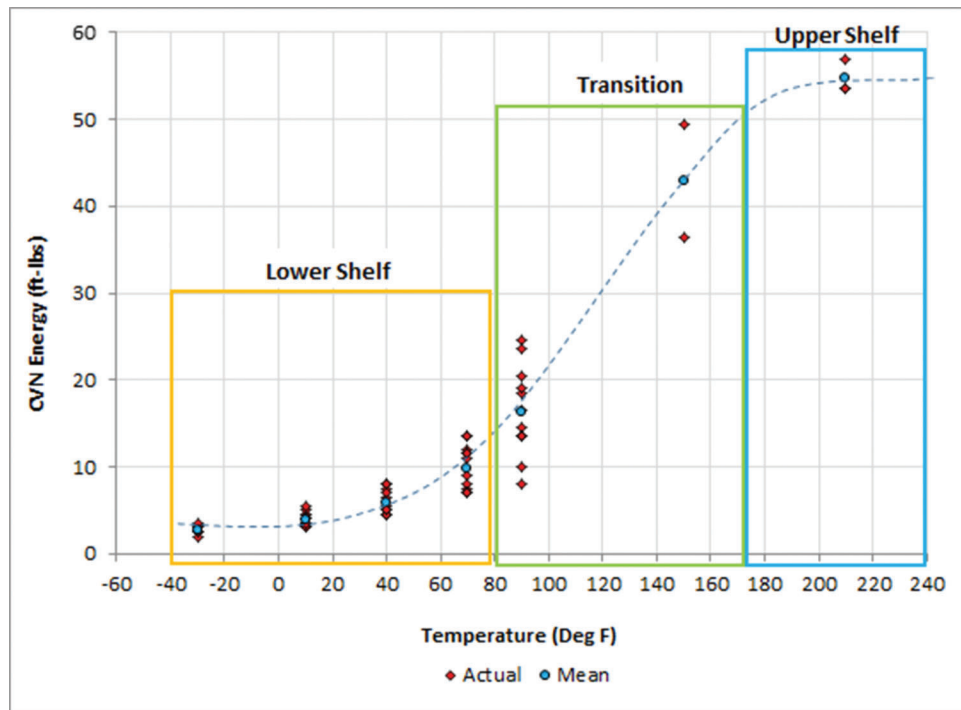
Figure 3.4 Sample of Charpy Impact Test data showing transitions.

The effect of temperature on the energy absorbed is often examined by repeating the test using identical specimens that have been cooled to various temperatures. A variety of tests at varying temperatures can establish the relationship between the measured absorbed energy and temperature. Figure 3.4 shows a sample of actual CVN test data from steel from a circa 1900 railroad truss. The general regions of the transition curve have been highlighted for emphasis. This figure illustrates that as the temperature is increased, the steel undergoes a brittle-to-ductile transition in terms of fracture toughness. The three regions often referred to are lower shelf, transition, and upper shelf. The lower shelf is associated with brittle fracture and is the region of fracture mechanics where LEFM is valid. The upper shelf is associated with ductile fracture, or tearing, where significant inelastic deformations form shear lips on the fracture surface. Between the lower and upper

shelves is called the transition region, associated with the brittle-ductile, or transitional, fracture behavior. Fractures in this region are characterized by a mix of brittle and ductile and often has larger scatter in the data. The temperature range for the transition region will differ for different steels, some being only a few degrees, while others might be spread over tens of degrees, such as is shown in Figure 3.4. It is noted that not all steels follow such an ideal curve, as shown in Figure 3.4, with some not exhibiting clear upper and lower shelves.

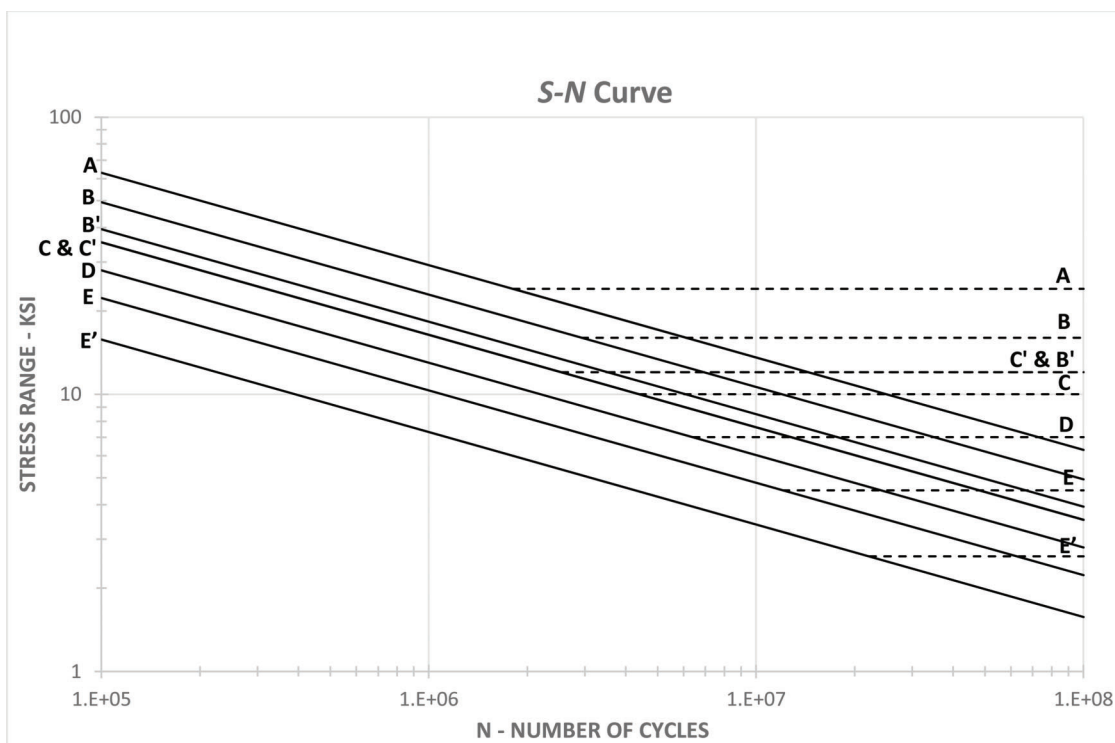
Figure 3.5 Modern S-N curve showing all AASHTO fatigue categories.

Wohler, in the mid to late 1800s to analyze failures of railroad components. The key to this approach was the $S-N$ curve, which is very similar to what is used today. An example of a modern $S-N$ curve is shown in Figure 3.5, discussed more below, where S is the nominal stress range and N is the number of cycles until significant cracking is detected. Using the stress-life method, extensive experimental fatigue testing developed the modern fatigue categories for typical steel bridge details, which were based on nominal stresses (Fisher *et al.*, 1974; Keating & Fisher, 1986; Schilling *et al.*, 1978). The current fatigue details are summarized in Section 3.4.

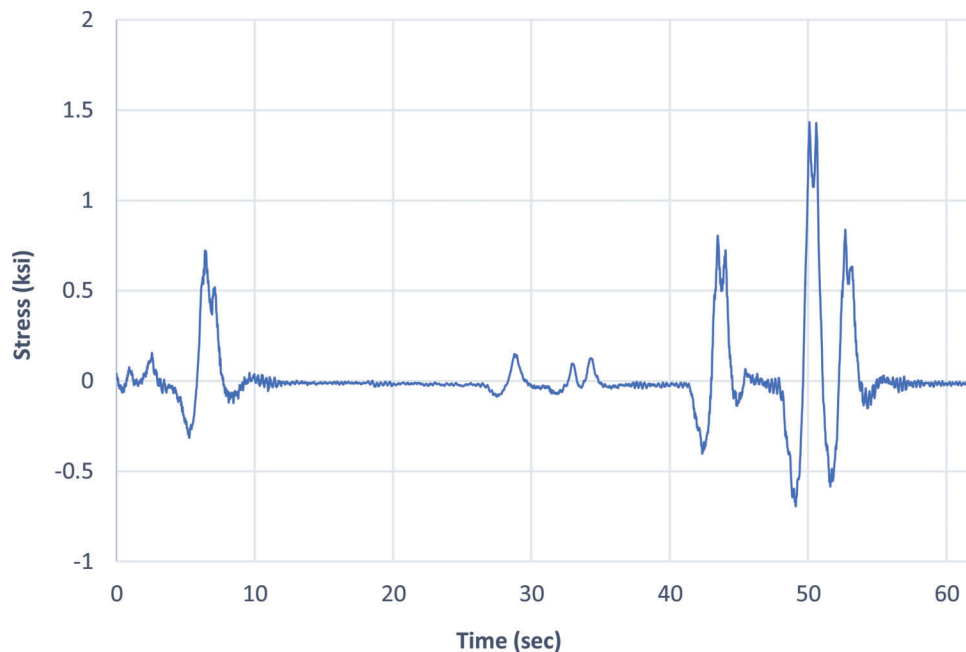
Figure 3.6 Sample variable amplitude load spectrum from field monitoring.

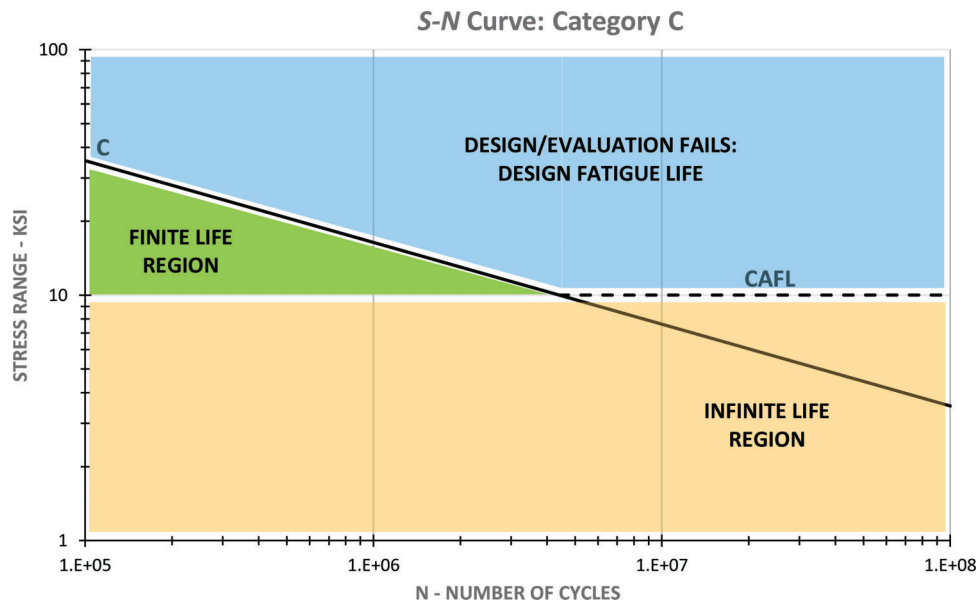
Figure 3.7 Category C *S-N* curve illustrating the regions of the plot.

Steel bridge details possessing similar fatigue resistance have been grouped into categories and assigned letters A through E'. There are eight categories in total, listed here in descending order of fatigue resistance: A, B, B', C', C, D, E, and E'. An AASHTO design curve, such as that seen in Figure 3.7, represents the fatigue resistance for each respective category. The sloped portion of the curve represents the number of cycles at a given stress range that can be expected for a detail before significant cracking will occur. The region of the plot below the sloped line is referred to as the

“finite life” region. The horizontal section of the curves are called the Constant Amplitude Fatigue Limits (CAFL) or Constant Amplitude Fatigue Thresholds (CAFT). These terms are synonymous and used interchangeably in the literature. If the maximum stress range is less than the CAFL for a given detail category, it can be expected that an infinite number of cycles can be resisted without incurring fatigue damage. The region of the curve below the CAFL is referred to as the “infinite life” region.

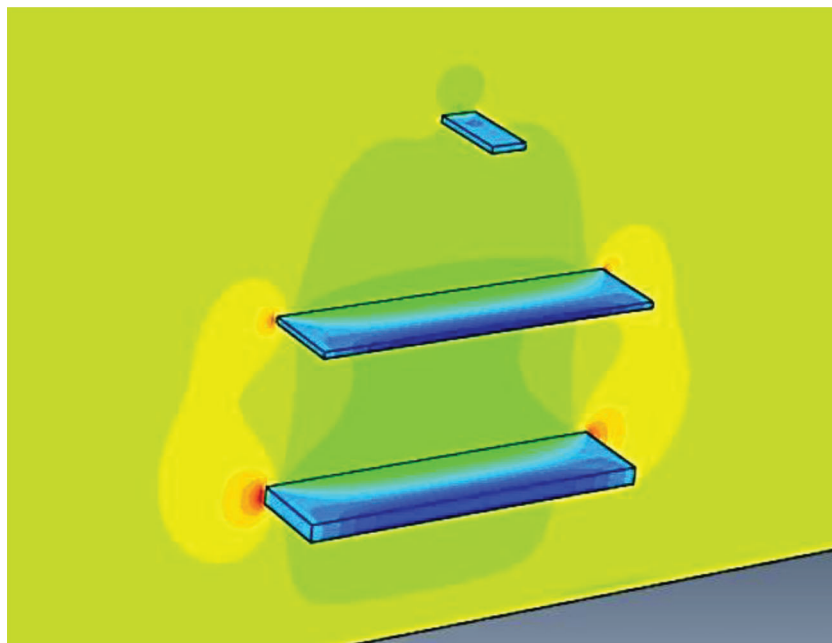
Figure 3.8 FEM illustrating differing stress concentrations for length and thickness effects.

Take for example Figure 3.8, where results from a finite element model (FEM) has been rendered with primary longitudinal stress plots. The three welded attachments represent generic welded plates attached to a web plate. The shortest (top) plate is 2 inches long and 3/8 inch thick and would be considered a Category D detail at the ends. The middle plate is 20 inches long and also 3/8 inch thick and would be considered a Category E detail at the ends. The bottom plate is also 20 inches long, but is 1 inch thick and would be considered a Category E' detail at the ends. Notice how the stress concentration changes from the top plate to the bottom plate, as seen by the increasing accrual of orange and red contours near the ends of the attachments. This FEM nominally illustrates how a longer attachment “collects” more stress than a shorter one of equivalent thickness and how similarly a thicker attachment “collects” more stress than a thinner one of equivalent length. Stresses flow from the web plate into each of the attachments and back out again, concentrating at the ends of each. A similar comparison could be shown where with increasing radii at the ends of the attachments the stress concentration is reduced.

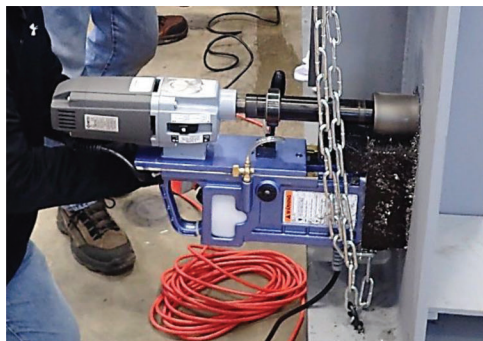
Figure 4.1 (Left) Example of magnetic-based drill, (Right) Annular cutter used for hole drilling.

The equipment recommended for hole drilling includes a magnetic-based drill and annular cutter, such as that seen in Figure 4.1. Although, hand drills have been shown to be effective, even for larger diameter holes, when operated by trained and experienced crews, magnetic-based drills offer superb control and precision for a wide range of hole sizes. The greatest challenge can be positioning the drill in tight spaces where intersecting elements of a detail leave little room for the drill to seat properly.

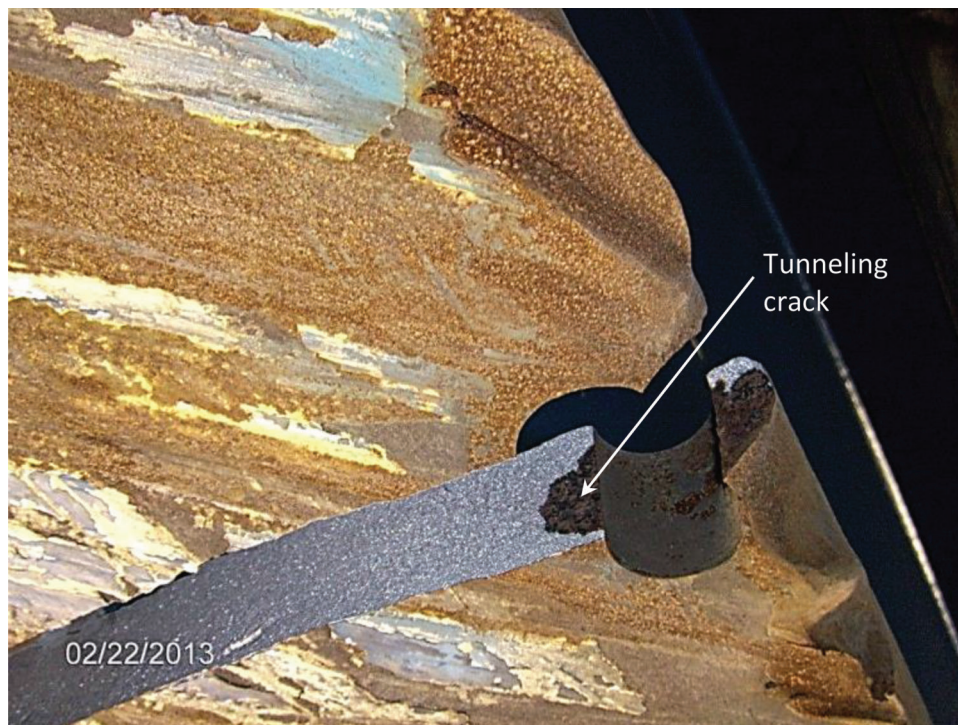
Figure 4.2 Crack tip tunneling contributing to a missed crack tip that later fractured.

Crack tunneling can also contribute to missed crack tips if the engineer or technician is unaware of this phenomenon. Crack tunneling is the term used to describe the preferential advance of the crack tip at the center of a plate with the edges lagging behind. Additional triaxial restraint through the thickness of the plate can promote slightly quicker growth rates with a hidden leading edge, particularly in thicker plates. An extreme example of crack tunneling is shown in Figure 4.2 where a drilled hole was installed to attempt to arrest a crack caused during an impact event. The corroded surface indicates the extent of the previous crack and the bright silver surface indicates the new fracture that propagated instantaneously during another impact event some months later. Notice that the previous crack tunneled ahead of where it breaks the surface of the plate. Furthermore, surface inspection methods

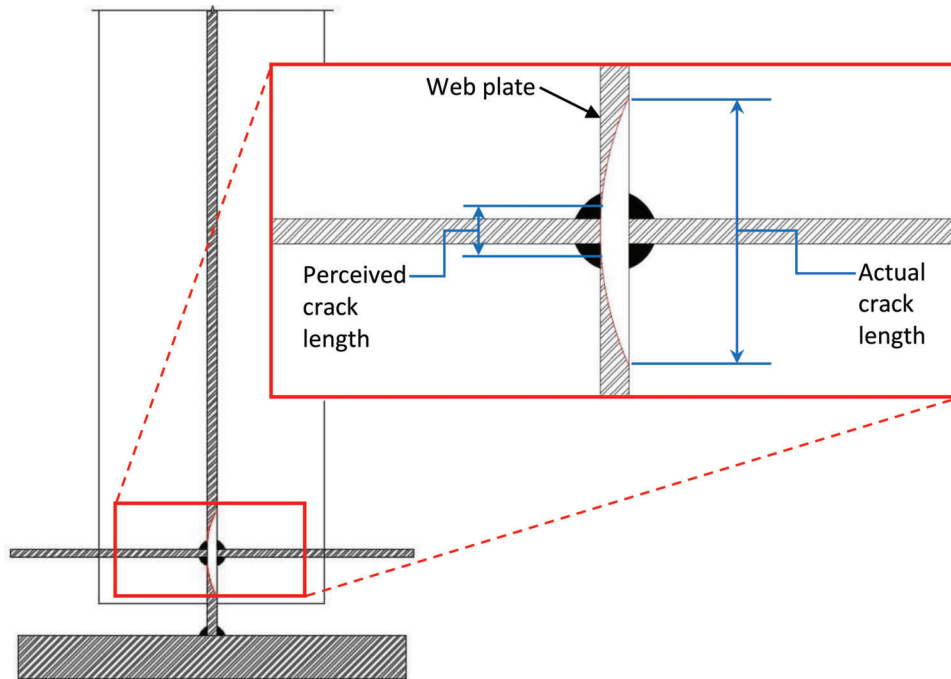
Figure 4.3 Crack length appears different on each side of a plate as it transitions to through-thickness.

A similar effect has been observed for penny-shaped fatigue cracks that will be one length on a given side of a plate and appear to be shorter on another as the crack transitions to a through-thickness crack. For this reason NDE should be performed on both sides of the cracked plate to ensure the longest dimension is characterized and the leading edge is arrested with the drilled hole. A sketch illustrating an extreme example of this concept is provided in Figure 4.3, which shows the cross section view of a typical interior plate girder with welded gusset plates. The hatched section indicates the uncracked section. Notice that if inspection only occurred on the left side of the web plate, the crack length would be severely mischaracterized and it would be possible that the crack tip would not be removed during hole drilling.

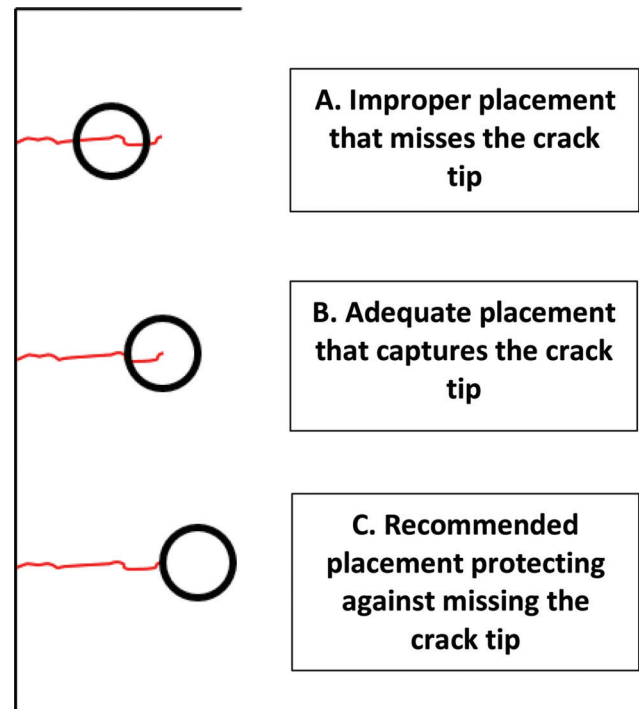
Figure 4.4 Improper and proper drilled hole placements for crack arrest.

Correct hole placement, relative to the crack tip, is one of the most important considerations for effectively drilled holes. Consider the examples of hole placement illustrated in Figure 4.4, as first proposed by Fisher *et al.* (1980). The top example, A, shows a case where the crack tip is entirely missed by the drilled hole and the crack tip is allowed to continue growing. The second, B, depicts an acceptably placed hole because it adequately captures the crack tip. The third scenario, C, is the recommended placement. The hole is drilled such that the edge of the annular cutter just intercepts the crack tip. This approach is recommended because it better safeguards against the possibility of missing the tip. Even if the hole is inadvertently drilled slightly ahead of the crack tip, the crack will only be able to grow until

- If the removed core splits in half, then the crack tip has been missed and the hole placement corresponds with scenario *A* in Figure 4.4. The crack tip should be relocated using MT or PT and then another hole drilled, or grinding should be performed to remove it.
- If the crack can be seen on one edge of the hole in the drilled plate, but not on the opposite side, then the tip has been adequately removed (see Figure 4.9). The crack may also appear on one side of the removed core, in which case the hole placement corresponds with scenario *B* in Figure 4.4.
- If the crack can be observed on one edge of the drilled plate, but not on the opposite side, and also cannot be observed anywhere in the removed core, then the hole placement corresponds with scenario *C* in Figure 4.4.

2. Position the magnetic-based drill as seen in scenario C of Figure 4.4. *Caution: Tie off the mag-based drill to the girder using sturdy clamps and chainrope in the event of power loss. This will help prevent injury or damage to equipment.*

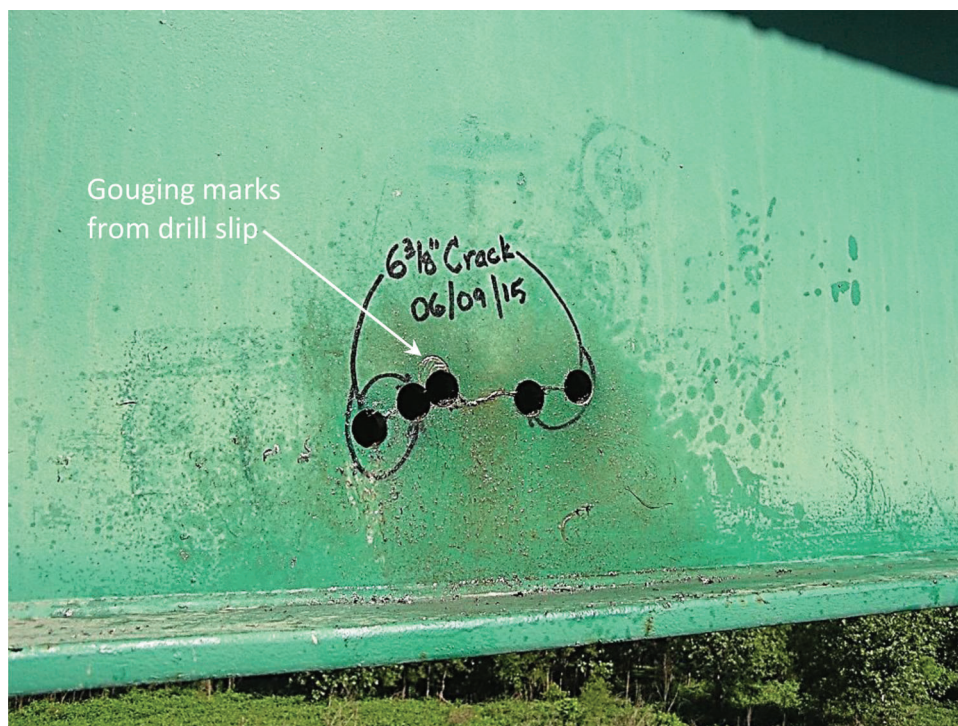
Figure 4.5 Example of chasing the crack tip with repeated drilling.

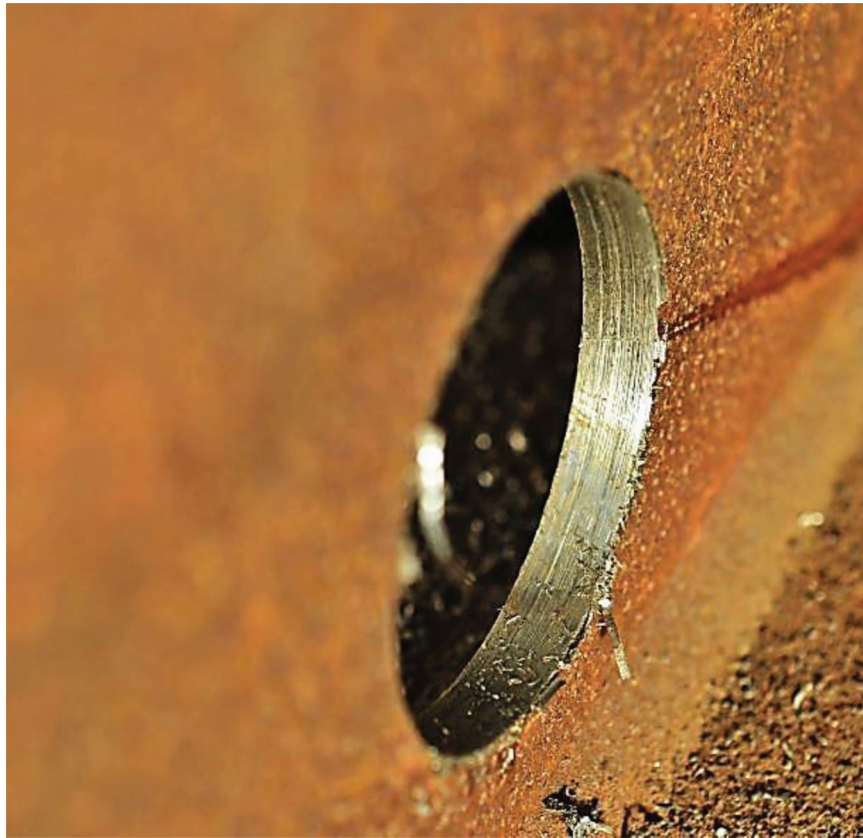
Figure 4.6 Drilled hole showing rough edges and burrs.

Another important consideration is the edge condition of the hole. The edge condition of the hole may very well impact fatigue life of the repair or retrofit more than the diameter of the hole. Even the quality of the drill bit used can have an effect on the fatigue life. Brown *et al.* (2007) found that holes drilled with dull bits often resulted in fatigue life similar to punched holes, or about Category C. They reference other research which reportedly has shown that these differences can drop the fatigue resistance of the hole to as low as Category D. Figure 4.6 shows an example of the edge conditions following drilling and before sanding. The

cutting process naturally leaves rough edges and burrs that can generate stress concentrations that over time can become initiation sites for fatigue cracks. A recommended sanding procedure includes using an 80 to 100 grit flap wheel with an angle grinder around the outer edges of the hole on both sides of the plate. Then the inside of the hole should be sanded using an 80 to 100 grit flap wheel with a die grinder. The result is a smooth-to-the touch surface free of burrs and rough and gouged edges, while being careful not to burnish the surface, as discussed for painting in Section 4.2. Also, sometimes when drilling begins, the magnetic base may shift as the annular cutter digs into the plate. This can happen when the magnetic connection to the plate is insufficient due to a number of possible reasons, such as excessive moisture, oil, or corrosion, plate curvature, or on very thin plates. When this happens, gouges can result that are capable of initiating cracks over time. This condition can be observed in Figure 4.5 above the third drilled hole from the left. The gouges should be removed using the surface grinding techniques discussed in Section 4.4.

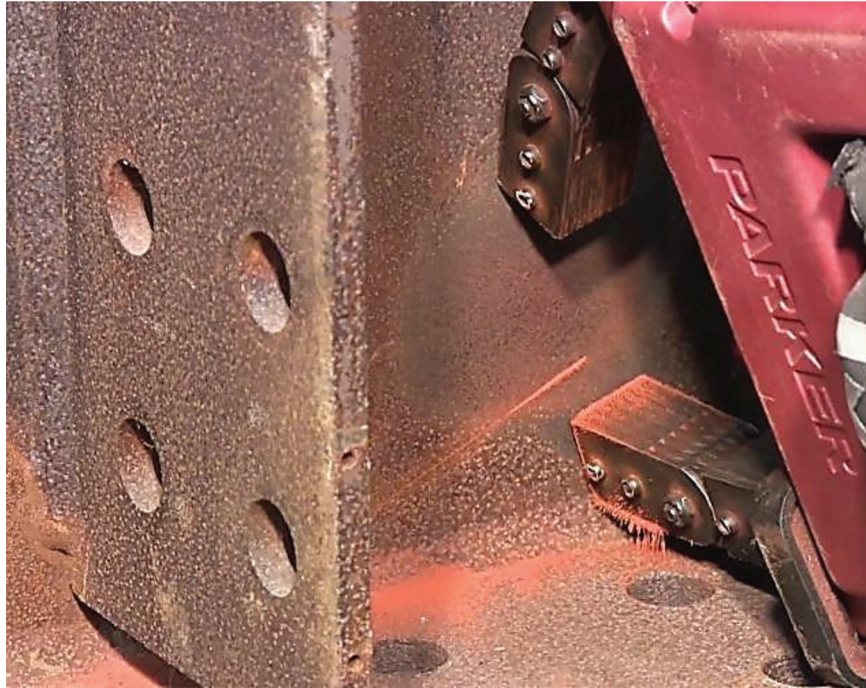
Figure 4.7 Magnetic Particle Test performed before drilling crack arrest hole in order to locate the crack tip.

1. Locate the crack tip using enhanced inspection techniques, such as MT or PT. Figure 4.7 shows a MT inspection being performed where the crack is highlighted by the red magnetic particle dust. Inspect both sides of the plate to ensure the tip is not missed.

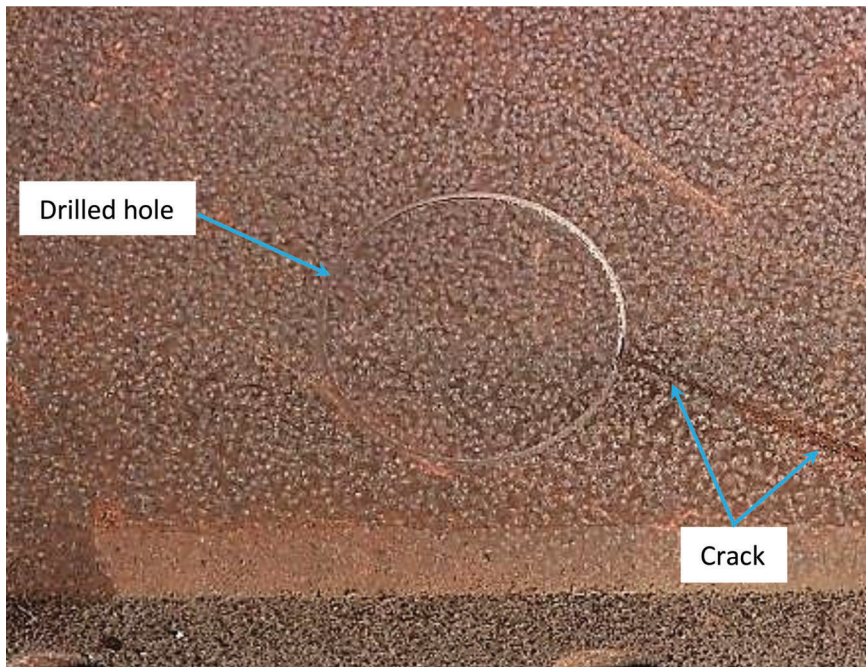
Figure 4.8 Shows annular cutter breaking the surface on the opposite side of the plate, positioned correctly to intercept the crack tip.

4. Check the drilled plate and removed core for evidence of the crack tip, as discussed in Section 4.3.1. Figure 4.8 shows the back side of a plate as the annular cutter breaks the surface. Proper placement of the drilled hole relative to the crack tip is evident.

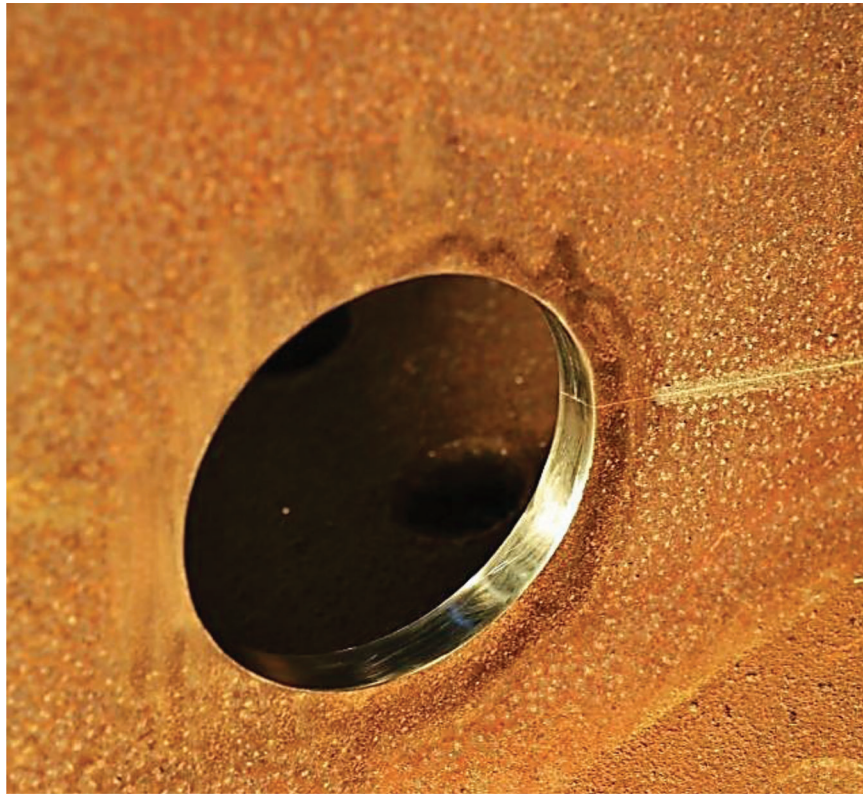
Figure 4.9 Example of finished crack arrest hole prior to painting.

6. Sand the edges of the drilled hole using an 80 to 100 grit flap wheel with an angle grinder on the exterior edges and 80 to 100 grit flap wheel with a die grinder on the interior edges. An example of a polished drilled hole is shown in Figure 4.9.
7. Paint the repair area using recommendations provided in Section 4.2.

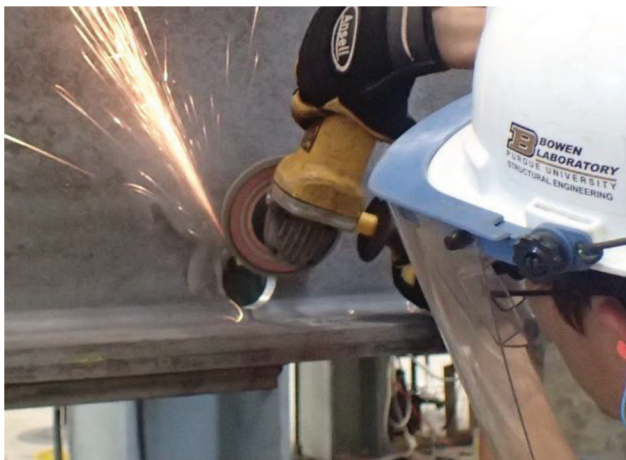
Figure 4.10 Typical angle grinder with flap wheel.

There are two main types of handheld grinders, angle and die. Grinding wheels for the angle grinder typically come in either 4.5 inch or 9 inch diameter and a wide range of types and grits. Also called a disc grinder, the angle grinder can also be used to quickly cut steel when using a cutting wheel. An example of an angle grinder is shown in Figure 4.10 paired with a flap wheel for sanding. A typical die grinder is shown in Figure 4.11 fitted with a rotary burr bit for rough grinding. The die grinder typically uses much smaller abrasive wheels and cutting wheels than the angle grinder, as well as carbide rotary burrs, allowing for access to smaller spaces. The angle grinder, although more difficult to get into tight spaces, has the advantage of faster material removal.

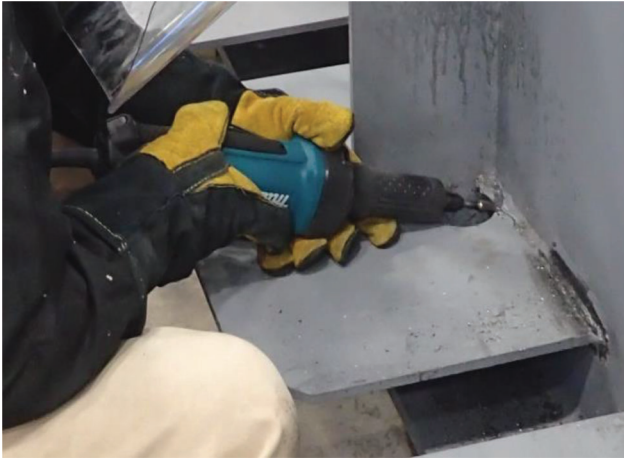
Figure 4.11 Typical die grinder with burr bit.

- c. A die grinder with carbide rotary burr is recommended for areas of restricted access.
3. Complete fine grit grinding to create a smooth and polished finish.

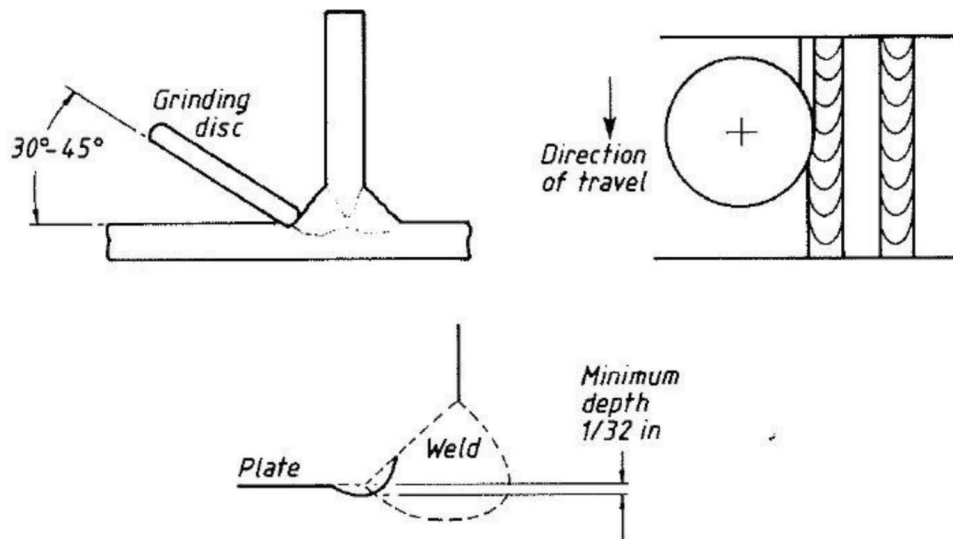
Figure 4.12 Correct tool position for angle grinding of weld toe (Gregory *et al.*, 1989).

2. If using a disc or angle grinder, position the tool as indicated in Figure 4.12.
3. If using a burr or die grinder, position the tool as indicated in Figure 4.13.

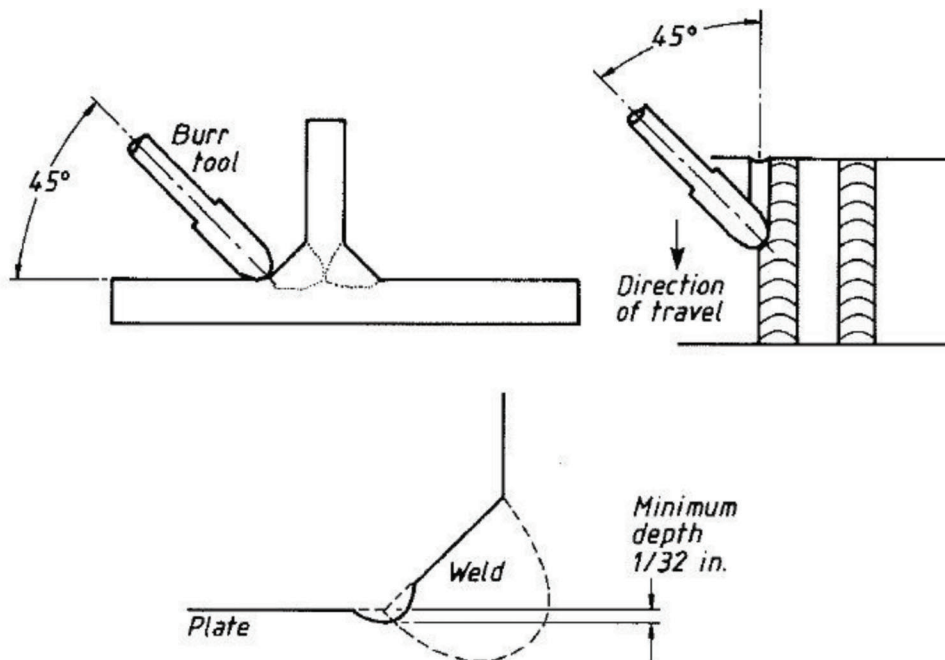
Figure 4.13 Correct tool position for die grinding with burr bit at weld toe (Gregory *et al.*, 1989).

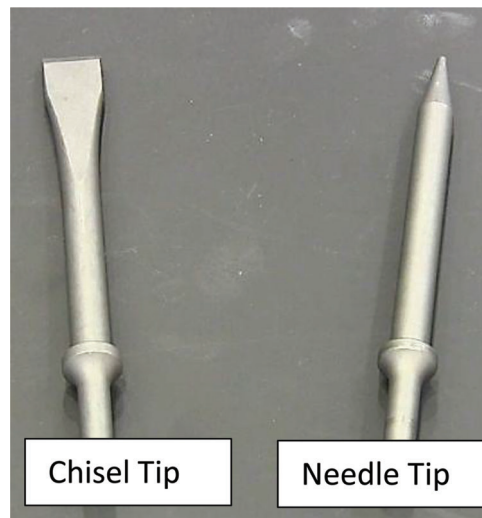
Figure 4.14 Typical peening bits.

- a. Adjust the pressure regulator to 40 psi when using a needle tip. When using a wider chisel-type tip, a higher pressure of up to 60 psi has been found to improve indentation at the weld toe. See Figure 4.14 for examples of a needle and chisel bit.

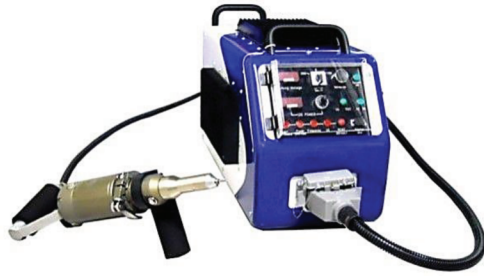
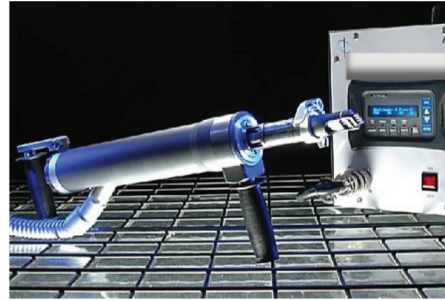
Figure 4.15 Examples of UIT tools.

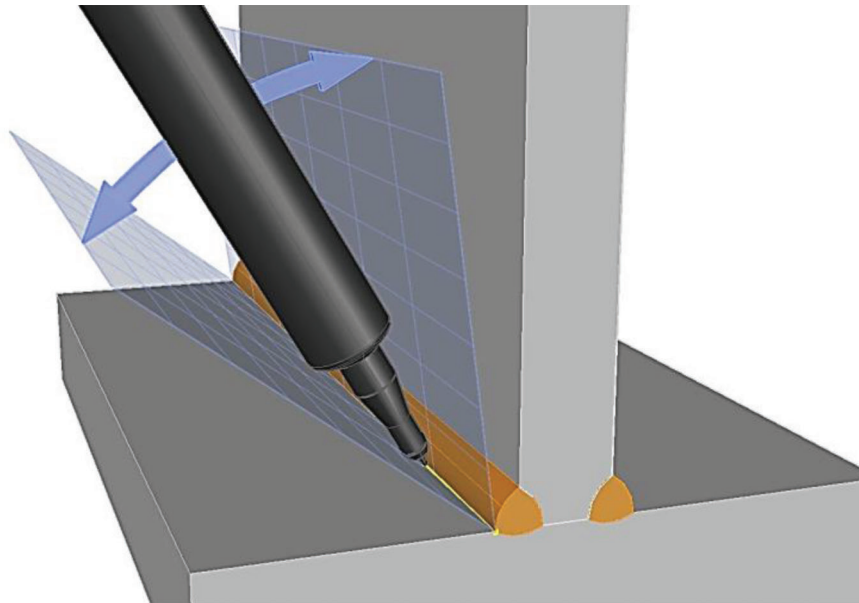
Figure 4.16 Sketch demonstrating the path of the handheld tool during UNP application.

5. Position the handheld tool with the needle on the weld toe at a 45° angle and perpendicular to the line of the weld toe.
6. Continuously run the tool along a path parallel to the direction of the weld, maintaining the handheld tool perpendicular to the weld toe. Repeat the same path of treatment two more times, each time rotating the handheld tool to a position that is $\pm 15^\circ$ from the original 45° angle, as shown in Figure 4.16. Avoid leaving the needle at a single location to avoid "digging" the material.

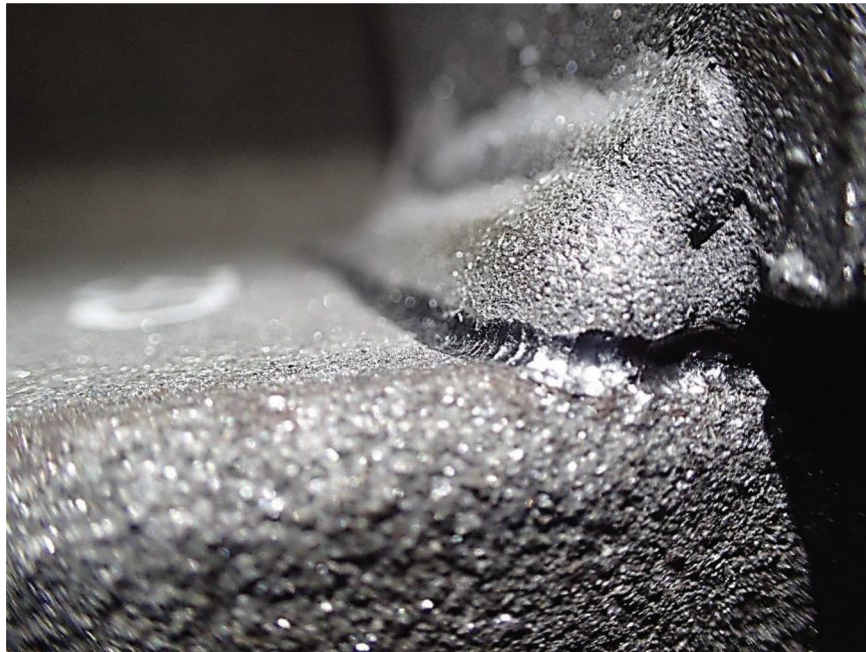
Figure 4.17 Appearance of properly treated weld toe using UNP method.

7. Inspect the groove, looking for uniform, shiny appearance, such as that shown in Figure 4.17. A 3/32 welding rod or a peening needle can also be lightly dragged through the groove. A well-formed groove will allow the rod/needle to slide without catching. If gaps in treatment are located, repeat treatment in those areas and inspect again.

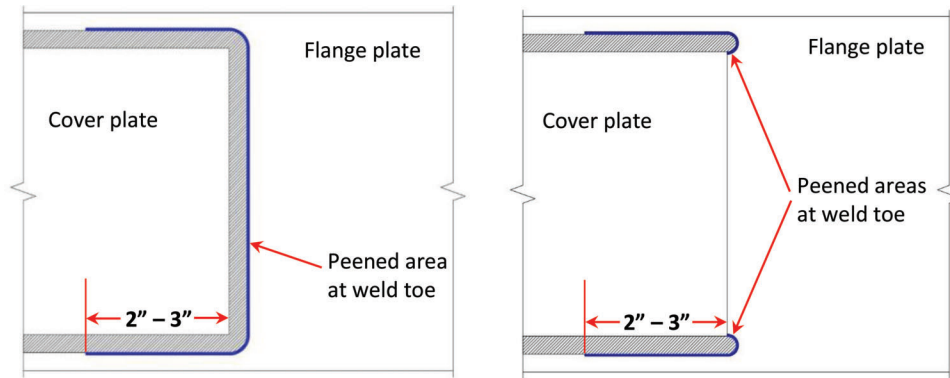
Figure 4.18 Recommended peening locations for cover plate details with (Left) and without (Right) the transverse weld.

Figure 4.18 is provided as a sample retrofit for a cover plate weld termination showing the areas recommended for peening with the bold blue lines. This detail would be categorized as E' or E, depending on the thickness of the cover plate. Notice that the peening is only performed at the termination of the cover plate welds, following the weld toe around the corner of the cover plate, and extending 2 to 3 inches back from the termination. The longitudinal weld that runs parallel to the plate is a category B fatigue detail and would not be expected to crack under typical live load stress ranges. UIT applications generally should focus around details with low fatigue resistance, such as E' or E, but can be used on most any weld to improve fatigue resistance. Applying UIT, and peening treatments in general, in this way will save significant cost.

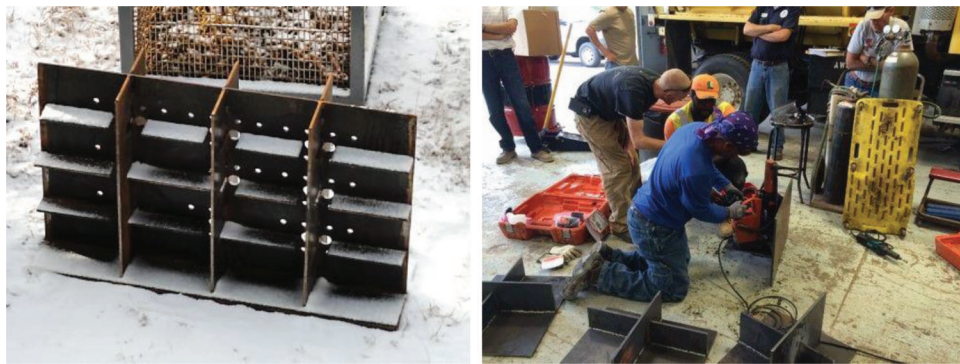
Figure 4.19 (Left) Example of used mockup, (Right) Performance testing of a contractor prior to implementation of a repair project.

Experience has shown that even the most experienced contractors and maintenance crews can underestimate the challenges of executing repairs on steel bridges. Unfortunately, in some cases it is not until they actually begin work that those challenges surface. This type of situation can cause costly delays for the owner and the contractor, or worse, actually cause damage to the structure. Figure 4.19 shows an example of a used mockup specimen (left) and ironworkers performing

repairs as part of a performance test (right). This type of testing can be successfully included in rehabilitation contracts where the scope of work requires the fabrication of mockups and satisfactory completion of the test before work can begin on the bridge. The performance test provides two primary functions, (1) to ensure the work can be completed as intended by the contractor, and (2) to establish the level of quality that is expected on the project to all parties. Typically, mockups can be fabricated for only a few thousand dollars, depending on the complexity of the detail. The fidelity of the mockup to the actual detail is very important. Size, quality, condition, and geometry should be replicated as much as possible. Economy is achieved by duplicating the detail like shown in Figure 4.19, without compromising authenticity. Difficult-to-access areas, such as corners of intersecting plates and connection elements should not be overlooked because often it is these details that make the actual repair or retrofit challenging and where the real benefit of the mockup will be gained.

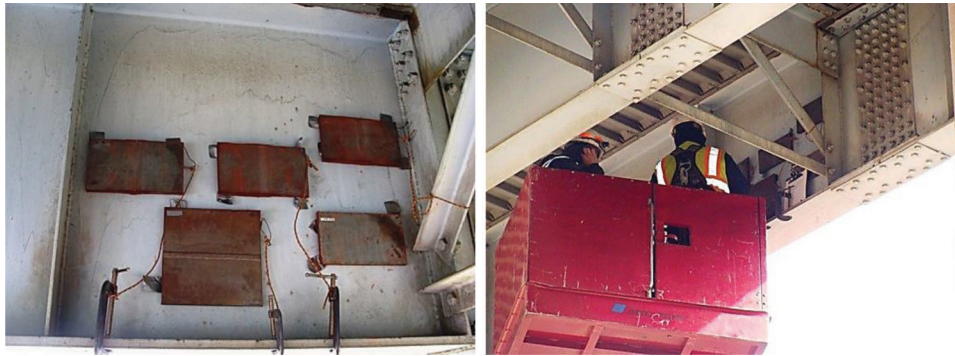
Figure 4.20 (Left) Welded steel test specimen hung on a bridge, (Right) Performance testing of an inspector prior to beginning NDT on bridge welds.

results has been shown to occur among certified inspectors where variances in thoroughness, care with which NDT procedures are followed, and interpretation of results differed. Washer *et al.* (2014) conducted performance testing of ASNT Level II and III certified UT and MT inspectors to establish inspector qualifications prior to inspection work beginning on the Sherman-Minton Bridge over the Ohio River near Louisville, KY. Before inspecting the tied arch structure, inspectors were first evaluated in a performance test program. The welded-steel specimens used for performance testing were fabricated plates with known flaws of various sizes. Figure 4.20 shows similar test specimens hung on a bridge (left) and an inspector completing a performance test (right).

Installing the test specimens on the bridge helps to make the test authentic, ensuring ambient factors present in actual inspection are also at play during testing (i.e., wind, temperature, access, bucket sway, lighting, etc.). A sample of the test results is provided in Figure 4.21 (Washer *et al.*, 2014). The horizontal axis is the actual flaw length and the vertical axis is the measured flaw length as reported by each inspector. The diagonal line passing through the plot represents the correct flaw length and the solid circles are the average measured lengths. The results of the performance tests identified inspectors whose performance was substandard and provided quantitative measures of

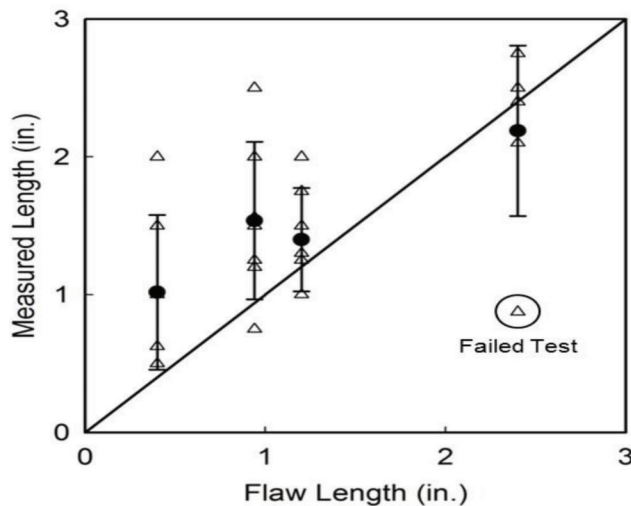
Figure 4.21 Sample of UT Performance Testing results (Washer *et al.*, 2014).

the variations in the NDT results (Washer *et al.*, 2014). The variations can be seen in the plot where it shows that scatter among inspectors was as much as the defect length, meaning that some inspectors were over or underestimating crack sizes by as much or more than 100 percent. At the same time a few inspectors were able to report very accurate results.

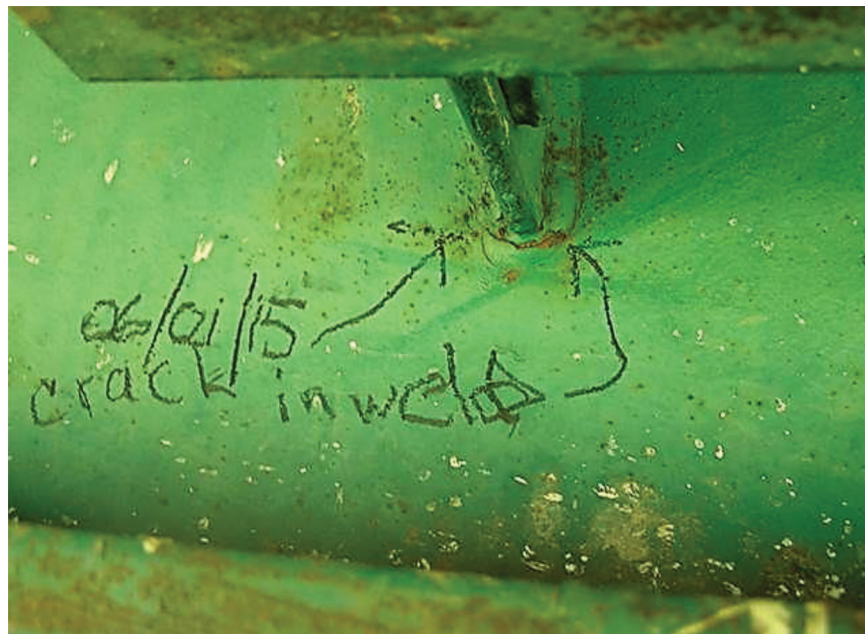
Figure 4.22 Distortion-induced fatigue crack growing out of the throat of the weld.
