Maintenance Actions to Address Fatigue Cracking in Steel Bridge Structures

PROPOSED GUIDELINES AND COMMENTARY

NCHRP Transportation Research Board of
The National Academies

Robert J. Connor and Jason B. Lloyd
Purdue University
West Lafayette, Indiana

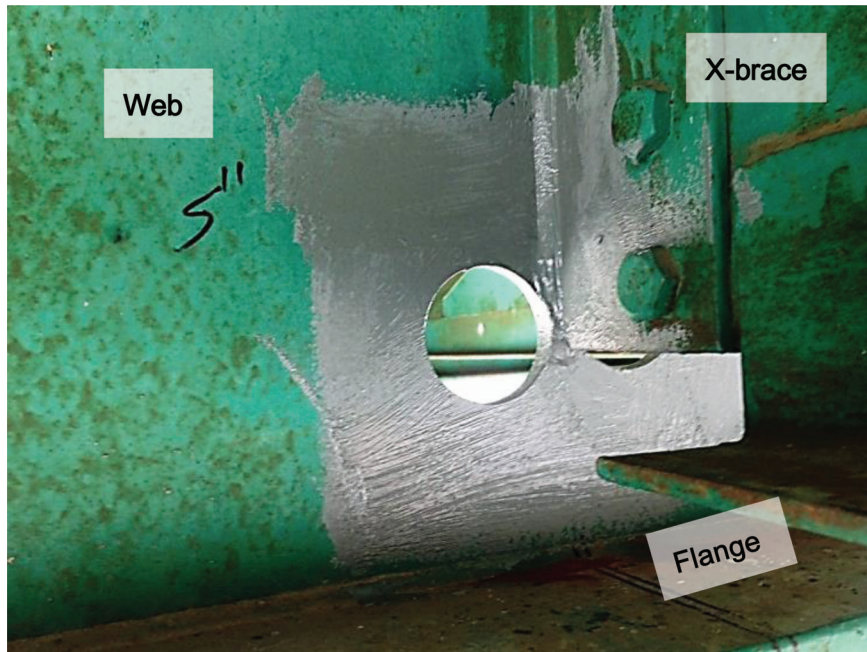
Figure 4.23 Example of prototype “two-hole” retrofit installed.

a few locations were identified to install a prototype. One example of the prototype can be seen in Figure 4.23. A 3 inch diameter hole was drilled on each side of the connection plate, surrounding the weld termination and isolating it against web crack propagation. Following installation of the prototype, the areas were instrumented, along with a couple benchmark locations where no repairs were made. Field monitoring of live load stresses in the primary members, in the web gap

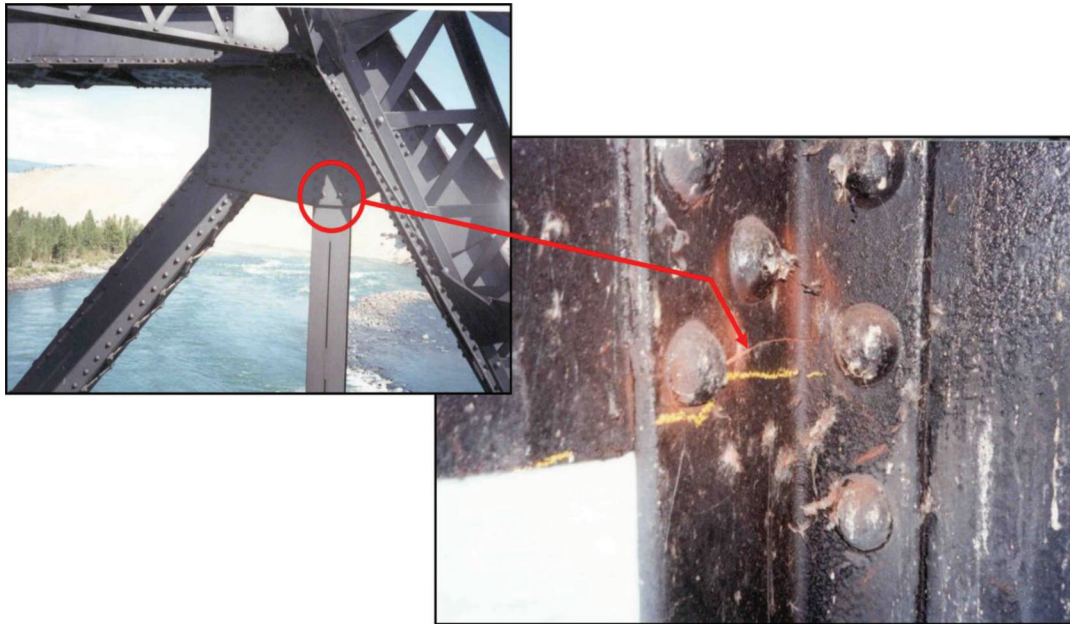
Figure 5.1 Example of load-induced fatigue crack located on a railroad through-truss hanger.

Load-induced fatigue is caused by the in-plane stresses in the primary structural members that make up the structure cross section. Load-induced fatigue stresses are directly correlated to the live load stresses that can be calculated using conventional axial and bending analysis at the location of the detail in question, or nominal stresses. This approach is valid because of the way the fatigue categories were initially developed by correlating large-scale fatigue test results with the nominal stress ranges. The detail category itself implies inclusion of the characteristic stress concentrations, residual stresses, and defect distribution inherent in that detail or group of details. An example of load-induced fatigue cracking is shown in Figure 5.1. This example shows a fatigue crack that has grown from the first rivet hole on a railroad truss hanger. This is a relatively common location for fatigue cracks to occur.

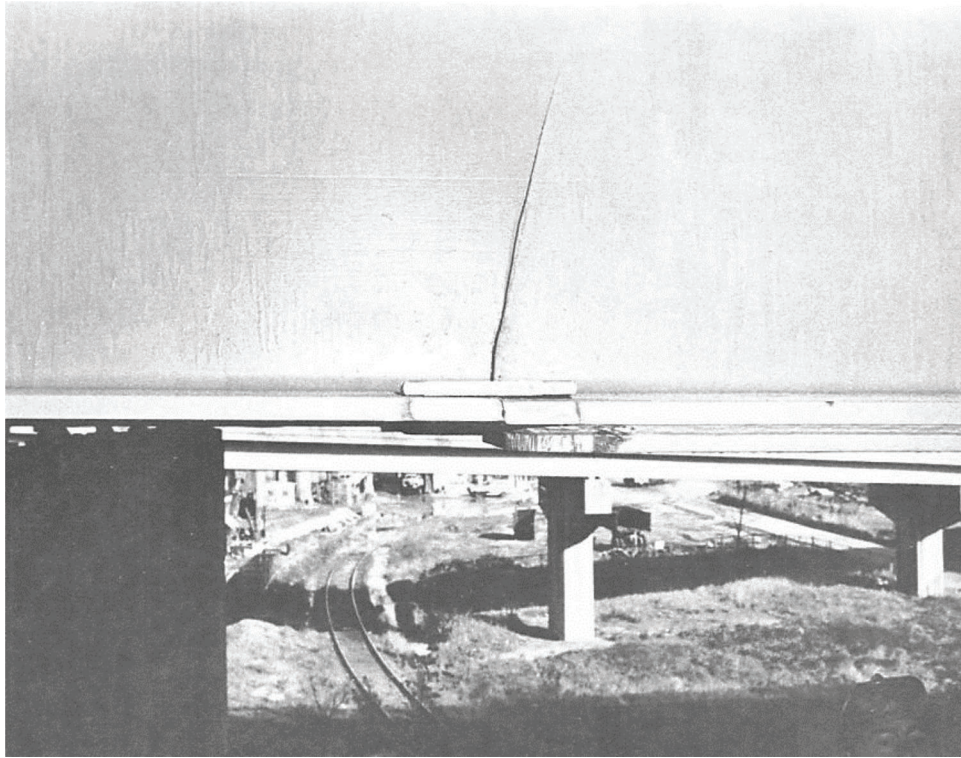
Figure 5.2 16 inch long fracture resulting from fatigue crack at cover plate weld toe (Bowers, 1973).

Fatigue cracks have been known to form in the weld toes of cover plate terminations since the 1960s when several such details cracked as part of the AASHTO Road Test. Relatively large stress ranges (~ 12 ksi) under controlled truck traffic developed fatigue cracks on multiple-beam bridges (Fisher, 1984). In 1970 a cover plate termination fatigue crack located on the Yellow Mill Pond Bridge in Bridgeport, Connecticut, resulted in the partial fracture of an internal cover plated beam (Bowers, 1973). Figure 5.2 shows an elevation view of the resulting fracture, which reached 16 inches into the web plate before it arrested and was later repaired. Subsequent inspections of other cover plated beams along I-95, prompted by the discovery of the crack on the Yellow Mill Pond Bridge, revealed many other small (less than 1 inch) fatigue cracks in cover plate weld toes (Bowers, 1973). These details, as well as that shown in Figure 5.2, were repaired with bolted splices or treated with hammer peening.

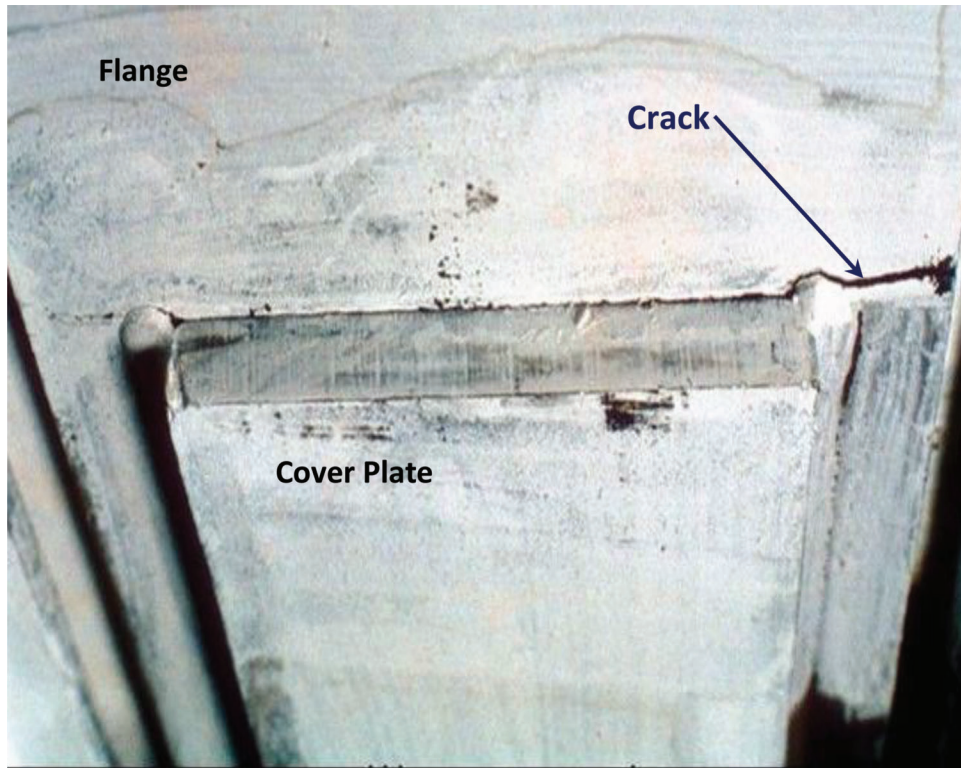
Figure 5.3 Example of cover plate fatigue crack at detail without transverse weld (Fisher *et al.*, 1979).

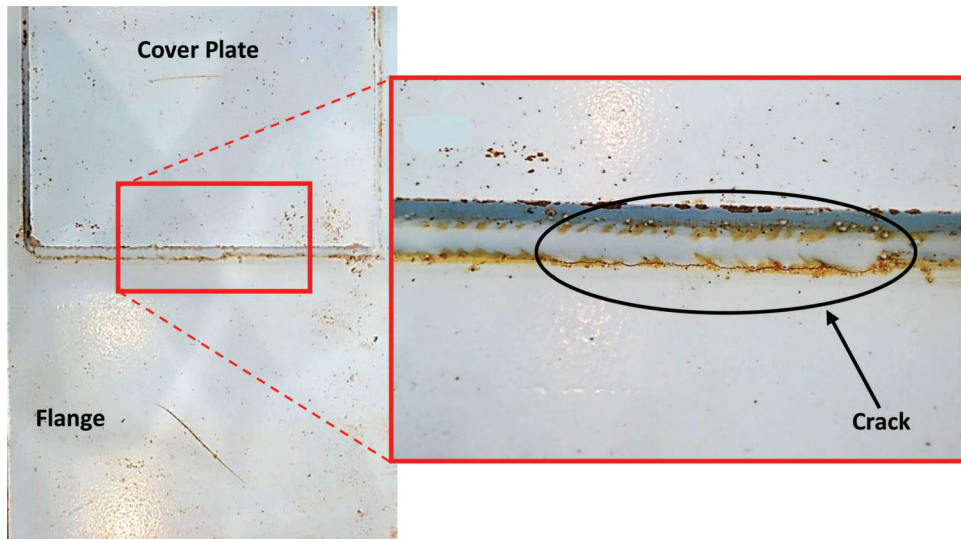
Figure 5.4 Example of fatigue crack at a cover plate with transverse weld.

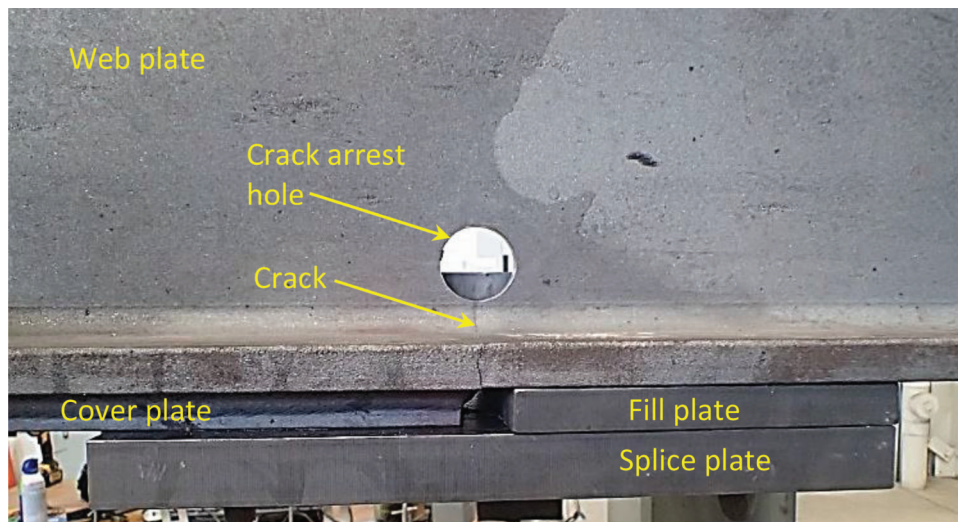
Figure 5.5 Crack arrest hole preventing crack from propagating into the web plate.

4. Drill a 2 to 4 inch diameter hole through the web plate directly above (or below in cases where the cover plate is on a top flange) the cover plate weld toe, as shown in Figure 5.5 to prevent further crack propagation. Refer to Section 4.4 for drilling techniques and hole edge finishing.

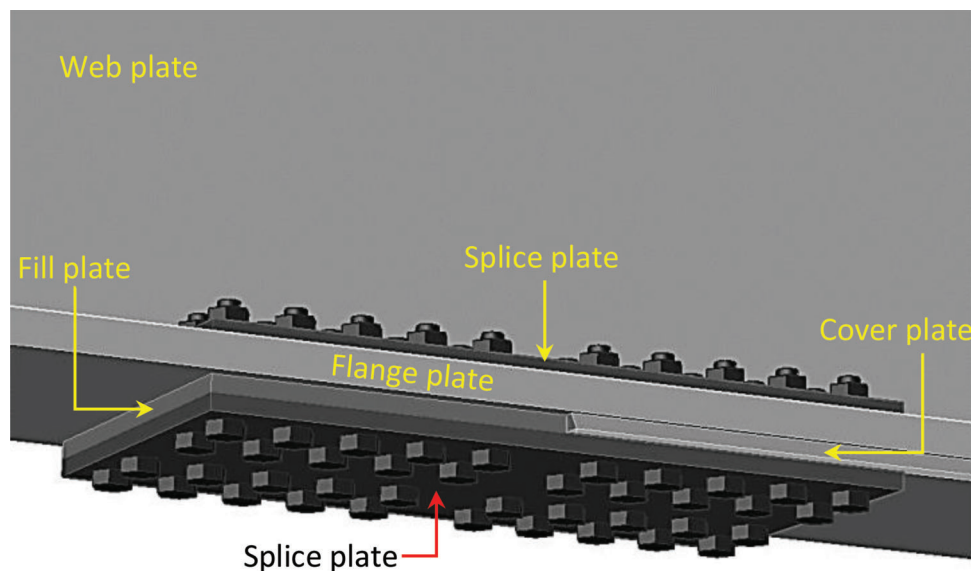
Figure 5.6 Rendering of full flange splice at cover plate detail.

(Hassan & Bowman, 1995). See Section 4.2 for hole drilling techniques. Adding a 2 to 4 inch diameter drilled hole in the web directly above (or below in cases where the cover plate is on a top flange) the cover plate weld toe could also be done to ensure that any future crack growth cannot extend into the web plate. An example of this is shown in Figure 5.5 showing a fatigue crack that has grown through the thickness of the flange plate and is arrested in the drilled hole. Figure 5.6 renders what a typical full bolted flange splice over the cover plate termination might look like.

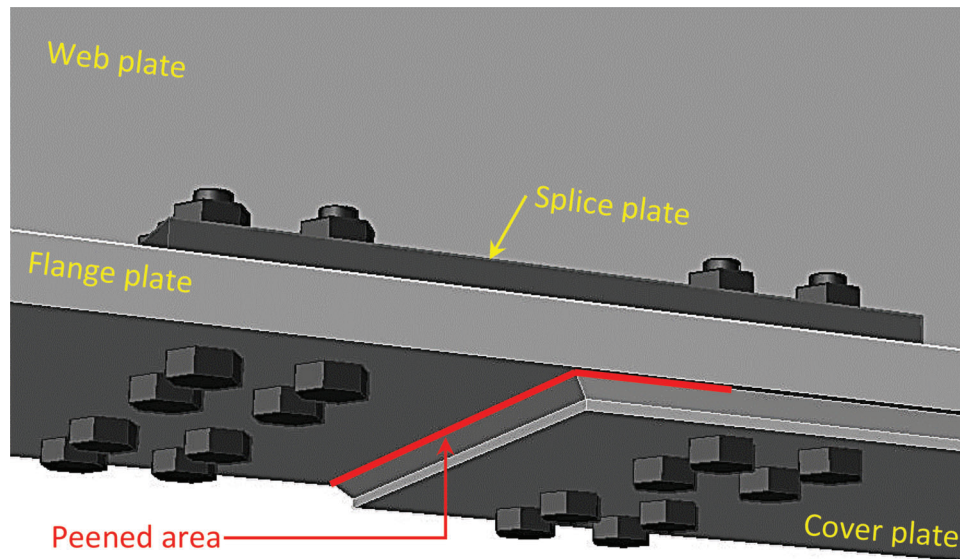
Figure 5.7 Rendering of partial flange splice at a bottom flange cover plate detail with weld toe peening.

4. Peen or apply UIT to the weld toes. The area treated should include all transverse welds at the end of the cover plate and at least 2 to 3 inches of weld back from the end of the cover plate (see Figure 5.7). Refer to Section 4.5.3 and Section 4.5.5 for peening techniques.

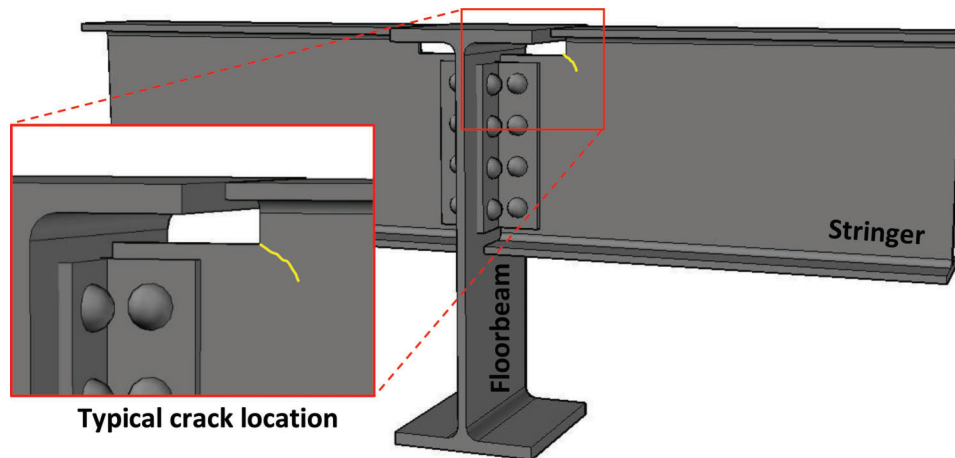
Figure 5.8 Sample re-entrant corner details with no transition radius.

Coped and blocked stringers and floorbeams have been commonly used to frame members together on steel bridges for decades. A typical design detail is shown in Figure 5.8. Variations of this detail have been used in

railroad and highway applications, alike. The typical location for cracking has also been highlighted.

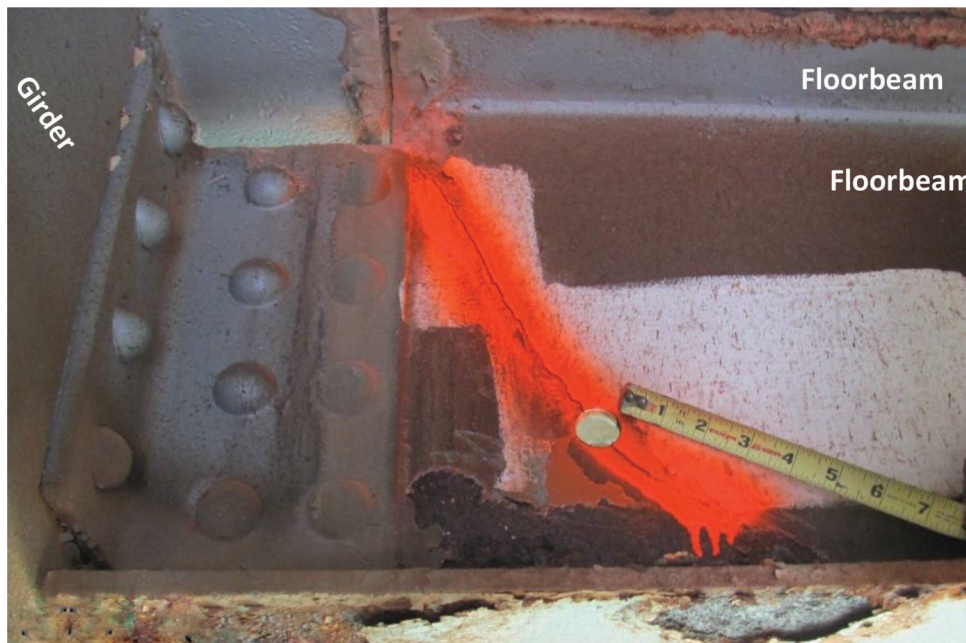
Figure 5.9 Example of load-induced crack at floorbeam cope (Photograph courtesy of Oklahoma DOT).

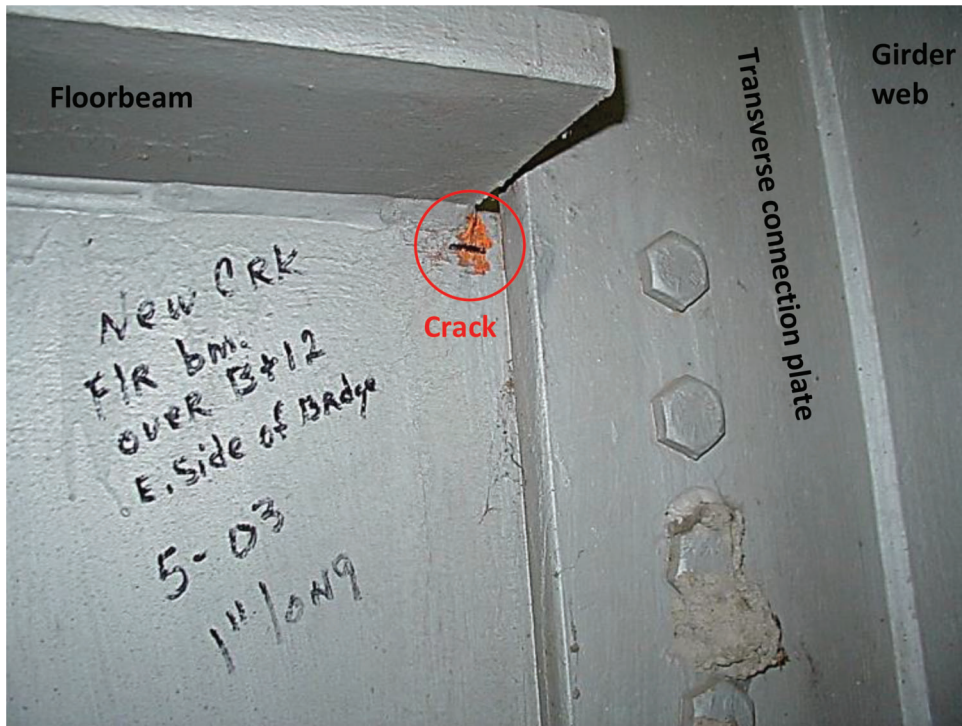
Figure 5.10 Example of floorbeam cope crack (Photograph courtesy of Kansas DOT).

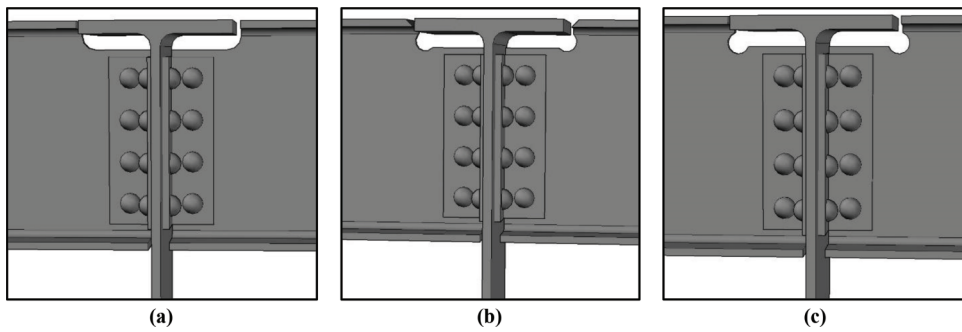
Figure 5.11 Examples of typical acceptable copes.

4. Use a thermal cutting process, such as plasma arc or oxygen cutting, etc., to make any straight cuts necessary. In some cases, this step may not be required, leaving an acceptable retrofit detail that is similar to Figure 5.11(c).
5. Follow the guidelines provided for surface grinding in Section 4.4. Grind the entire length of any thermally cut edge (after cooled) removing approximately 1/16 inch of material while maintaining smooth and gradual transitions.
6. Perform MT or PT after grinding to check for remaining flaws. If a flaw is located, continue grinding to remove the flaw while maintaining a smooth cope profile.
7. Paint the repair area using recommendations provided in Section 4.2.
8. Follow up with typical visual inspections scheduled with the regular inspection cycle for the bridge.

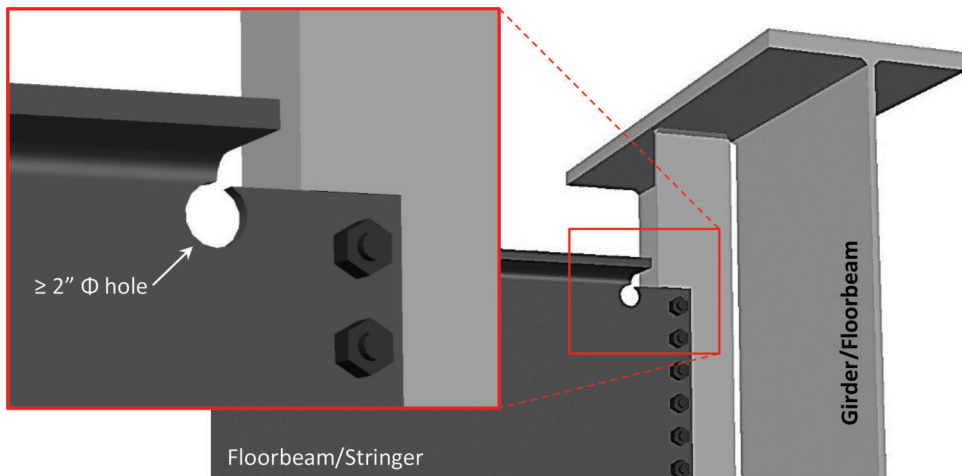
Figure 5.12 Drilled hole used to increase cope transition and reduce stress concentration.

The following steps outline the proper procedure for increasing the transition radius to retrofit re-entrant corners at floorbeams and stringer copes. Reference Figure 5.12 for further details.

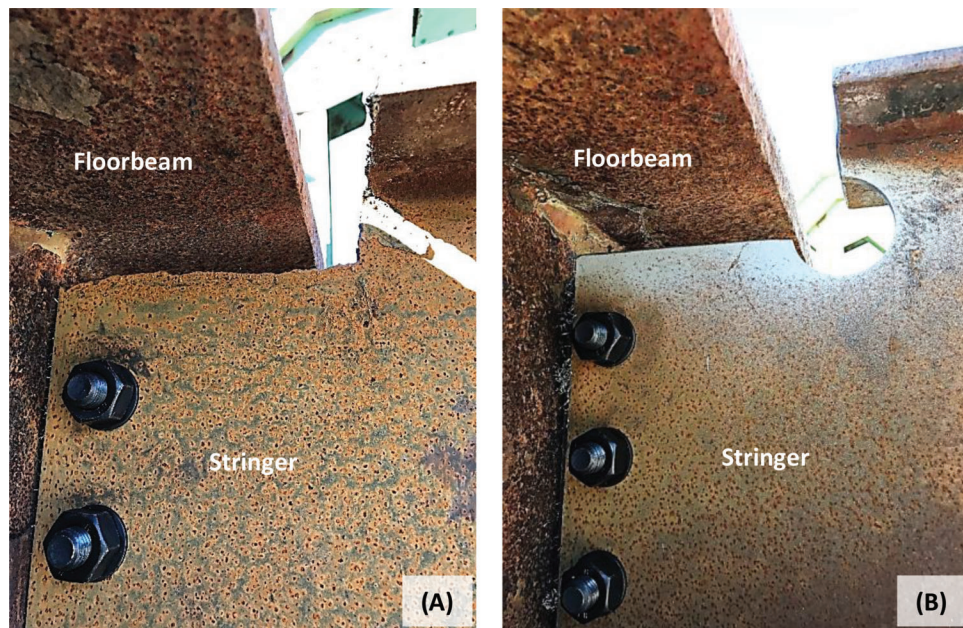
Figure 5.13 Before (A) and after (B) pictures of cope transition retrofit.

Figure 5.13 shows an example of a properly retrofit cope detail with before and after views. Notice in photograph (B) the drilled hole and the former cope discontinuity that improves stress flow into the bolted connection. Also, the flame cut edges have been ground smooth, removing flaws and brittle material.

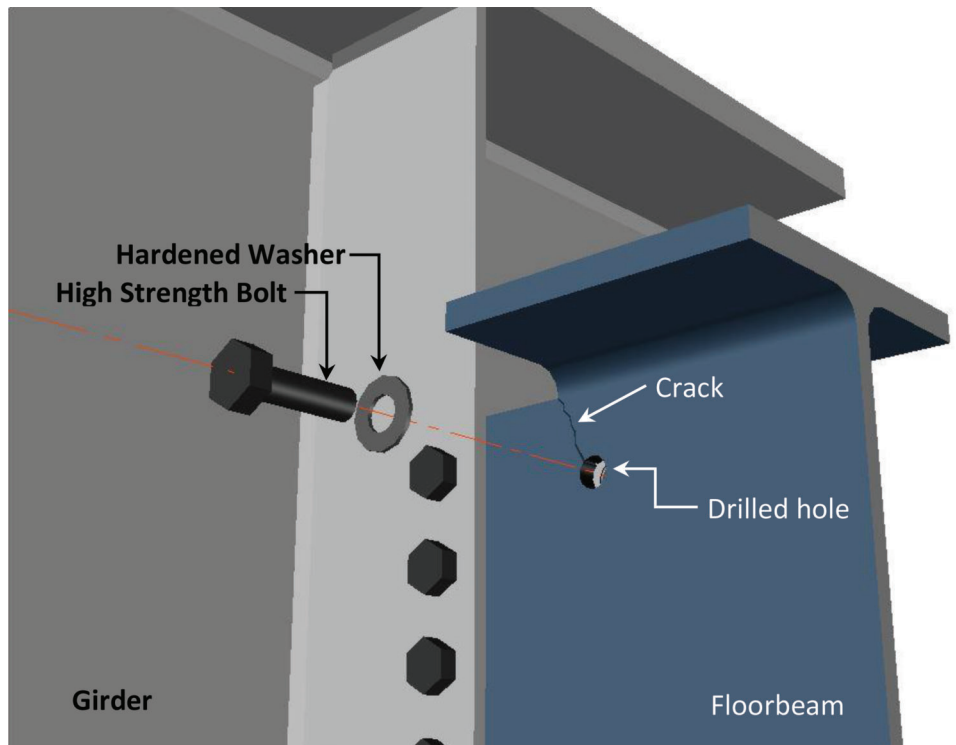
Figure 5.14 Drilled hole retrofit for cracked cope details using high strength bolt assembly.

The following steps outline the proper procedure for repair of cracked re-entrant corners at floorbeams and stringer copes using drilled holes. Reference Figure 5.14 for further details.

3. *Recommended:* For improved fatigue resistance, install F3125 Grade 325 or 490 high strength bolts using turn-of-nut or other approved method according to current RCSC specifications. Install the bolts with F436 hardened washers on both sides of the drilled plate. The bolt assembly detail is shown in exploded view in Figure 5.14.

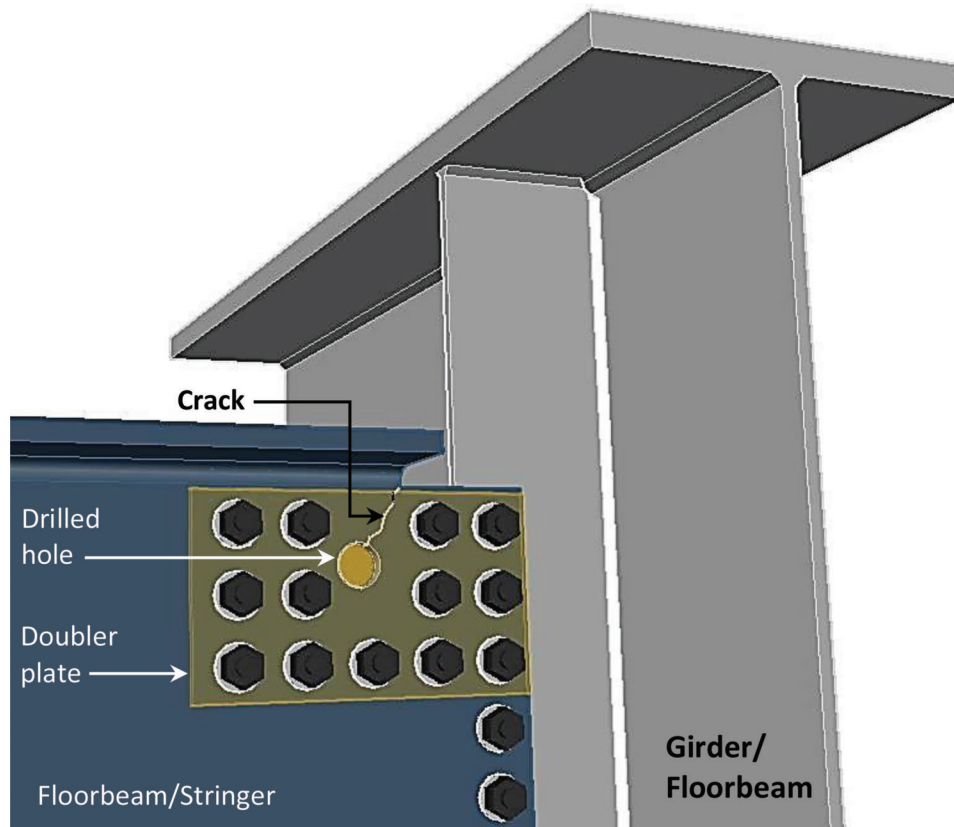
Figure 5.15 Bolted doubler plate retrofit with drilled hole for crack arrest.

The following steps outline the proper procedure for repair of cracked re-entrant corners at floorbeams and stringer copes using a bolted doubler plate detail. Before installation can begin, a qualified engineer should design the doubler plate detail. Figure 5.15 illustrates a typical design where two doubler plates, each equal in thickness to the original floorbeam or stringer web, are installed. When possible, extend the doubler plates onto the connection plates, as shown, and replace the fasteners with F3125 high-strength bolts. The doubler plate has been rendered semi-transparent in Figure 5.15 to reveal the crack and drilled hole behind it.

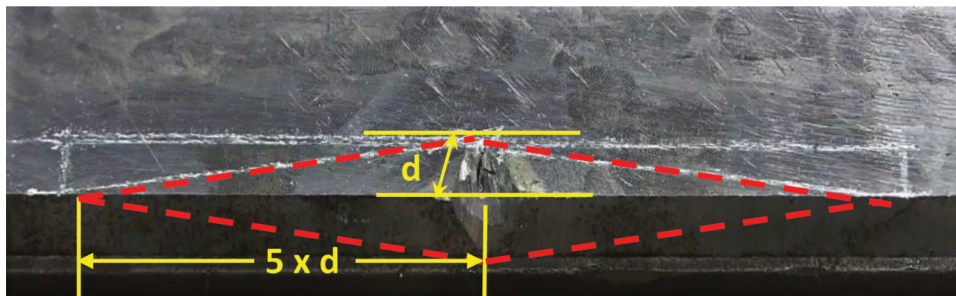
Figure 5.16 Example of 5:1 taper ratio markings.

2. Mark the limits of the grinding area using between a 5:1 and 10:1 grinding area length-to-defect depth ratio. For example, if an edge crack is determined to be 1 inch deep, the grinding area should extend 5 inches in each direction, for a total length of 10.0 inches (1 inch x 5:1 ratio x 2 sides). Figure 5.16 shows an example of a 5:1 taper ratio marking before grinding. The dashed red lines indicate the area that would be ground smooth.

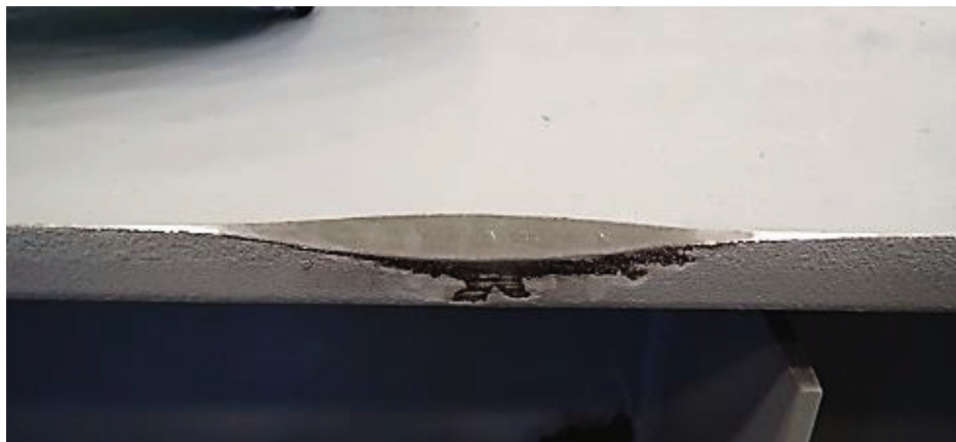
Figure 5.17 Example of edge flaw removed with 5:1 fairing ratio.

4. Complete the fine grit grinding step using 80 to 100 grit flap wheels. Figure 5.17 shows an example of a 5:1 taper following removal of an edge gouge on a flange. Notice the smooth and gradual surface of the repair.
5. Inspect using MT or PT to ensure no crack tips were left behind. If a crack is located, complete steps 2 – 5 again.
6. Paint the repair area using recommendations provided in Section 4.2.
7. Document the section reduction for load rating analysis purposes. Follow up with typical visual inspections scheduled with the regular inspection cycle for the bridge.

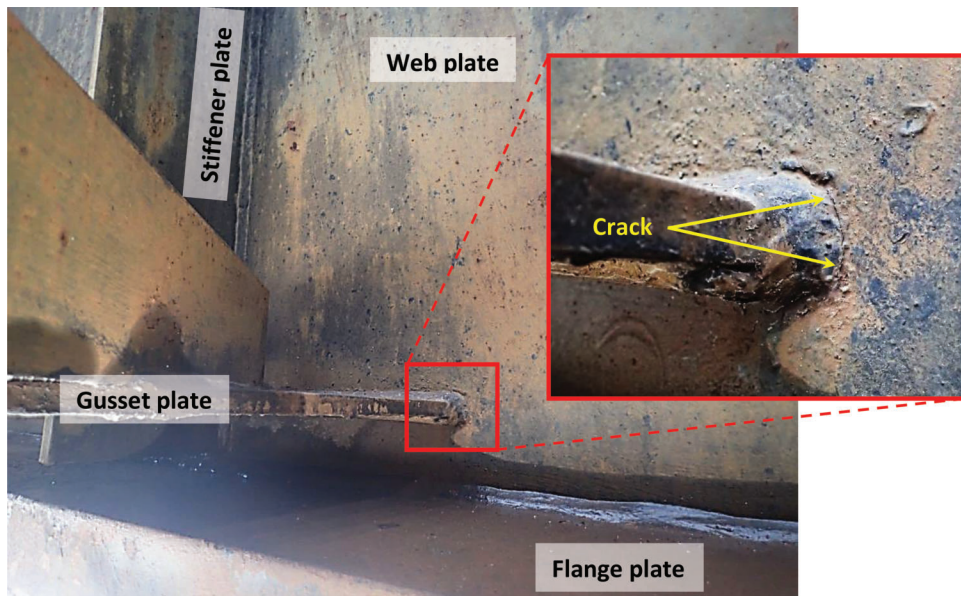
Figure 5.18 Example of fatigue crack at gusset plate weld termination.

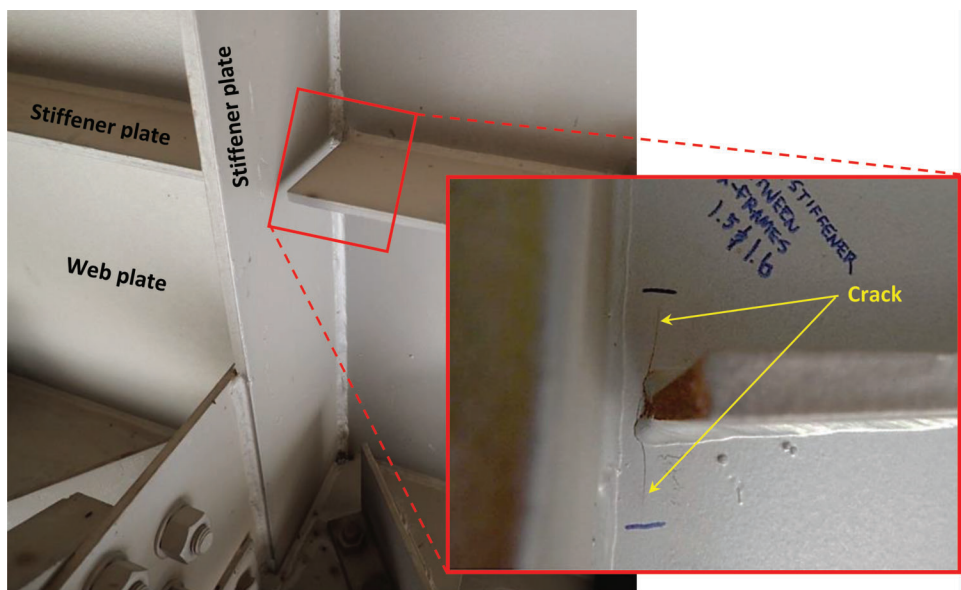
Figure 5.19 Example of fatigue crack at longitudinal stiffener weld termination.

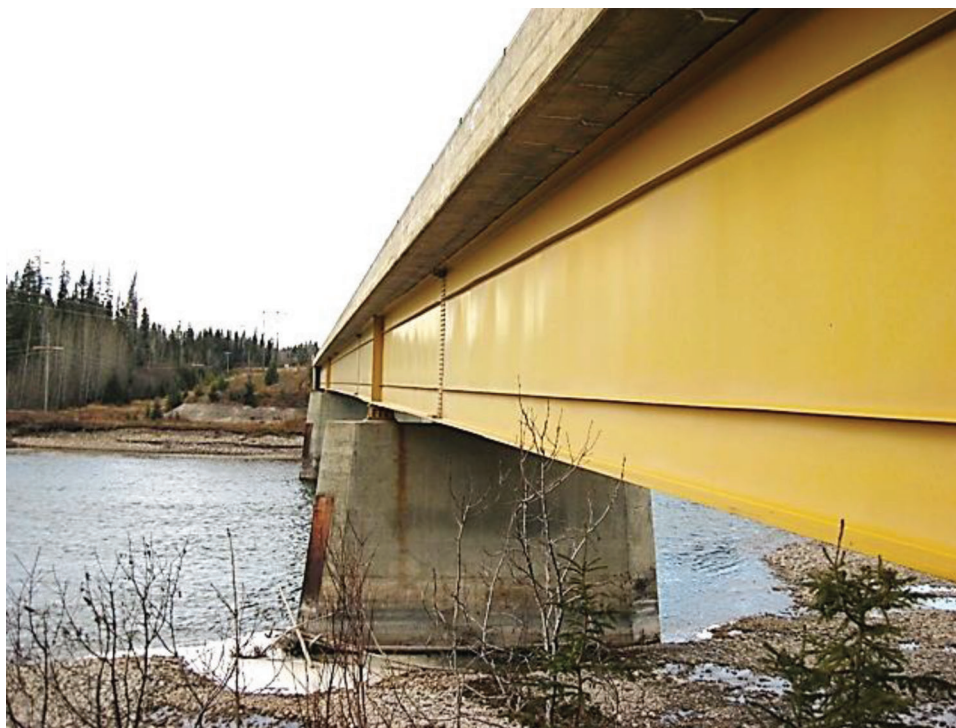
Figure 5.20 Example of longitudinal stiffeners located in tension and compression zones.

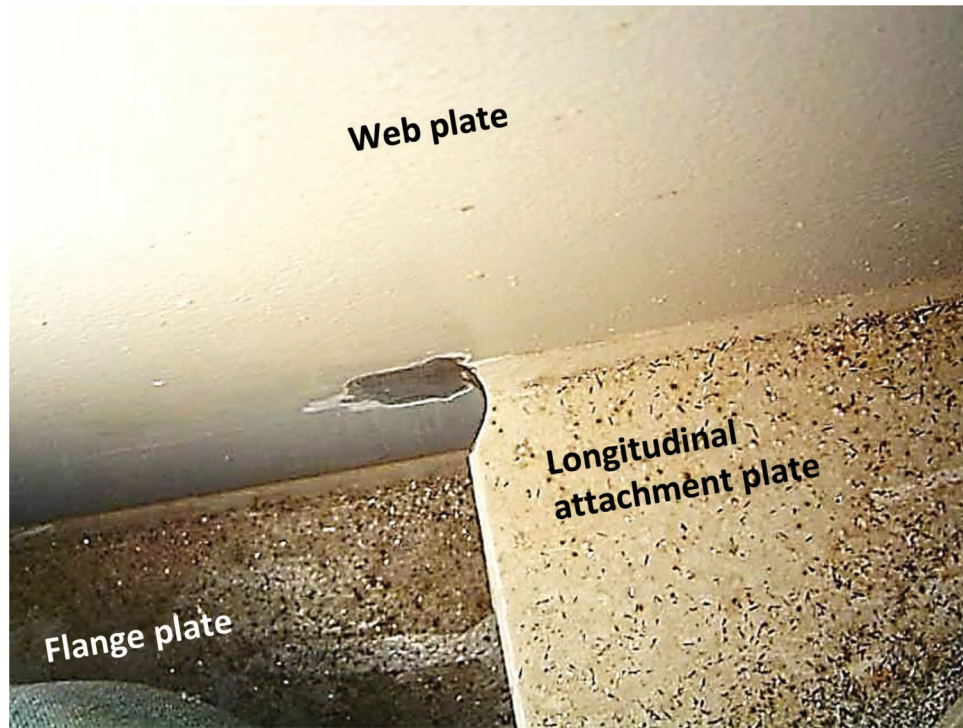
Figure 5.21 Weld termination removal using burr bit and die grinder (Photograph courtesy of Iowa DOT).

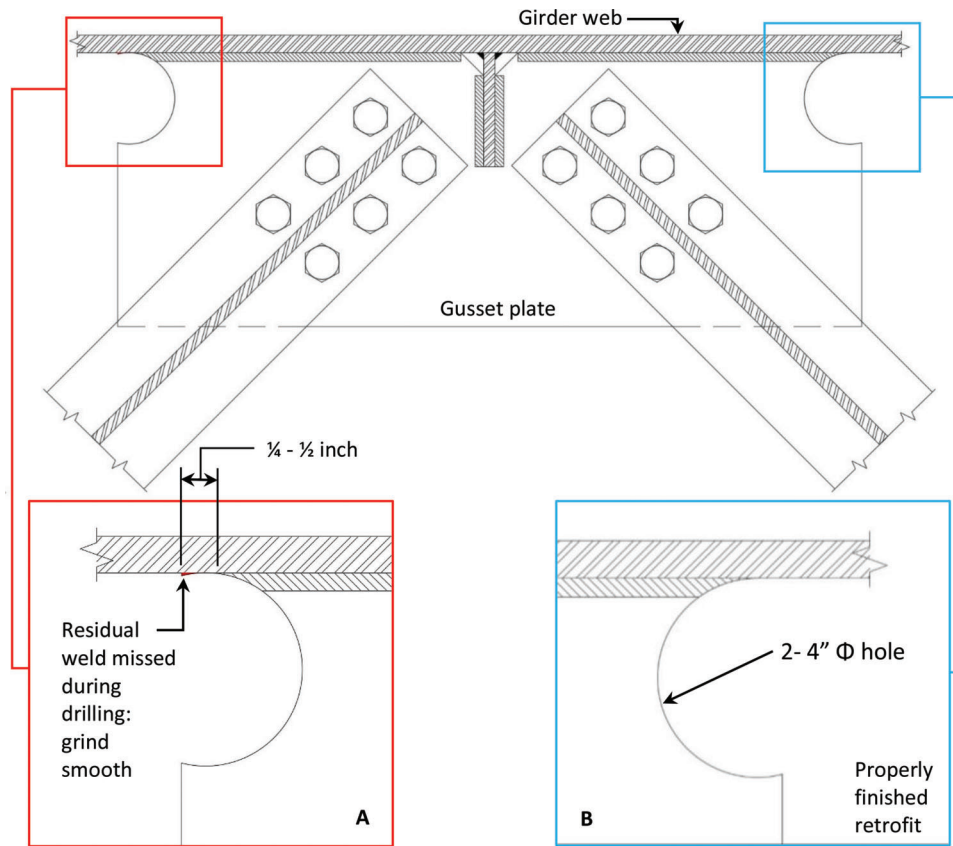
Figure 5.22 Retrofit for plate termination using drill and annular cutter.

Option: Remove the bulk of the material and weld from the plate using a mag-based drill. Align the annular cutter such that it is flush with the web plate at a point approximately 1/4 inch to 1/2 inch back from the end of the weld. This will result in a partial circle cut at the edge of the gusset or longitudinal stiffener plate with some weld remaining attached to the web. Grind off the residual weld flush with the web plate. Figure 5.22A shows what a typical plate termination will look like after drilling a 4 inch diameter hole. Notice the small weld material that was missed by the drilling, which needs to be ground smooth in Figure 5.22A. Figure 5.22B shows the retrofit as it should be completed, with the weld ground smooth to the web. Although Figure 5.22 is drawn for a gusset plate termination, the same detail can be used on a longitudinal stiffener plate termination.

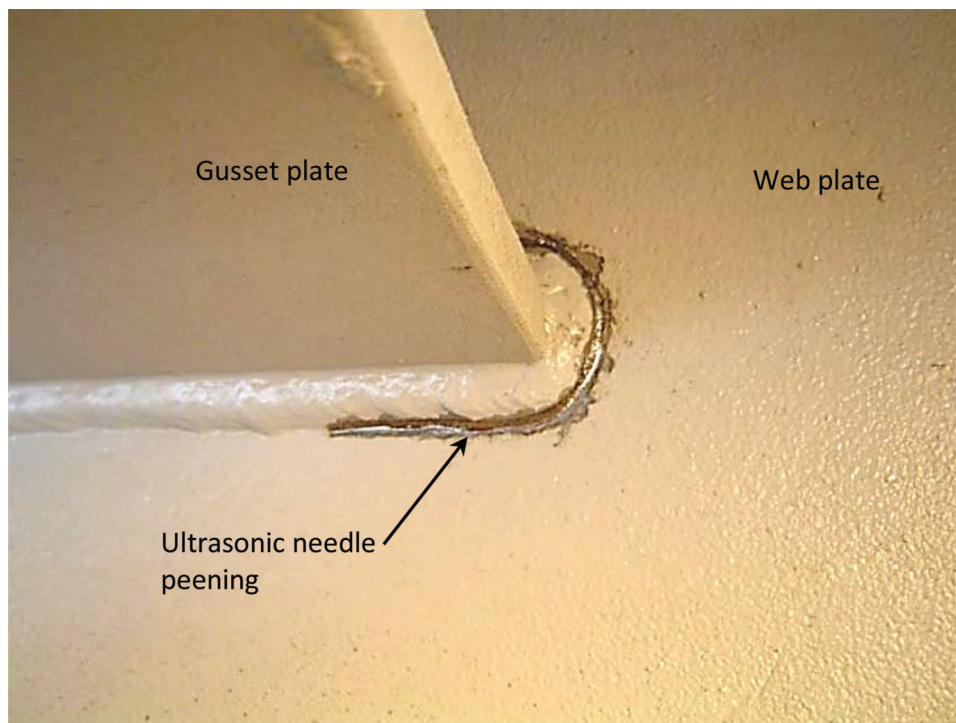
Figure 5.23 Weld toe peening at gusset plate termination (Photograph courtesy of Iowa DOT).

5.4.2.2 Weld Toe Treatment. Weld toe treatment is described in detail in Section 4.5 of this guideline. Refer to this section for a complete description of weld toe grinding for removing existing cracks, as necessary, and to apply post weld peening treatment. Peening should be applied to the last 2 to 3 inches of the gusset or longitudinal stiffener plate weld, following the weld toe in contact with the web plate. If the weld wraps around the end, ensure that the peening treatment follows the weld toe around and continues for 2 to 3 inches along the underside of the plate, as seen in Figure 5.23. It is not clear from this figure whether or not the paint coating was removed prior to peening. This is an important step to ensure quality peening treatment. Tool access between the attachment plate and adjacent flange plate should also be considered before choosing this retrofit approach.

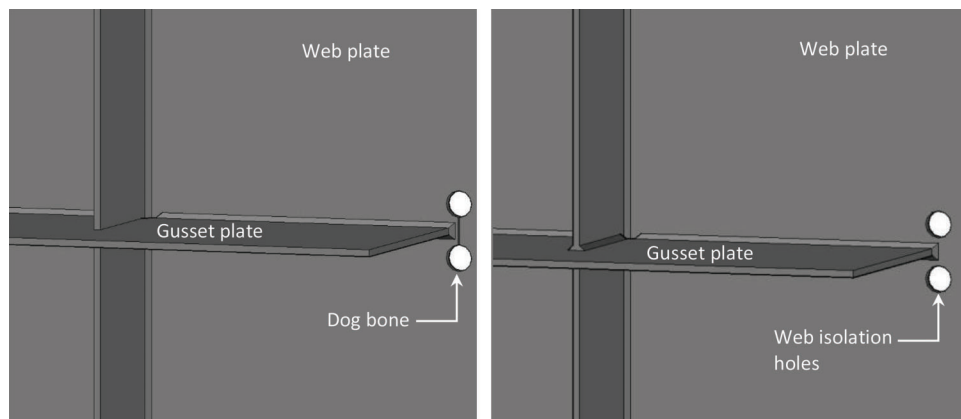
Figure 5.24 Example of dog-bone retrofit (left) and web isolation holes (right).

Two to 4 inch diameter drilled holes are recommended. Larger holes improve fatigue resistance by further reducing stress concentration at the edge of the holes. Figure 5.24 shows an example of the dog-bone retrofit on the left and the web isolation holes retrofit on the right.

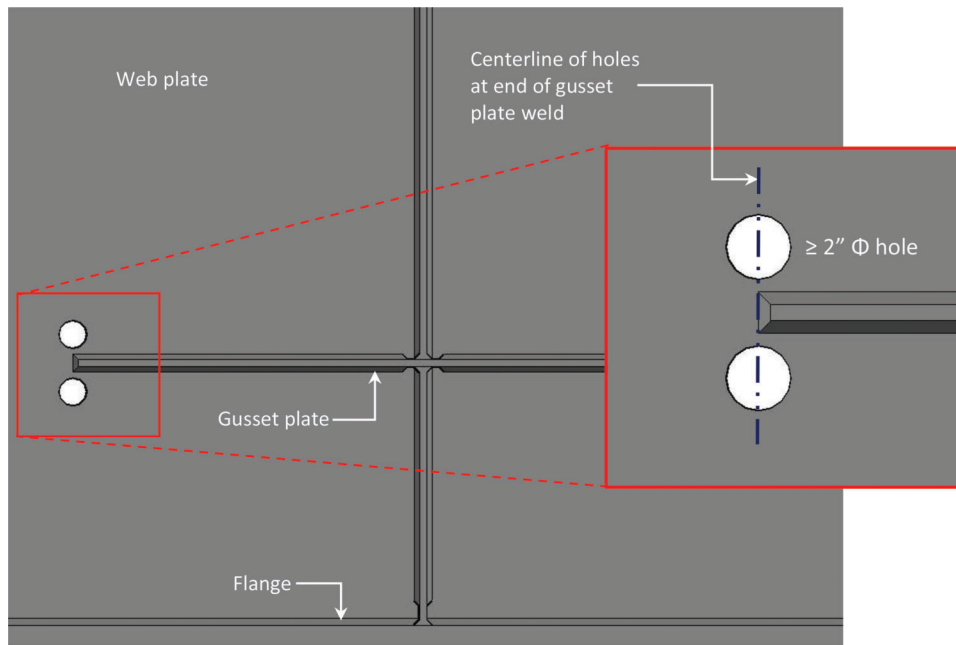
Figure 5.25 Example of web isolation hole placement at weld termination of a gusset plate.

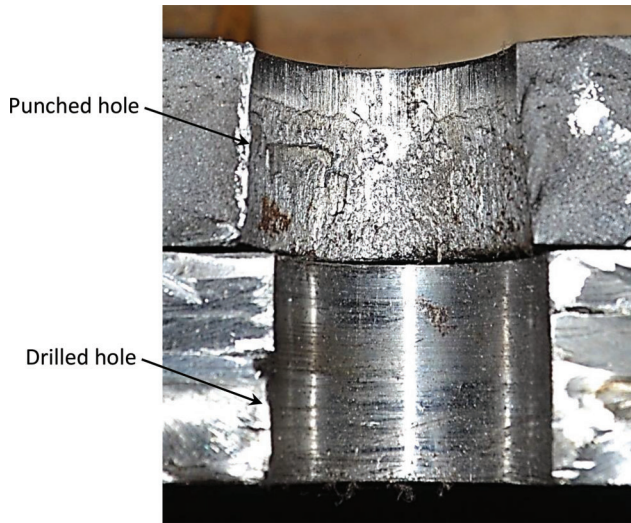
Figure 5.26 Example of punched and drilled hole quality.

Figure 5.26 shows a punched hole and a drilled hole side-by-side. Notice that the punched hole has shear lap defects where it appears as if the material was smeared. Drilled holes will not always appear as smooth as Figure 5.26 appears, this will be a product of the drilling rate and bit sharpness. Another look at a drilled hole is shown in Figure 5.27(a) where it reveals the drilling striations. Figure 5.27(b) also shows a similar perspective for a punched hole. This is the view that a worker would have in the field when trying to determine whether the holes are punched or drilled.

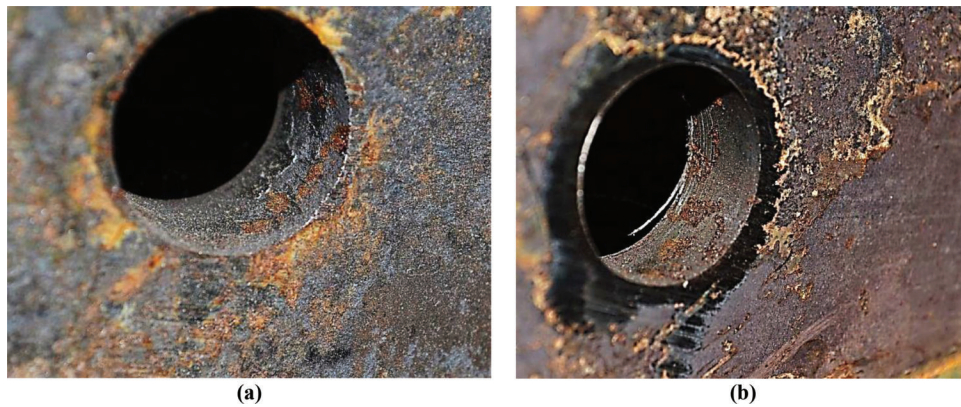
Figure 5.27 Perspective with rivet removed revealing appearance of punched (a) vs. drilled (b) hole.

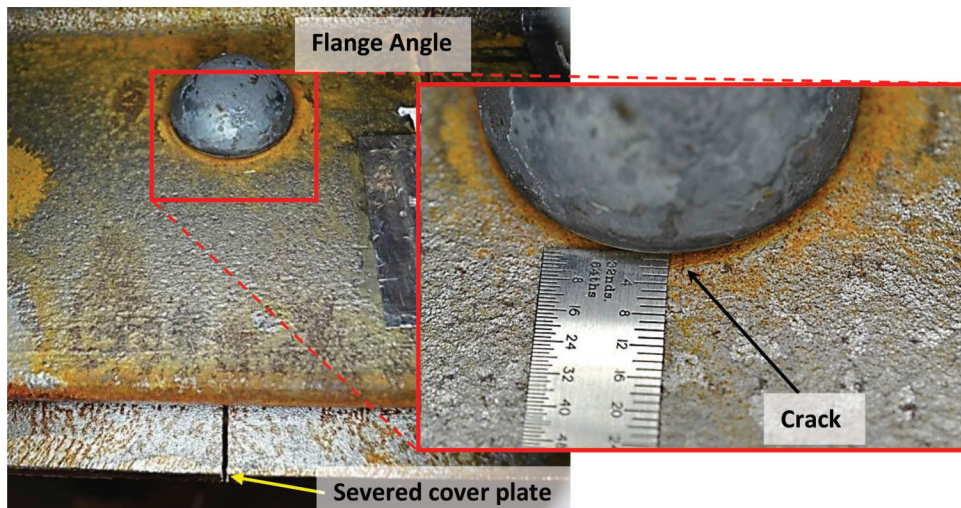
Figure 5.28 Test specimen showing fractured cover plate with fatigue crack propagating from rivet hole in the flange angle (Hebdon, 2015).

Hebdon (2015) took this a step further by determining the fatigue resistance of riveted built-up full scale girders after a single component (i.e., cover plate or flange angle) was completely failed (either due to fatigue or fracture). An example of these test specimens is shown in Figure 5.28 where it shows the severed cover plate and a fatigue crack propagating out from underneath the rivet head. Results from this research indicated that the AASHTO Category D was a reasonable lower bound for girders with drilled holes, based on an amplified net-section stress range that incorporates localized stress redistribution.

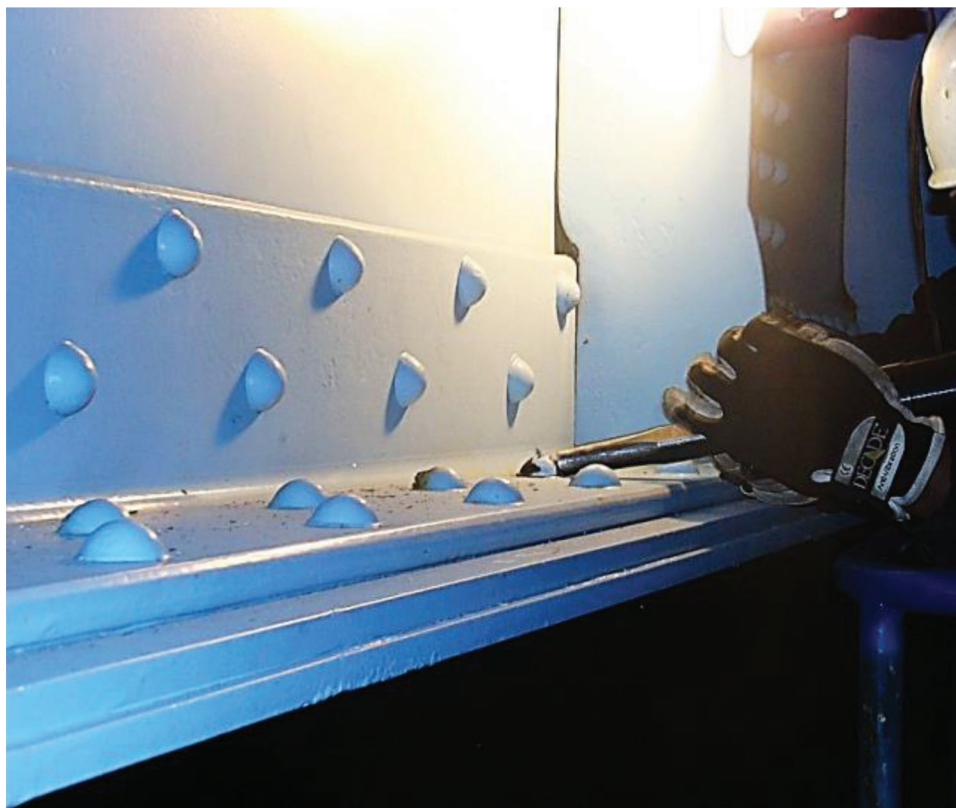
Figure 5.29 Rivet removal using blunt tip and pneumatic rivet buster hammer.

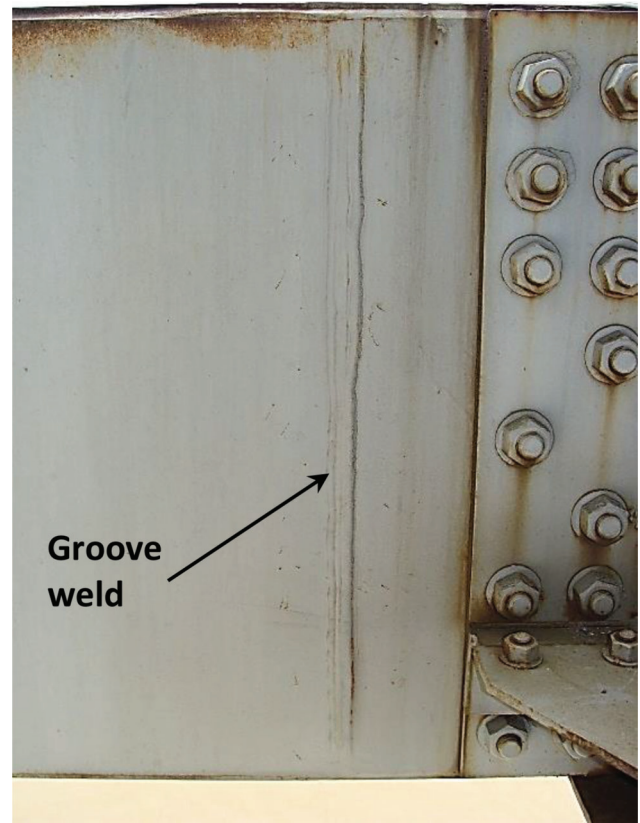
Figure 5.30 Transverse groove weld *with* reinforcement left in place (Category C).

If the weld reinforcement is left in place, such as that shown in Figure 5.30, the fatigue resistance is reduced by the additional stress concentration at the weld toes. Thus, transverse groove welds with the reinforcement not removed, with or without the correct thickness or width transition slope, are AASHTO Category C. This is relatively good fatigue resistance, and it is not often that a crack will develop at Category C fatigue details on typical highway bridges. However, cracks have been found propagating out of this type of detail, particularly

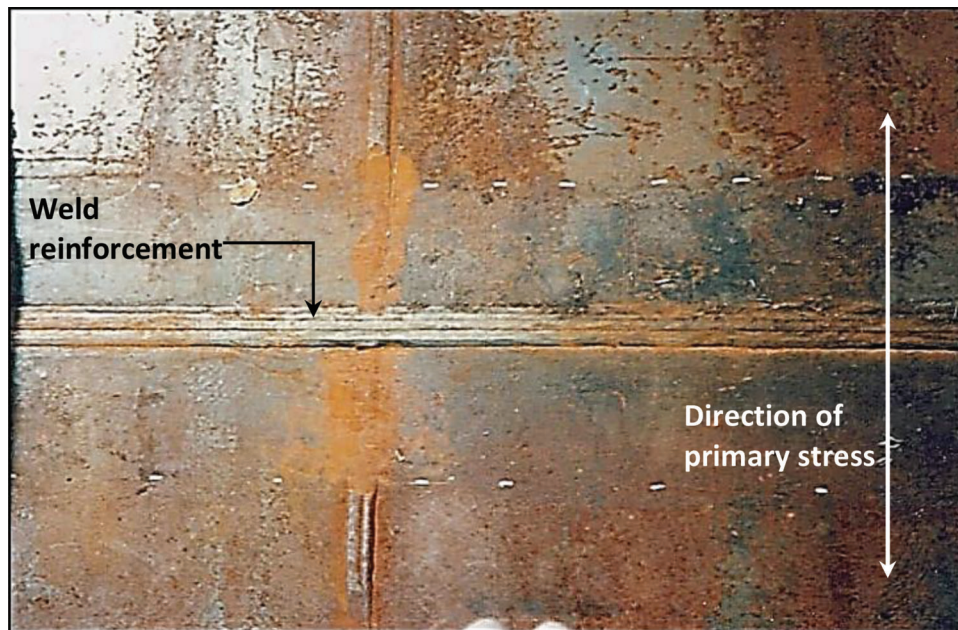
Figure 5.31 Category C transverse groove weld.

5.6.2.1 Grind Weld Reinforcement Smooth. Once the internal soundness of a transverse groove weld has been determined by NDT, one of the most efficient ways to improve fatigue resistance from Category C to Category B is to grind off the weld reinforcement. Figure 5.31 shows a typical transverse groove weld in a flange plate. The weld reinforcement has been left in place. The weld toe creates a stress concentration that reduces fatigue resistance and is the most likely point of crack initiation. By removing the weld reinforcement, the weld toe is also removed, which reduces stress concentration and improves the fatigue strength of the detail. To perform this retrofit, first establish the soundness of the weld using UT or PAUT. Next, follow surface grinding techniques discussed in Section 4.4 being careful to remove the entire
