Maintenance Actions to Address Fatigue Cracking in Steel Bridge Structures

PROPOSED GUIDELINES AND COMMENTARY

NCHRP Transportation Research Board of
The National Academies

Robert J. Connor and Jason B. Lloyd
Purdue University
West Lafayette, Indiana

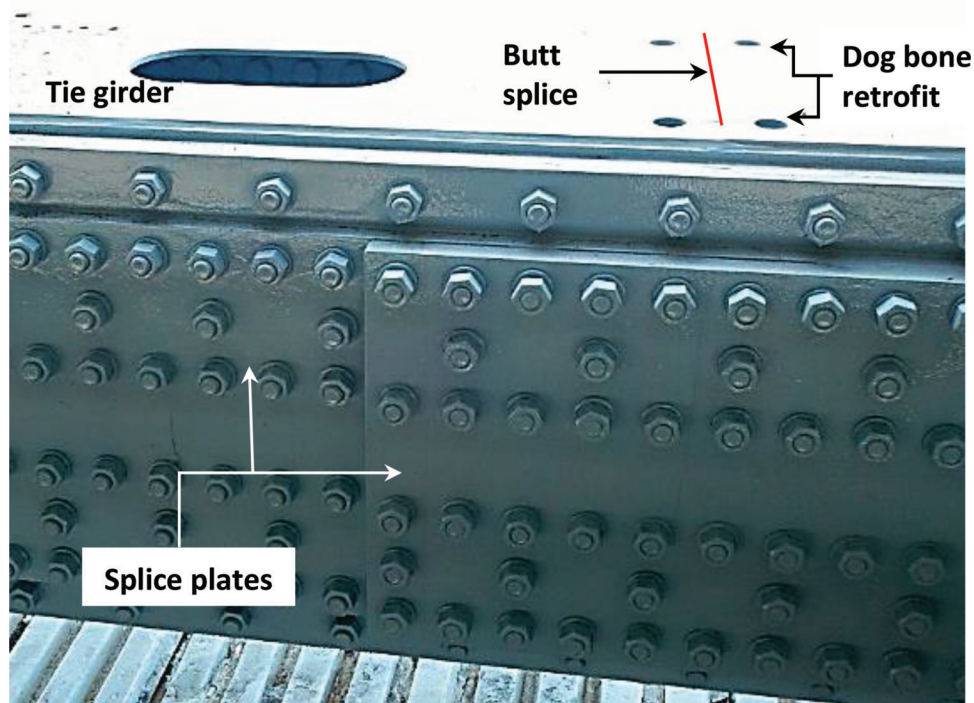
Figure 5.32 Example of bolted splice installed on a tie girder.

of a bolted splice installed on a tie girder on the Sherman-Minton Bridge in Indiana and Kentucky. Note the dog bone retrofit that was also added at the butt splice weld as a safeguard to arrest any unstable crack extension that was deemed possible in a Fitness-for-Service evaluation for the T1 steel. The dog bone retrofit is made up of two drilled holes connected by a cut, as seen better in Figure 5.33. This strategy is typically used for fracture arrest applications and is discussed in further detail in Section 6.6. It is highly recommended to drill a hole at the crack tip of any known cracks, as research has shown that a bolted splice installed after fatigue cracking has initiated may not prevent subsequent crack growth (Hassan & Bowman, 1995).

5.6.2.3 Bolted Splice Retrofit. A slip-critical bolted splice is the most reliable retrofit that can be installed at a transverse groove weld detail. However, it is also the most expensive. For flexural girder applications where cracks are *not* found or where cracks are found to be within the flange plate only, the splice can simply be designed to carry only the flange moment. If an existing fatigue crack has propagated into a girder web plate, then a web plate and flange splice is recommended, sufficiently designed to carry the full moment of the girder at that location. Adding a 2 to 4 inch diameter drilled hole or a dog bone retrofit in the web directly in line with the groove weld could also be done to ensure that any future crack growth cannot extend into the web plate. An example of this is shown in Figure 5.5 showing a fatigue crack that has grown through the thickness of the flange plate and arrested in the drilled hole. For truss or tie girder applications, it is recommended that the splice be designed to carry the entire dead load and live load. Figure 5.32 shows an example

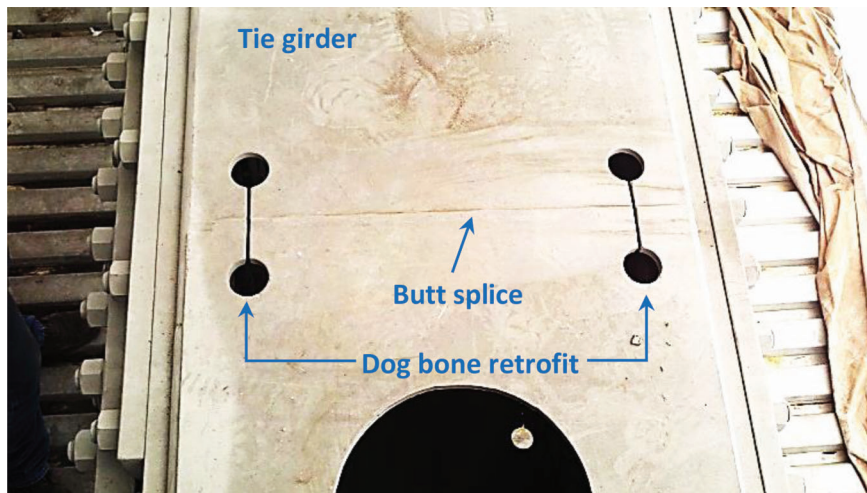
Figure 5.33 Top view showing dog bone retrofit on a tie girder butt weld.

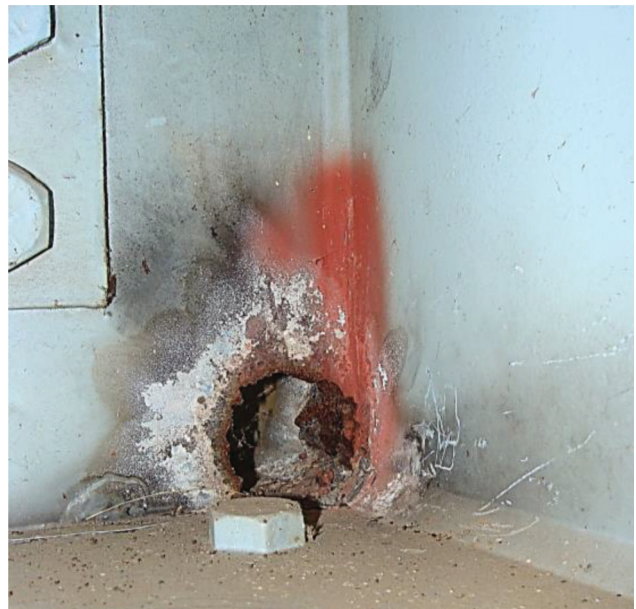
Figure 5.34 Poor quality flame-cut hole that is prone to fatigue and fracture.

Using thermal cutting makes sense for some retrofit applications, but it is important that the hole not be left in conditions anything like seen in Figure 5.34. Further, plasma cutting is strongly encouraged over traditional oxy-acetylene thermal cutting whenever possible. Drilling the hole is also highly recommended whenever possible and will produce a much higher quality edge finish with minimal sanding at the edges. If a thermal cut is used to make a weld access hole or a retrofit hole, it is recommended that a carbide rotary burr bit and die grinder be used to remove the hardened and brittle martensite layer at the burned edge, grinding down to bright metal and removing gouges. Additional grinding and sanding is recommended following the burr bit, as listed below. This will not only remove discontinuities

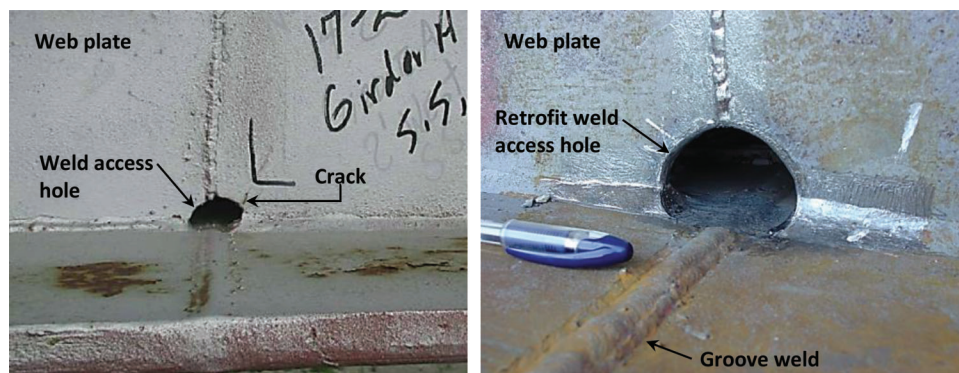
Figure 5.35 Repair of cracked weld access hole showing before (Left) and after (Right) (Photographs courtesy of Kansas DOT).

at the edge of the hole related to roughness of the cut, but also any micro-flaws that may have formed in the brittle layer during cooling. Figure 5.35 shows a before and after repair of a cracked weld access hole. Notice the increased and improved radius, smooth and polished edges, and gradual transitions into the flange plate. This particular repair also included peening treatment around the edge of the hole and at the termination of the flange-to-web welds to further improve fatigue resistance. Grinding the transverse groove weld smooth would have likely resulted in an overall Category B fatigue detail. Leaving the weld reinforcement in place made this a Category C detail. See Section 5.6 for retrofit techniques for transverse groove welds.

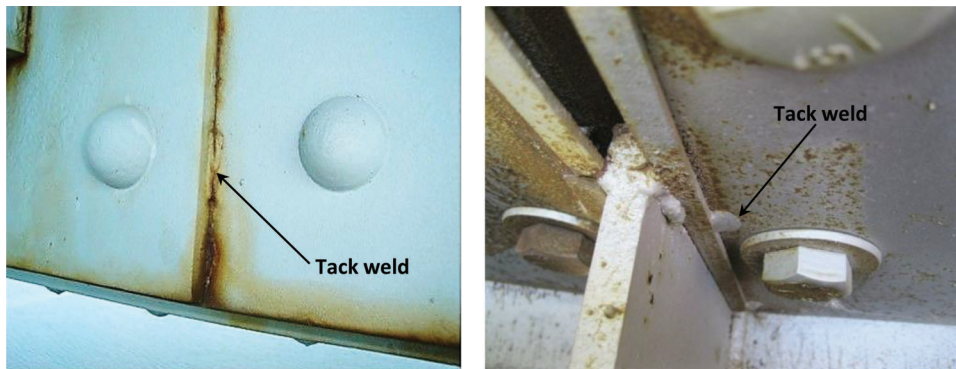
Figure 5.36 Examples of tack welds used in fabrication.

Tack welds are welds made to hold parts of a weldment in proper alignment until the final welds are made (AWS, 2015). Tack welds have also been used for many decades to align geometry for bolted and riveted members together for drilling, punching, and fastening. Often the tack welds were left in place following fabrication and construction leaving details like what are shown in Figure 5.36.

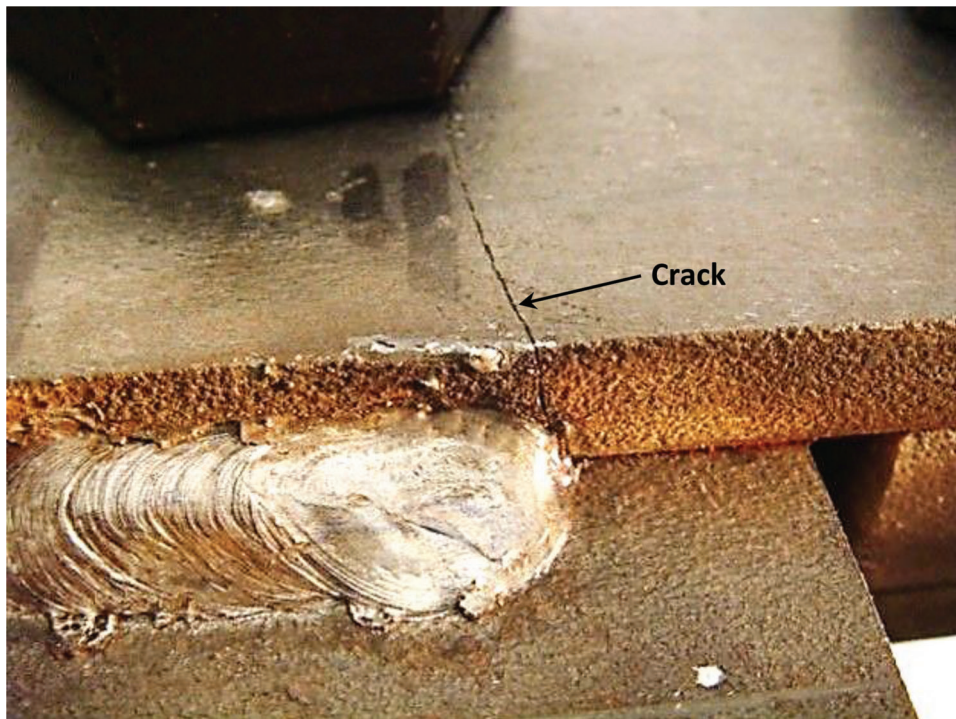
Figure 5.37 Common crack location at tack weld (Bowman *et al.*, 2012).

or simply become unfused to the base metal. However, in rare cases, they can also crack into the base metal in which case the problem can become more serious. In these cases, the crack typically grows out of the end of the weld, as can be seen in Figure 5.37.

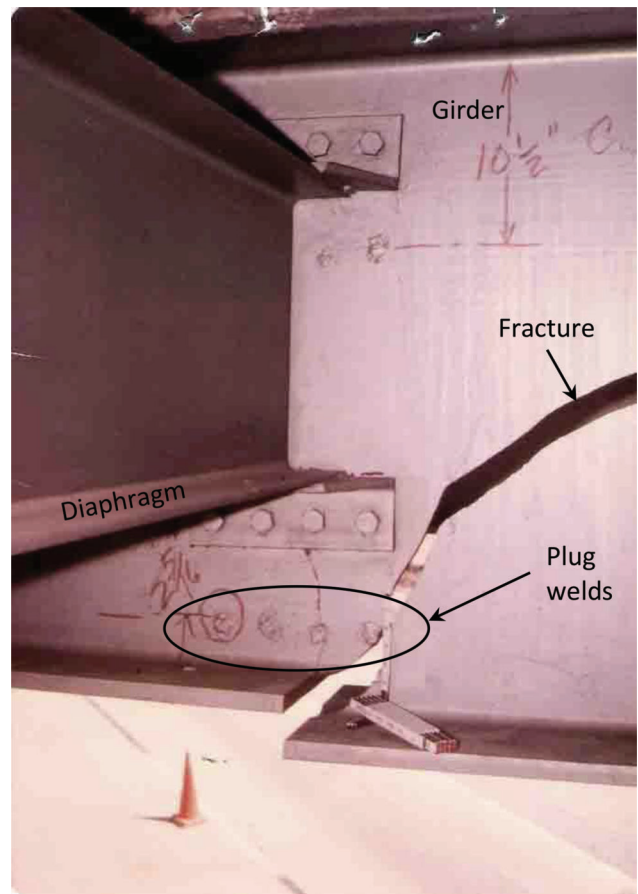
Figure 5.38 I-57 Farina Overpass fracture at plug weld (Steel Fatigue Knowledge Base, 2008).

Plug weld failures have been observed in several bridges, including the I-57 Farina Overpass. An interior girder of this bridge fractured during the winter of 1976-1977 resulting from fatigue cracks initiated at plug weld sites in the tension side of the web to correct for miss-drilled bolt holes during fabrication (Steel Fatigue Knowledge Base, 2008). Figure 5.38 shows the fracture and plug welds. Figure 5.39 shows a magnetic particle test result for a plug weld detail on a tied arch bridge in Sault Ste. Marie, Michigan. The results highlight the lack of fusion around the original hole that is not uncommon for these often poorly-executed welds. In addition to the risk of fracture, a plug weld is not currently classified in any existing AASHTO fatigue category, and therefore has unknown fatigue resistance.

If a large crack is found, a full bolted splice over the crack or a girder section replacement may be required. This was the repair for the I-57 Farina Overpass shown in Figure 5.38 where a long section of the girder was removed and replaced with new WT section using a combination of longitudinal welds and bolted splices.

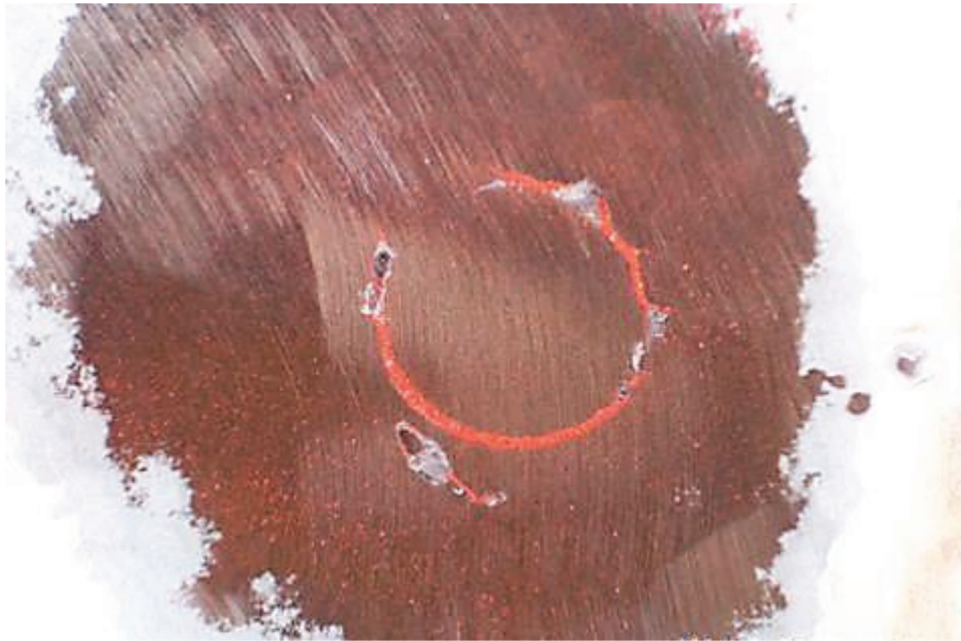
Figure 5.39 Magnetic particle test results at a plug weld showing lack of fusion defects (Photograph courtesy of Phil Fish).

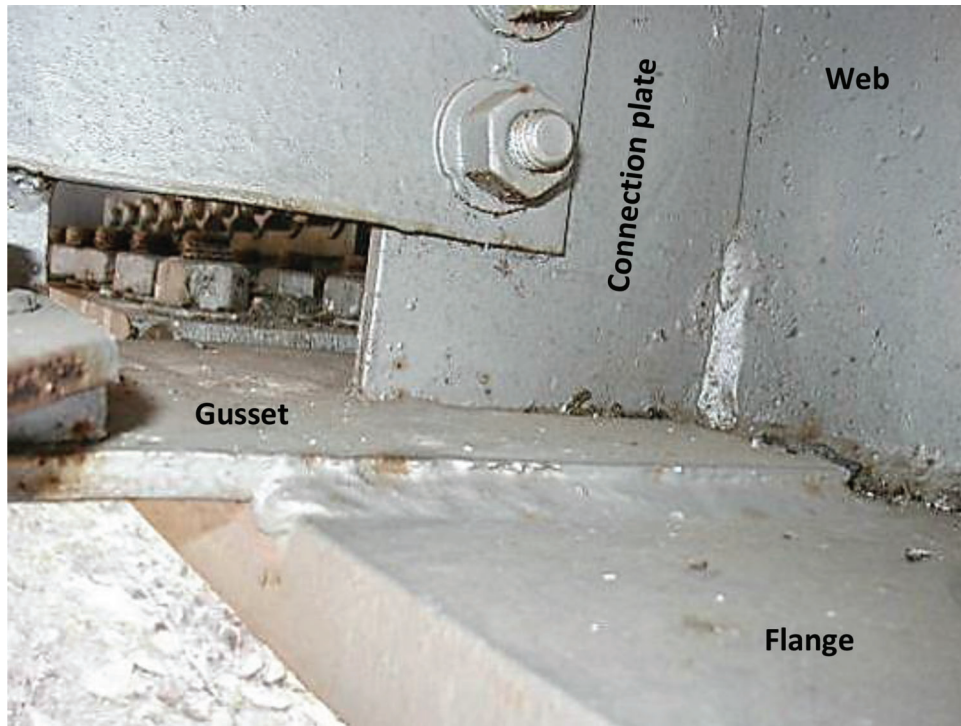
Figure 5.40 Example of gusset plate welded to the flange with only transverse welds.

similar to what is shown in Figure 5.40. They concluded that most often the fatigue cracking developed from the weld root, propagating through the entire width of the transverse weld. In most of their tests, the gusset plate was left severed from the flange with a fatigue resistance comparable to AASHTO Category E' or possibly even less. In addition to the low fatigue resistance, another challenge with this type of detail is that the fatigue crack will grow undetected through the throat of the weld and does not become detectable to VT, MT or PT until the weld is essentially failed. Another challenge with a gusset plate attached with *only transverse* welds would be that peening treatment at the weld toe would not improve the fatigue resistance since the fatigue crack is developing at the weld root, rather than the toe, away from the benefits of the peening treatment. The best way to mitigate weld root fatigue cracking is to increase the size of the weld, but this typically is not feasible with the gusset plates attached to flanges due to the relatively thin gusset plates that are typically used for these applications. For this reason, the following contains a recommended retrofit to convert to a bolted connection. Another viable option may also be to add a longitudinal weld to the length of the gusset plate. Gusset plates that were attached to a flange with both longitudinal and transverse welds were not observed to fail by weld throat cracking in the transverse weld as they were with those attached with only a transverse weld. Thus, weld toe treatment is recommended below for gusset plate attachment details that include both the longitudinal and transverse welds.

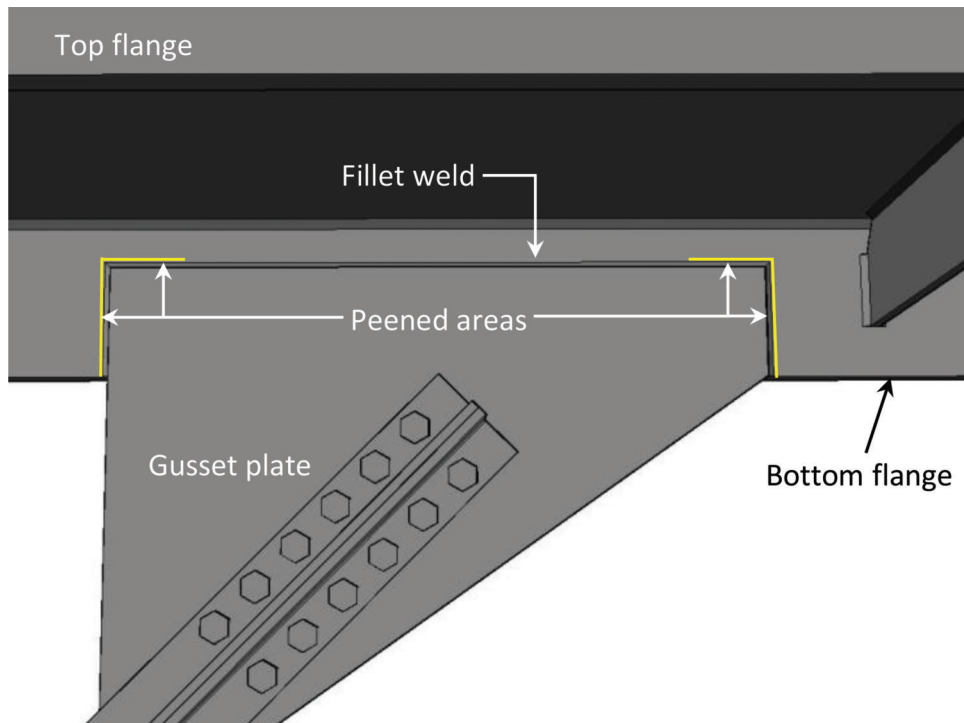
Figure 5.41 Weld toe peening for gusset plates attached to flanges.

transverse welds, weld toe treatment has been found to be a very effective retrofit. Weld toe treatment is described in detail in Section 4 of this guideline. Refer to this section for a complete description of weld toe grinding to remove existing surface cracks and to apply post weld peening treatment. Peening should be applied across the entire length of the transverse weld toes, wrap around the corner and continue down the longitudinal weld 2 to 3 inches, as highlighted on Figure 5.41 with yellow lines. For cases where the gusset is attached to the flange by transverse welds only, weld toe treatment is not recommended unless longitudinal weld can be added. This is because treating the toe, in this particular case, may push the fatigue initiation to the weld root where it will not be detectable.

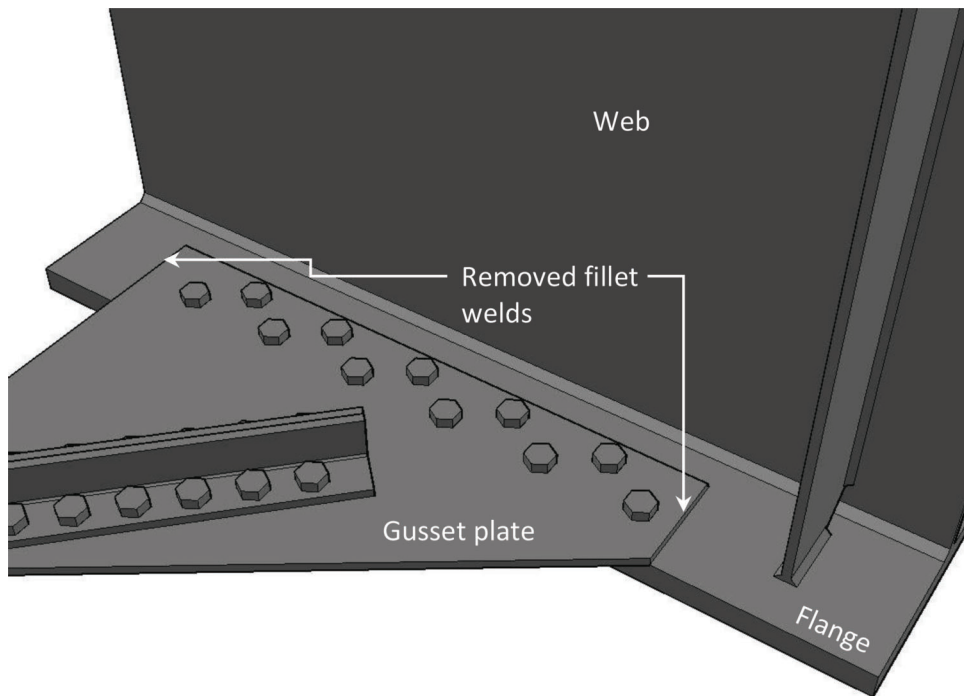
Figure 5.42 Completed retrofit showing removal of welds and bolted connection.

For the case where the gusset plate is welded to the flange with transverse welds only, the following procedure is recommended. Prior to installing the bolted connection, a qualified engineer must evaluate the detail to check the new net section of the flange plate and gusset plate with drilled bolt holes. Figure 5.42 shows the completed retrofit.

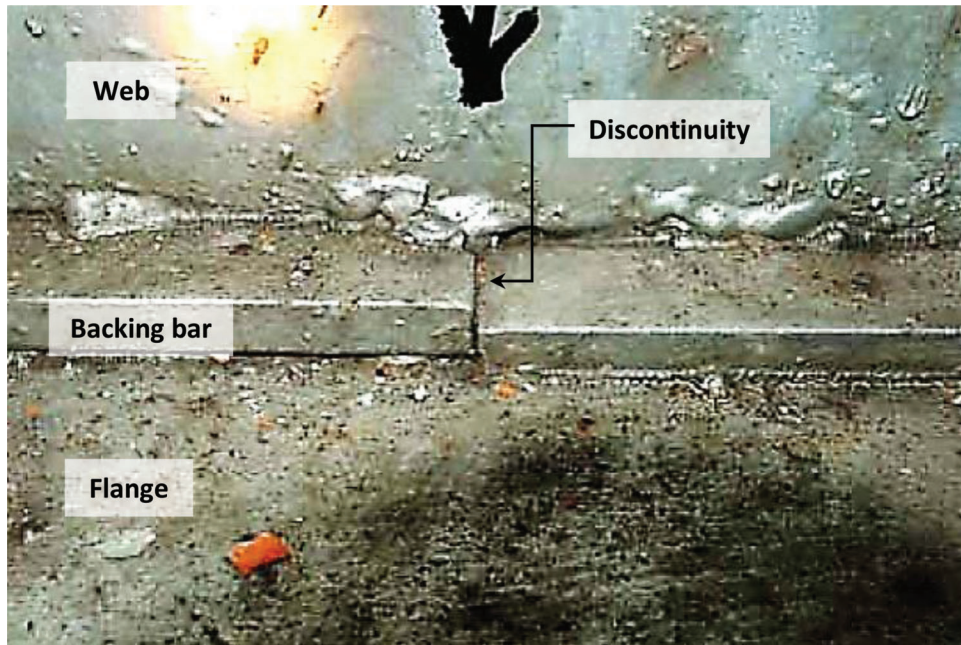
Figure 5.43 Example of backing bar discontinuity found in Fort Duquesne approach spans.

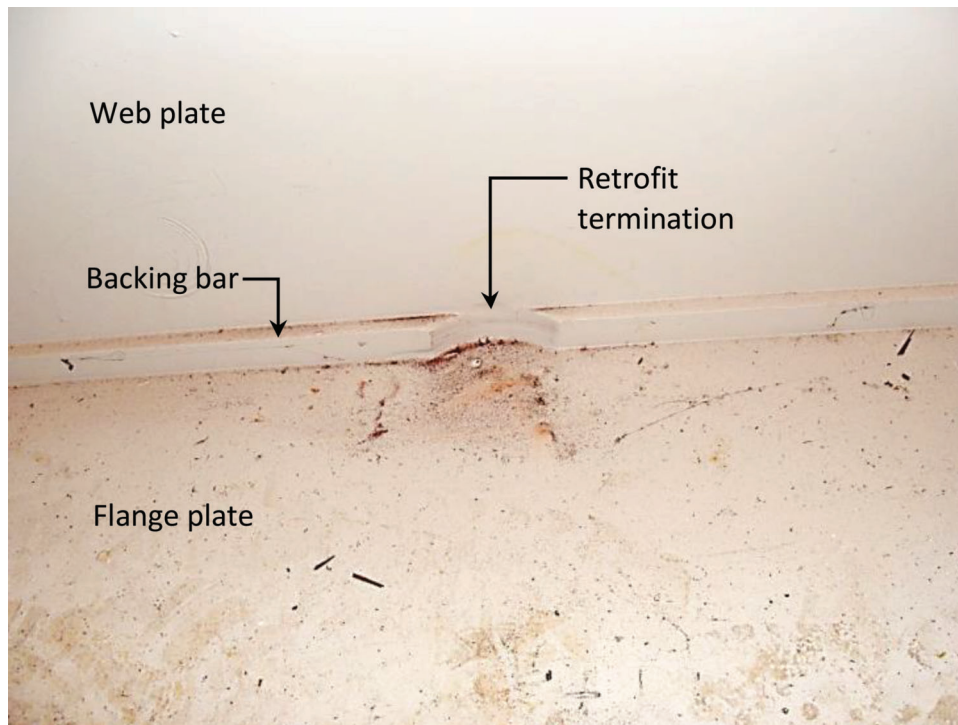
Figure 5.44 Example of backing bar termination removed inside the tie girder of the Hoan Bridge.

back to base metal. This approach is much more feasible, economical, and will provide sufficient resistance to fatigue and significantly reduce risk of fracture. Figure 5.44 shows an example of this method used in the tie girder of the Hoan Bridge in Milwaukee, WI. Notice that the backing terminations were removed down to the base metal of the web and flange plates leaving no residual weld material behind.

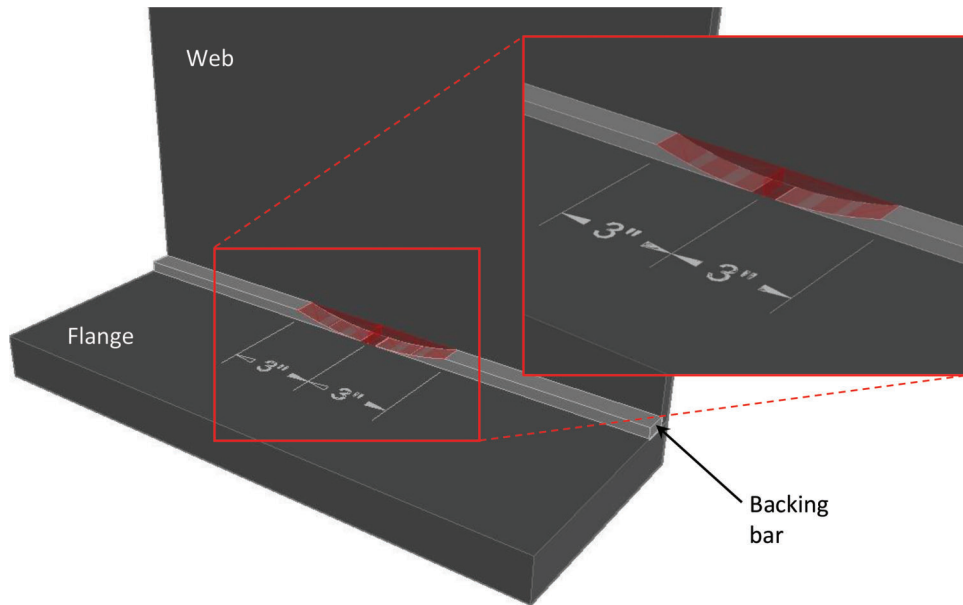
Figure 5.45 Discontinuous backing bar retrofit showing fairing of weld terminations.

- b. Grinding: Using techniques discussed in Section 5.3 for repair of notches and gouges, grind down the backing bar at a gradual slope between 5:1 and 10:1. Thus, for a 3/8 inch thick backing bar, grind back a distance of between about 2 inches and 4 inches on each of the backing bars. See Figure 5.45 for further detail of a typical grinding repair.

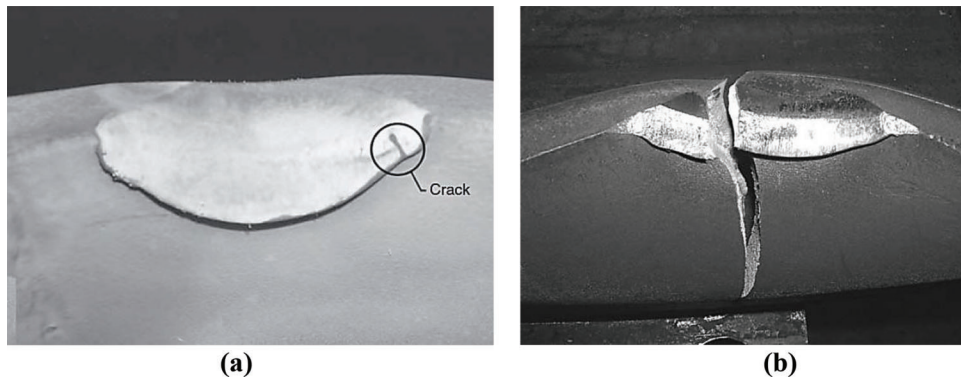
Figure 5.46 (a) Example of micro-crack resulting from impact (b) Example of brittle fracture resulting from impact at another location (Taken from Connor *et al.*, 2008).

they determined that a thin layer of cold-worked material with very low fracture toughness was formed at the local area during impact. Small cracks, as seen in Figure 5.46(a), resulting from severe strain, as well as rolling and bunching of the material, was observed at the exact point of impact on tested steel girder flanges. These defects, if left untreated, resulted in brittle fracture during subsequent impacts at different locations on the girders, as seen in Figure 5.46(b).

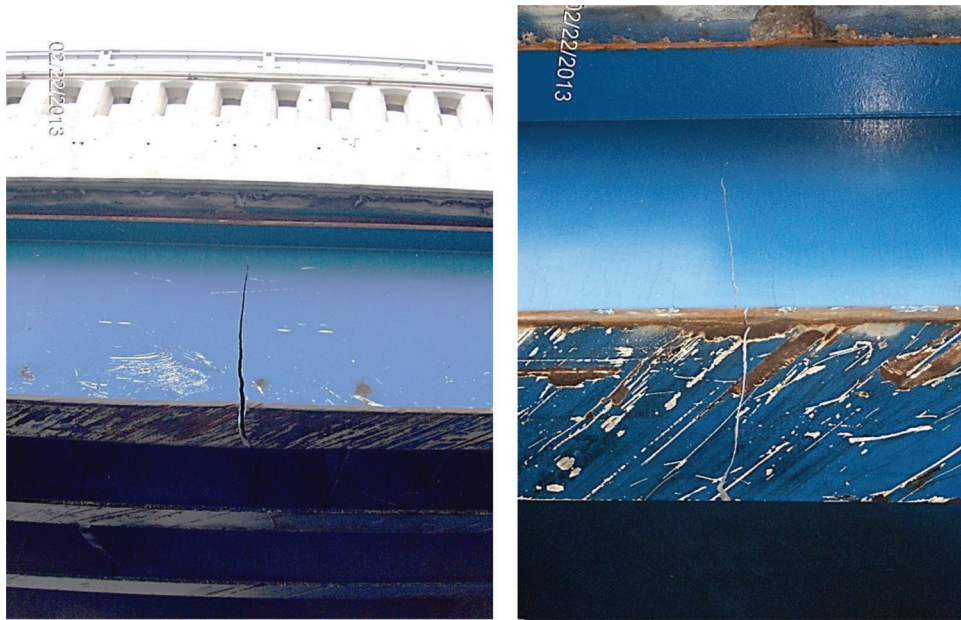
Figure 5.47 Fractures on the same girder resulting from a singled impact event.

This same phenomenon has also been observed outside of the laboratory. One example is the Virginia Ave Bridge over the I65/I-70 northbound lanes near downtown Indianapolis. In 2013, the fascia girder was impacted by the boom of an aerial lift being hauled on a flatbed trailer. The non-composite girder instantly fractured at two locations, one on either side of the point of impact, just beyond the adjacent cross frames. The fractures are shown in Figure 5.47. The fractures both initiated at locations of *previous* impacts in the hardened, cold worked zones where small cracks existed. Fortunately, the fractures both arrested in the

web plate just inches from the top flange keeping the nearly 40-foot girder section from falling into traffic. For bridges like the Virginia Ave. Bridge that span over interstate traffic and are frequently impacted, proper inspection and maintenance following an impact event can be very difficult. Often the impacts are not reported and are challenging to distinguish from past impacts documented during regular inspections. As a result, the damaged areas can easily go unrepaired. However, the repair is relatively quick and simple, requiring only common hand tools and a few minutes.

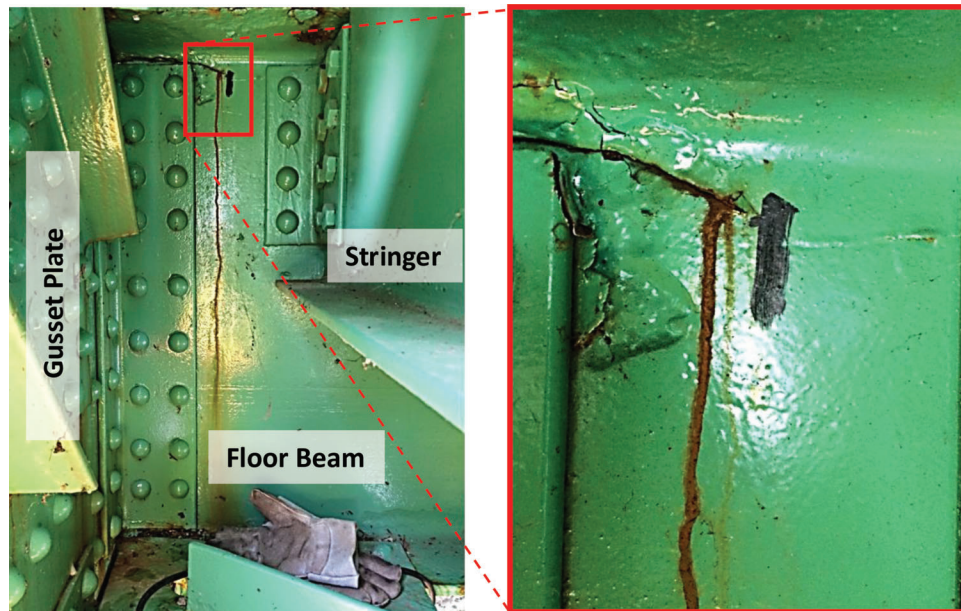
Figure 6.1 Example of floorbeam web gap cracking.

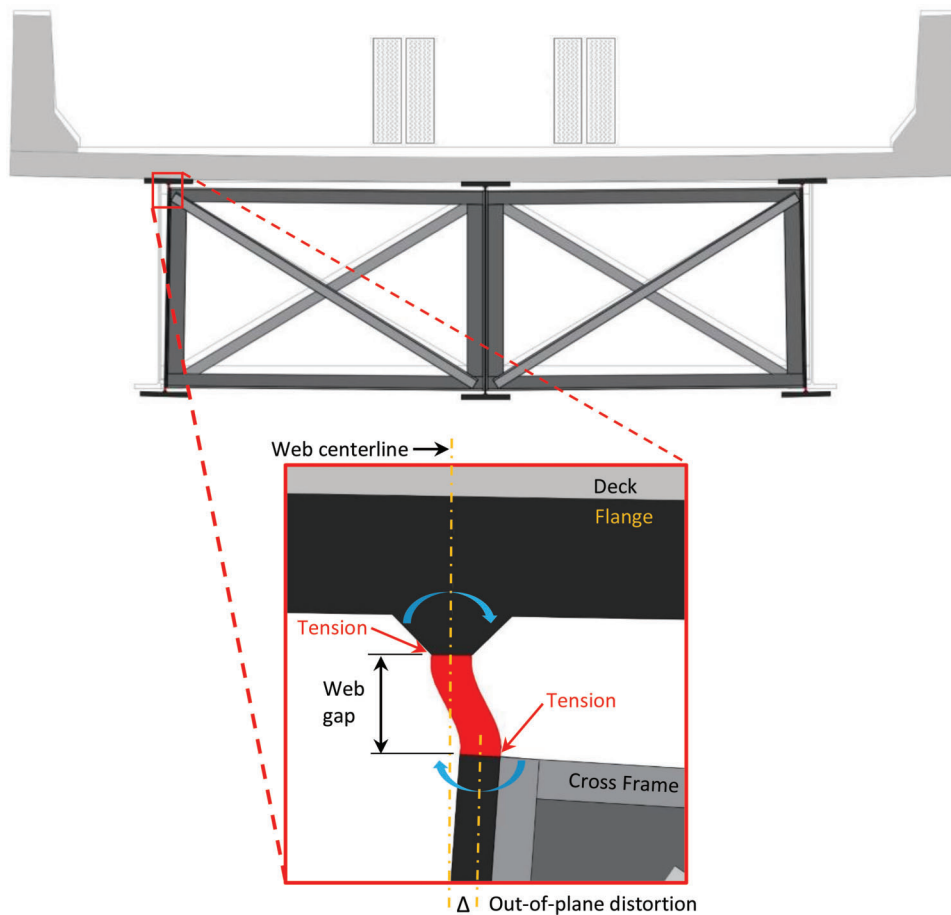
Figure 6.2 Exaggerated illustration depicting bending in a web gap caused by uneven loading of the plate girders.

The driving mechanism for distortion-induced fatigue in the web plate of primary members is illustrated in Figure 6.2. Uneven loading of bridge girders can cause differential vertical deflections. Lateral loads are transferred through the connecting elements into the web plate, which is very flexible out of plane, resulting in web plate reverse bending immediately adjacent to the flange. The inset of Figure 6.2 shows a red portion of the web located in the web gap region between the connection plate and the top flange with a yellow dashed line accenting the web gap distortion. This is the problematic area where cracking can occur. The flange restrains the web plate at the concrete deck similar to the fixed end of a cantilevered beam, generating bending stresses. However, this type of cracking can also occur at the bottom of the connection plate, even in positive moment regions, due to the out-of-plane flexibility of the web plate as compared to the relatively stiff flange plate. Bridges that experience relatively large differential displacements of adjoining members are more prone to this phenomenon, such as skewed bridges, curved bridges, or bridges with large girder spacing. An example of distortion-induced cracking in a girder web gap is shown in Figure 6.3. Note in this

image that the cracking has occurred at the transverse weld termination as well as the web-to-flange weld. The dual cracks are common for distortion-induced fatigue due to the reverse curvature of the web plate imposing tensile stresses at the top and bottom of the web gap (which has been illustrated in Figure 6.2, as well).

results in a bending of the floorbeam web plate within the small web gap area, similar to that shown in Figure 6.2 for transverse connection plates (within the web gap region, the two modes of fatigue cracking are identical). Very large tensile stresses result at the top and bottom of the web gap often causing cracks at both of these locations. Typically, this type of fatigue crack will be most prevalent in locations of largest global shear stress where the incompatibility between the floor system and tie girders will be the highest. An example of the fatigue cracks are shown in Figure 6.16 on the Birmingham tied-arch bridge over the Monongahela River in Pittsburgh, PA.

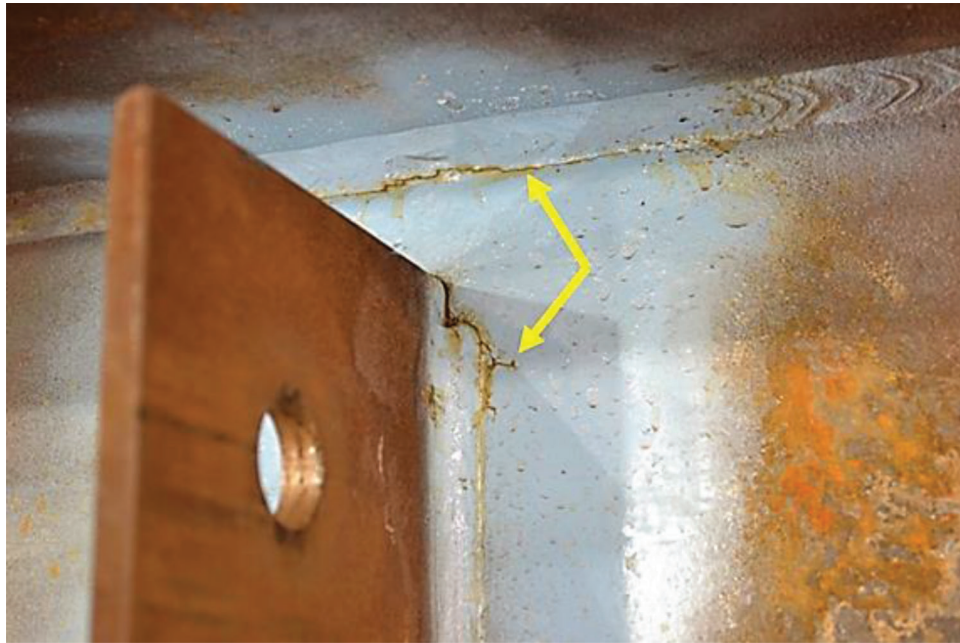
Figure 6.3 Example of web gap cracking resulting from distortion.

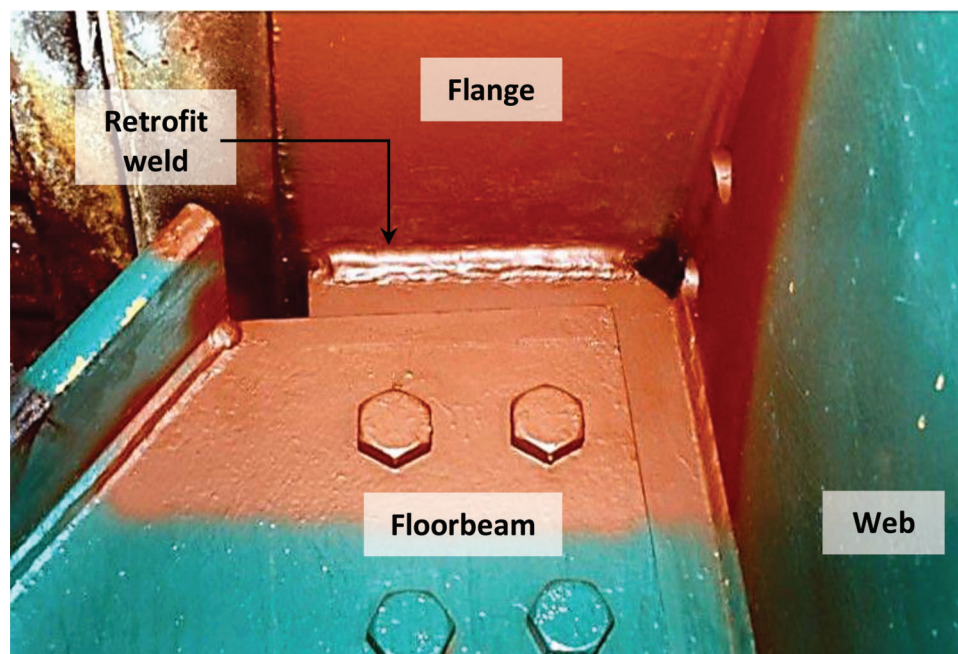
Figure 6.4 Welded splice at connection plate and top flange (Koob *et al.*, 1985).

If the connection plate does not extend close enough to the flange to make the welded splice directly, filler plates can be used to close the gap, stepping up until the gap is sufficiently closed to make the final welds. A number of bridges have been successfully retrofit using this approach (Fisher, 1984). A welded attachment to a flange, however, should be made shorter than 2 inches (parallel with the flange longitudinal axis) in order to be achieve Category C fatigue resistance. This

is recommended so that the load-induced fatigue life of the detail is not reduced by the addition of the splice filler plate. In addition, oversizing the welds where possible and adding weld to the transverse and longitudinal sides will help to prevent any possible fatigue development at the weld root. Figure 6.5 demonstrates a welded splice retrofit that includes a filler plate to close the gap between the flange and the transverse stiffener.

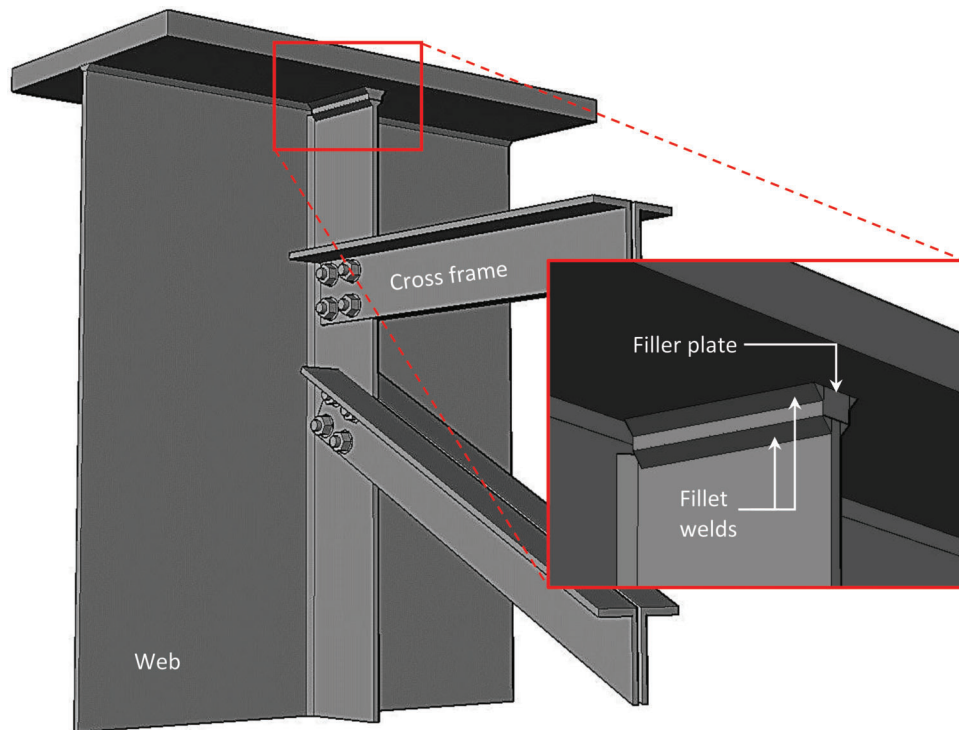
Figure 6.5 Completed welded splice retrofit showing filler plate option to close gap.

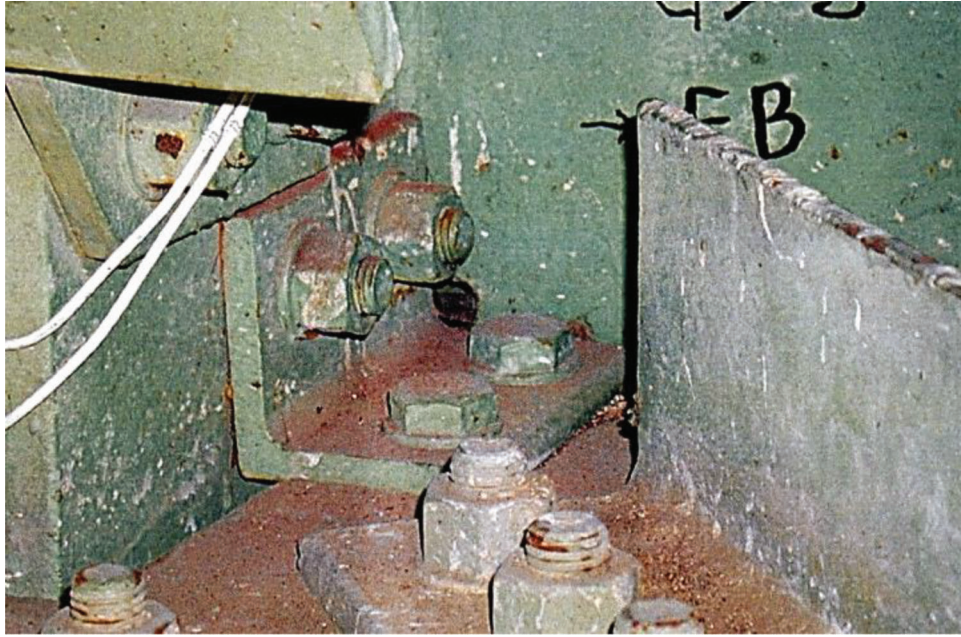
Figure 6.6 Insufficiently stiff splice angle shown installed on gusset-connection plate web gap.

When properly designed and installed, a bolted splice retrofit can be very effective in minimizing distortion stresses in the web gap region. However, when the stiffening elements are not sufficiently rigid, the retrofit will be ineffective. An example of this, shown in Figure 6.6, was investigated by Connor and Fisher (2006). The angle was a 3x3x3/8 angle attached with two bolts per leg and was not capable of providing enough rigidity between the gusset plate and transverse connection plate to prevent the high web gap cyclic stresses. Conceptually this can be seen when comparing the scale of the stiffening angle to that of the adjacent lateral bracing element and floorbeam connection. Not only would this not mitigate the distortion fatigue, but likely the stiffening angle would begin to fatigue as well.

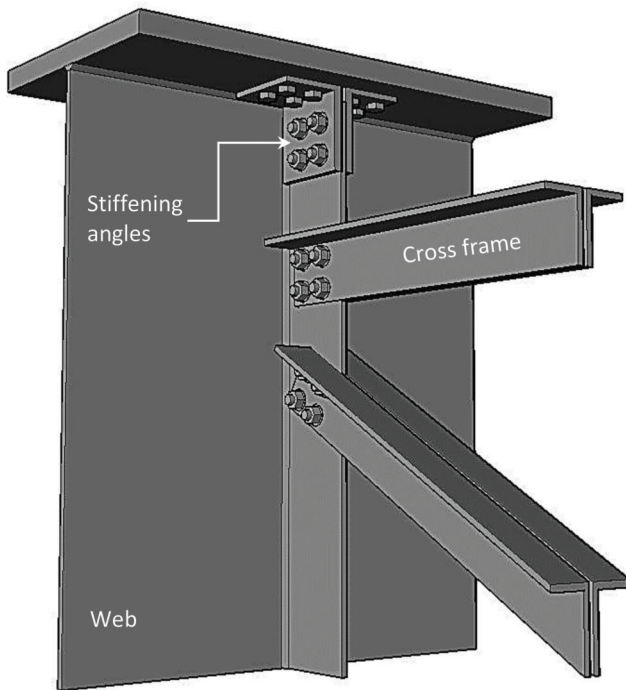
Figure 6.7 Completed bolted splice retrofit showing double angle stiffening elements.

- Double angles configurations (with an angle on each side of the transverse connection plate) provided similar improvement to the WT configuration. A minimum thickness of 5/8 inch angles was recommended. Fisher *et al.* (1990) recommended a minimum 3/4 inch thickness angle

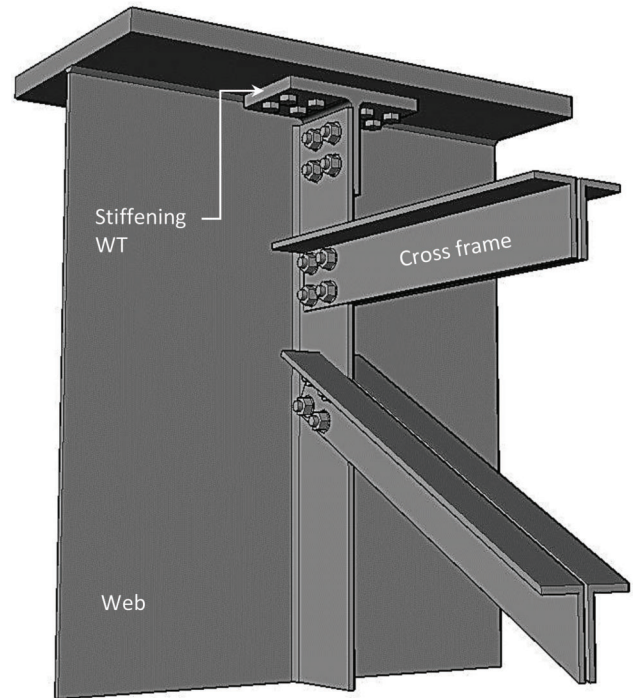
Figure 6.8 Completed bolted splice retrofit showing WT stiffening element.

- WT splicing elements provided excellent distortion mitigation. The flange thickness of the WT was determined to be the most important parameter and a flange thickness of 3/4 inch was found to mitigate cracking better than one with a 1/2 inch thickness.

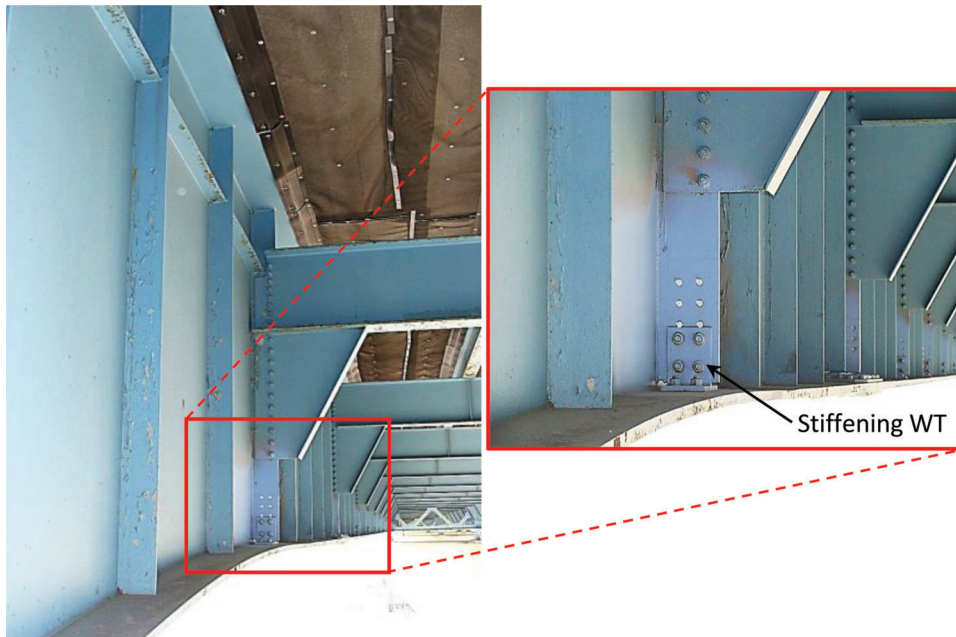
Figure 6.9 WT stiffening retrofit implemented on the Hoan Bridge.

Fish *et al.* (2015) recommended use of a WT shape for stiffening web gaps over hot rolled angles because the section properties for the WT can provide for a stiffer connection. They suggested a WT section such as WT13.5x89, but have also observed a section like a WT12x52 perform successfully on the I-64 Kanawha River Bridge in Dunbar, West Virginia, with reference to Connor and Fisher (2001). The section properties of the WT12x52 are also consistent with the minimum section recommended by Bowman *et al.* (2012). See Figure 6.7 and Figure 6.8 for an illustration of this retrofit. Figure 6.9 shows a WT stiffening retrofit that was implemented as part of the Hoan Bridge repairs discussed more in Section 7.1 of this guideline.

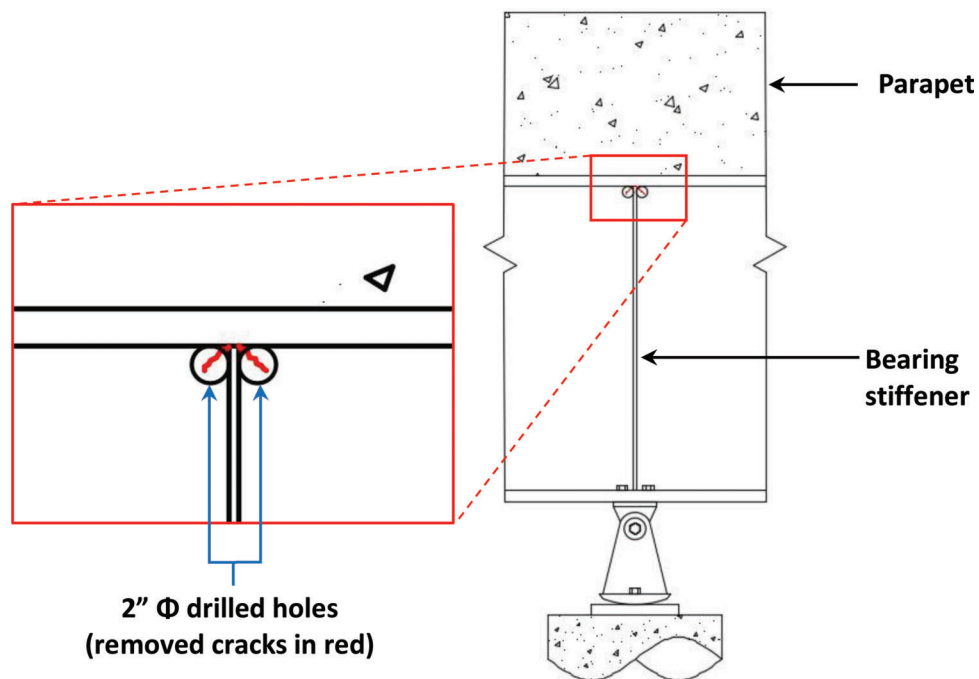
Figure 6.10 Drilled hole prototype installed at bearing stiffeners (Reproduced from Koob *et al.*, 1985).

Koob *et al.* (1985) investigated a large-hole retrofit as an economical way to remove or intercept any existing cracks near the top flange at bearing stiffener-to-floor-beam connections. The prototype retrofit was installed in three locations on the Poplar Street Bridge Approaches, near St. Louis, to determine if the out-of-plane stiffness of the connection would change and to measure the stress range along the weld toes adjacent to the drilled holes. Figure 6.10 shows the basic detail used. They drilled 2 inch diameter holes on either side of the stiffener connection plate, intercepting the flange-to-web weld toe and bearing stiffener-to-web weld toes by 1/8 inch. Intercepting the weld toes in this way prevents a fatigue crack from propagating along the weld toe without being arrested in the retrofit holes. Results from the field test showed that the retrofit was effective in reducing the distortion-induced stress ranges to 6.6 ksi or less, which is less than the Category C CAFL determined for a typical quality drilled hole (Brown *et al.*, 2007; Fisher *et al.*, 1987). The actual fatigue resistance will depend on the quality of the finished hole. A larger diameter hole would further reduce the stress range by increasing the connection compliance.

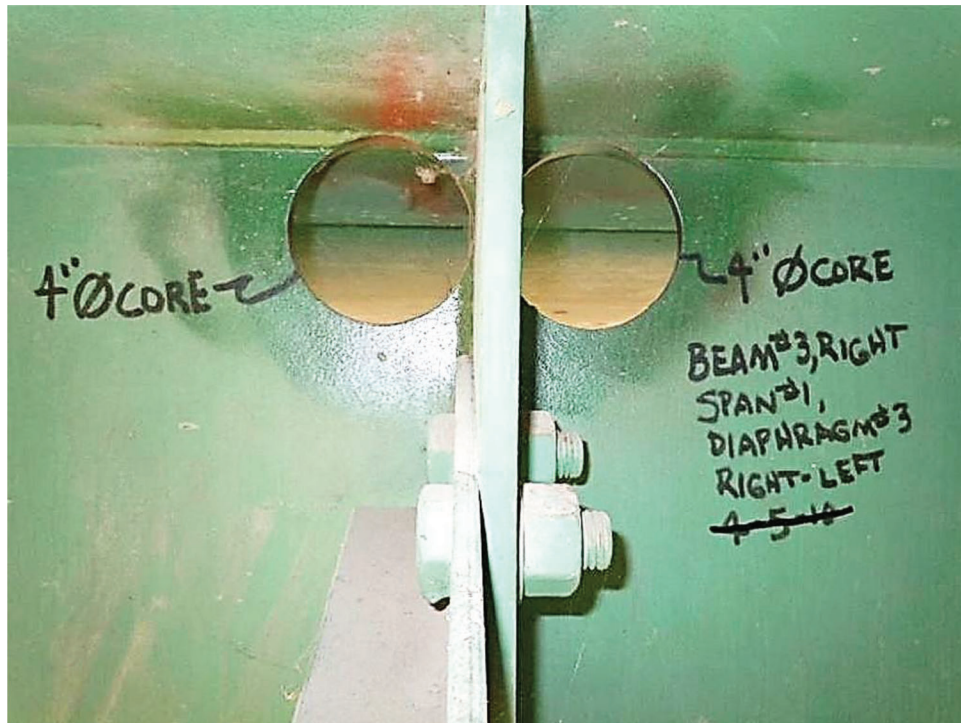
Figure 6.11 Large-hole retrofit – note interception of horizontal and vertical weld toes (Photograph courtesy of Iowa DOT).

This retrofit should be installed using techniques discussed in Section 4.3. The drilled holes are recommended to be at least 3 to 4 inches in diameter and each hole should intersect the horizontal and transverse welds approximately 1/8 inch. If a hole misses either of the welds, use a die grinder and carbide rotary burr bit to grind from the inside of the drilled hole toward the missed weld until the hole is extended sufficiently to intercept it. Maintain a round and gradual profile as best as possible. In the case that there is an existing

crack at the detail, the hole should be drilled to either completely remove the crack, or if the crack is too long to be completely removed, the hole should be drilled such that it removes the crack tip. See Figure 4.4 for recommendations on hole placement. This may require that the drilled hole be placed such that the horizontal flange-to-web weld is missed. If this is the case, it is recommended that grinding or an additional hole be used to ensure the horizontal weld toe is intercepted to isolate the web plate from crack propagation.

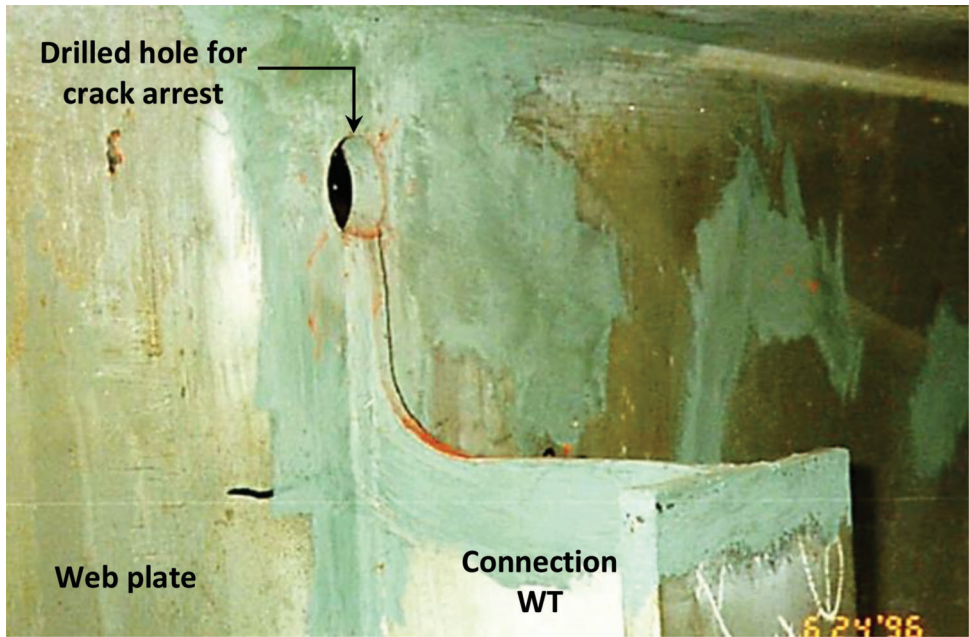
Figure 6.12 Lexington Ave Bridge cutback retrofit (Photograph courtesy of MNDOT).

the web and it was decided that it could be left in place. Shortly after the retrofits were completed, fatigue cracks were found initiating at the end of the remaining weld. The bridge owner had a drilled hole added to the details later to remove the weld terminations and cracks, as see in Figure 6.12.
