Maintenance Actions to Address Fatigue Cracking in Steel Bridge Structures

PROPOSED GUIDELINES AND COMMENTARY

NCHRP Transportation Research Board of
The National Academies

Robert J. Connor and Jason B. Lloyd
Purdue University
West Lafayette, Indiana

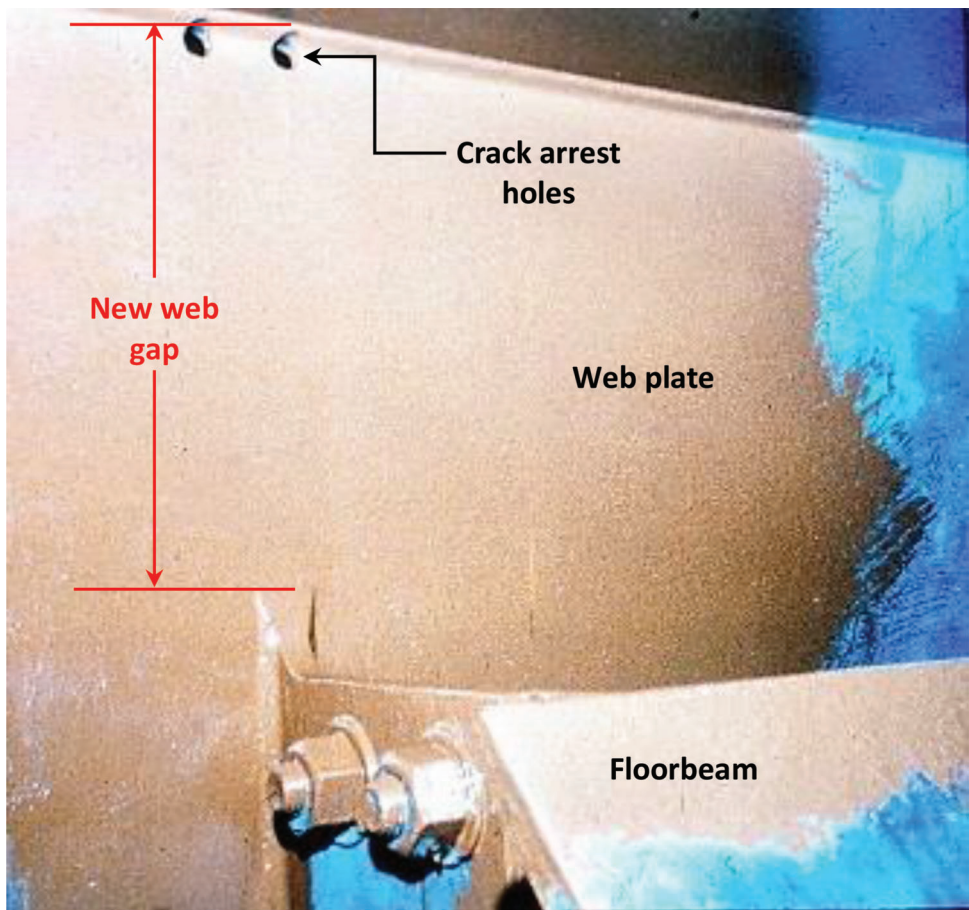
Figure 6.13 Cutback retrofit installed on Polk County Bridge (Photograph courtesy of Iowa DOT).

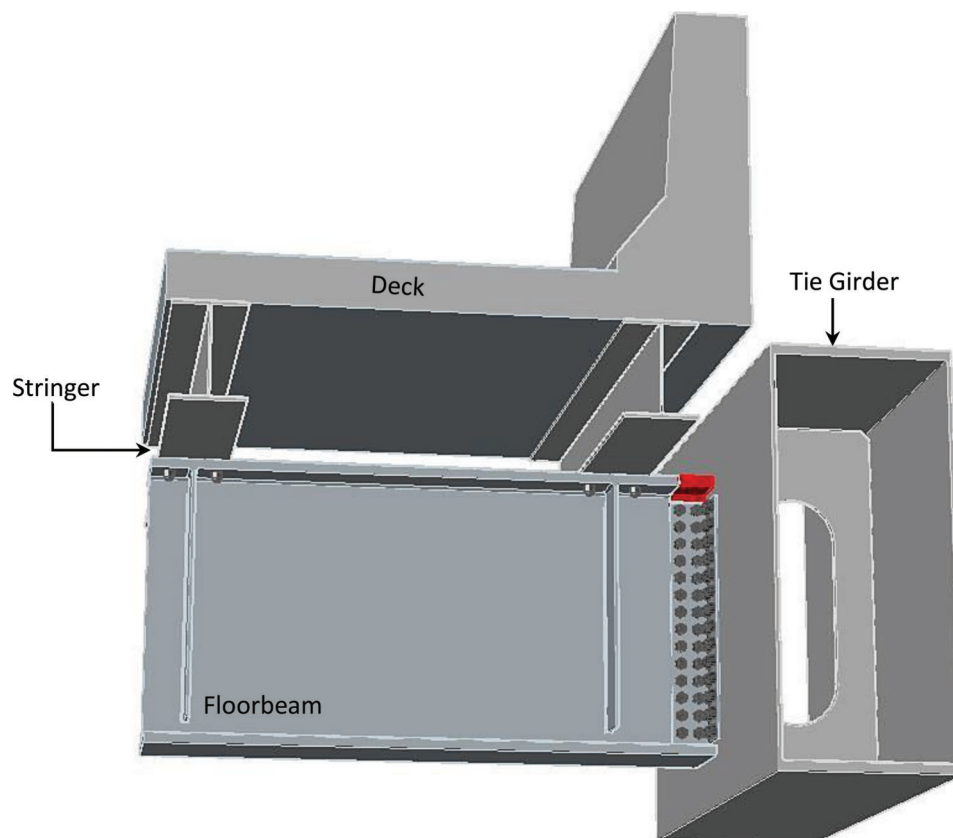
Figure 6.14 Illustration highlighting in red the area of a floorbeam web prone to web gap cracks.

The driving mechanism for distortion-induced fatigue in the web plate of secondary members, such as floorbeams or cantilever brackets, is illustrated in Figure 6.14.

The red area highlighted on the floorbeam at the top of the connection to the tie girder is the location where the cracking is most often seen. Note, however, that distortion-induced fatigue cracks have also been observed at the web gap that sometimes exists between the transverse stiffeners on the floorbeam directly beneath the stringers when the stiffener is not attached to the floorbeam flange (Albrecht & Wright, 2000). Use Section 6.1 for retrofit and repair of these areas.

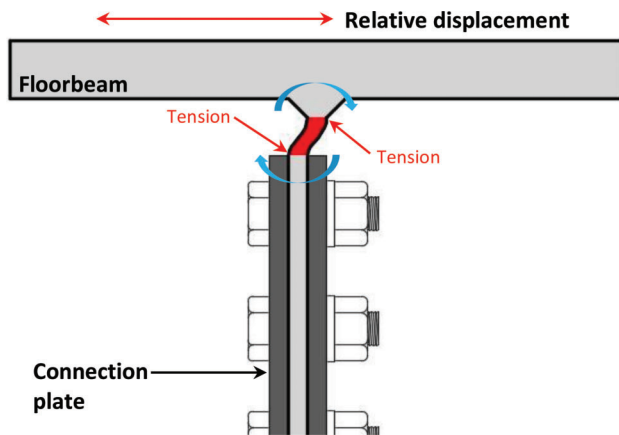
Figure 6.15 Cross section illustrating driving stresses for the floorbeam web gap cracking.

A cross section of the floorbeam-tie girder connection is shown in Figure 6.15. A relative displacement between the floorbeam top flange (which is connected to the stringers) and the connection plates (which are connected to the tie or primary girder) occurs. This

results in a bending of the floorbeam web plate within the small web gap area, similar to that shown in Figure 6.2 for transverse connection plates (within the web gap region, the two modes of fatigue cracking are identical). Very large tensile stresses result at the top and bottom of the web gap often causing cracks at both of these locations. Typically, this type of fatigue crack will be most prevalent in locations of largest global shear stress where the incompatibility between the floor system and tie girders will be the highest. An example of the fatigue cracks are shown in Figure 6.16 on the Birmingham tied-arch bridge over the Monongahela River in Pittsburgh, PA.

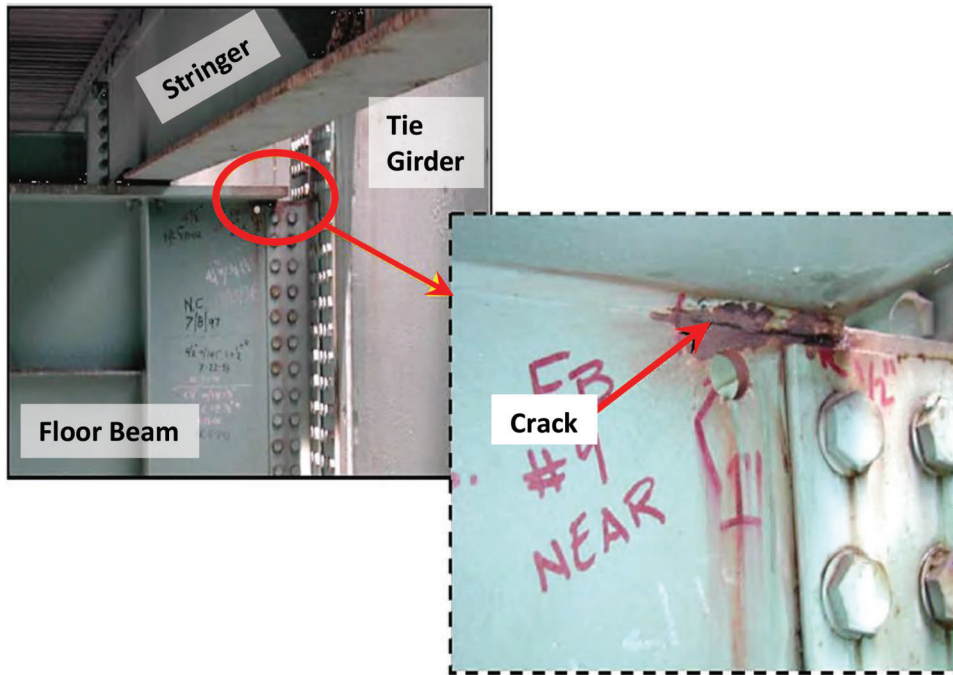
Figure 6.16 Example of distortion-induced cracking in web gap of floorbeam connected to tie girder.

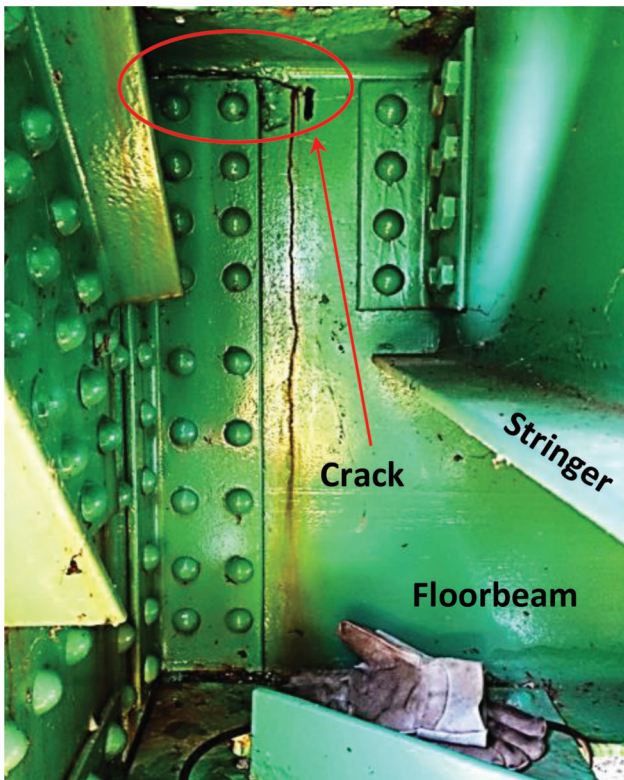
Figure 6.17 Floorbeam web gap crack.

6.2.2.1 Drilled Hole for Crack Arrest. The simplest and most economical repair is a large drilled hole for crack arrest. The reader is referred to Section 6.1.2.1 on use of drilled holes for repair and retrofit of web gap regions for transverse connection plates. An example of this repair method is shown in Figure 6.17 through Figure 6.20. These images are from the SR 119 through-truss bridge in Indiana. The end floorbeams of the simple span truss were experiencing distortion-induced fatigue cracks in the web gap region between the floorbeam top flanges and the connection angles which tied the floorbeam to the truss gusset plate. Figure 6.17 shows one of the cracks with corrosion staining. Notice how the crack initiates inside the web gap at the end of the floorbeam and extends parallel to the direction of the floorbeam primary stress (perpendicular to flow of traffic). This is an important attribute of distortion-induced fatigue that is driven by secondary stresses not normally accounted for in the design. It is also important to realize that the cracking was only manifest on the end floorbeams, where the global shear incompatibility between the floor system and the very stiff truss would be the greatest. Figure 6.18 shows the crack enhanced with dye penetrant, which was used to reveal the crack tip before drilling the hole. Figure 6.19 shows the completion of the drilled hole, prior to finishing sanding to clean up the edges for improved fatigue resistance. A 2-1/2 inch diameter hole was drilled, which when combined with the length of the crack will provide improved compliance at the detail and further relieve the secondary stresses while blunting the crack tip. Figure 6.20 shows the final step of the repair with the application of zinc-rich paint to protect against corrosion on the exposed steel. Refer to Section 4.2 for guidelines and tips for drilling effective crack arrest holes.

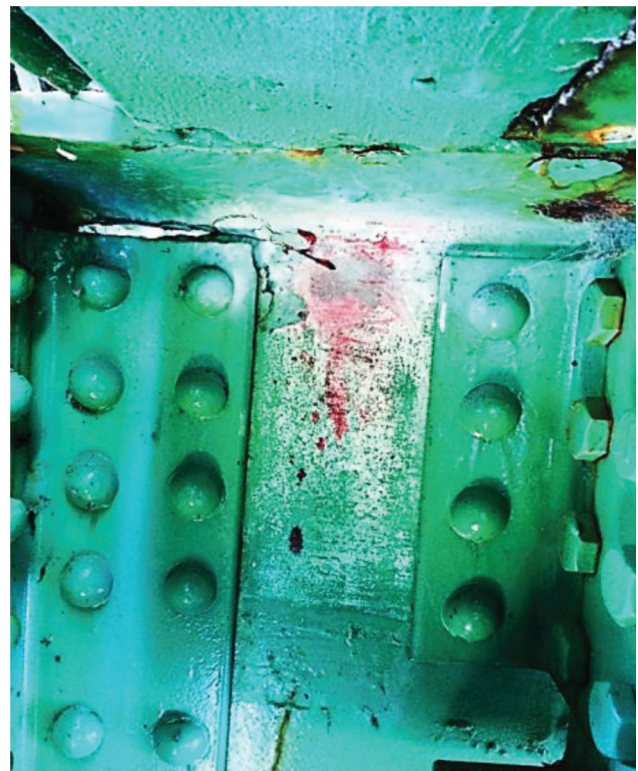
Figure 6.18 Results of PT revealing extent of crack.

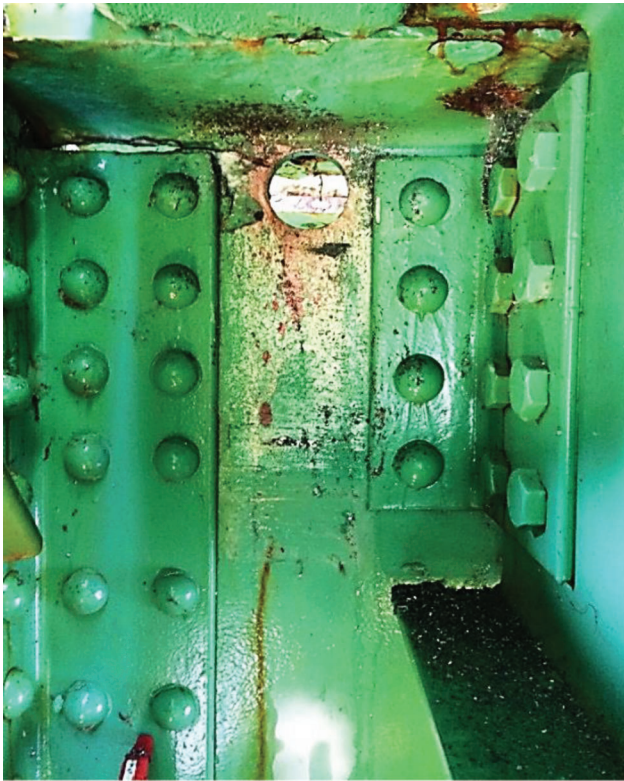
Figure 6.19 Drilled hole prior to sanding edges.

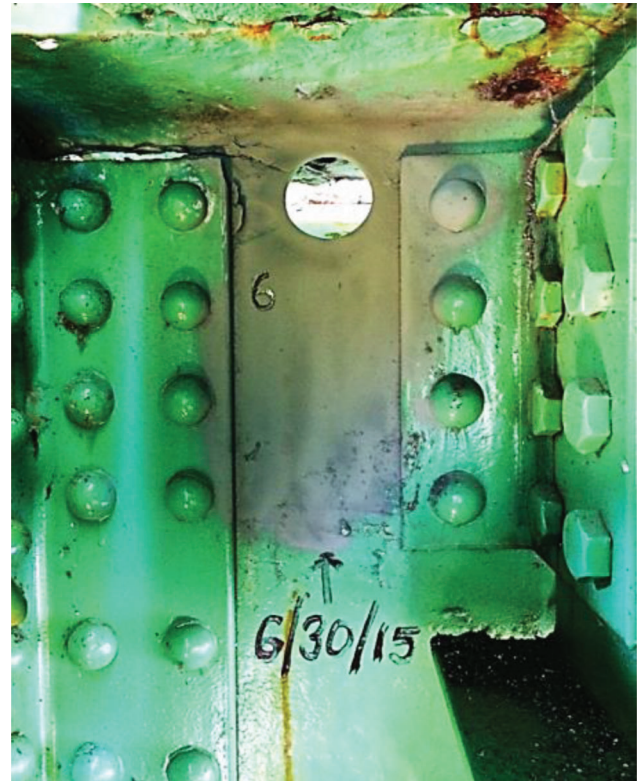
Figure 6.20 Finished repair with zinc-rich paint.

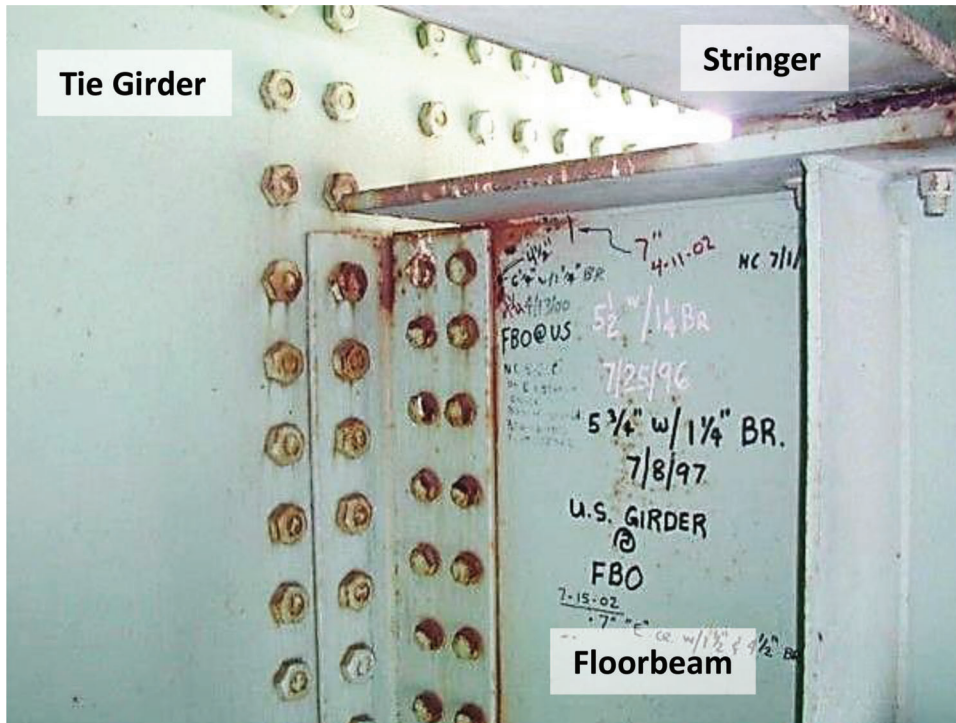
Figure 6.21 Birmingham Bridge before retrofit showing web gap cracking.

Cutting back the floorbeam connection to the primary girder has been demonstrated through prototyping (including field testing and finite element analysis) to be a very effective retrofit method and would be much less costly than a stiffening approach. Pennsylvania DOT and Lehigh University carried out a study of a prototype retrofit on the Birmingham tied-arch bridge over the Monongahela River near Pittsburgh, PA. Fatigue cracks were located on a number of the floorbeam webs near the connection to the tie girder. Field monitoring revealed that the top flanges of the floorbeams were moving out-of-plane (parallel to traffic) during traffic loading. Figure 6.21 shows the detail before retrofitting. Notice the crack extending from the floorbeam web gap above the connection angles (highlighted by corrosion staining) and positive

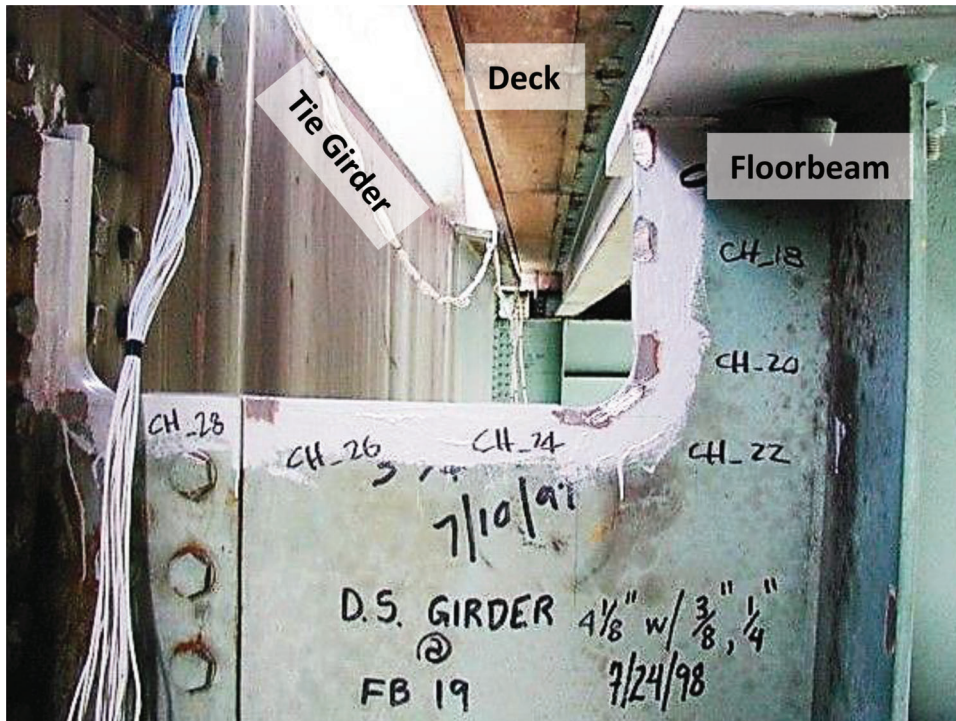
Figure 6.22 Birmingham Bridge softening retrofit that cut back the floorbeam.

attachment of the stringer to the floorbeam. The attachment to the stringer facilitates the out-of-plane movement of the floorbeam top flange as the floor system deflects independently of the tie girder. After removing the top six bolts in the connection angles and cutting out the floorbeam flange, web material, and connection angles seen removed in Figure 6.22, vertical stress ranges in the floorbeam web (those which drive the cracking) were reduced to less than the constant amplitude fatigue limit, meaning infinite fatigue life for the detail.

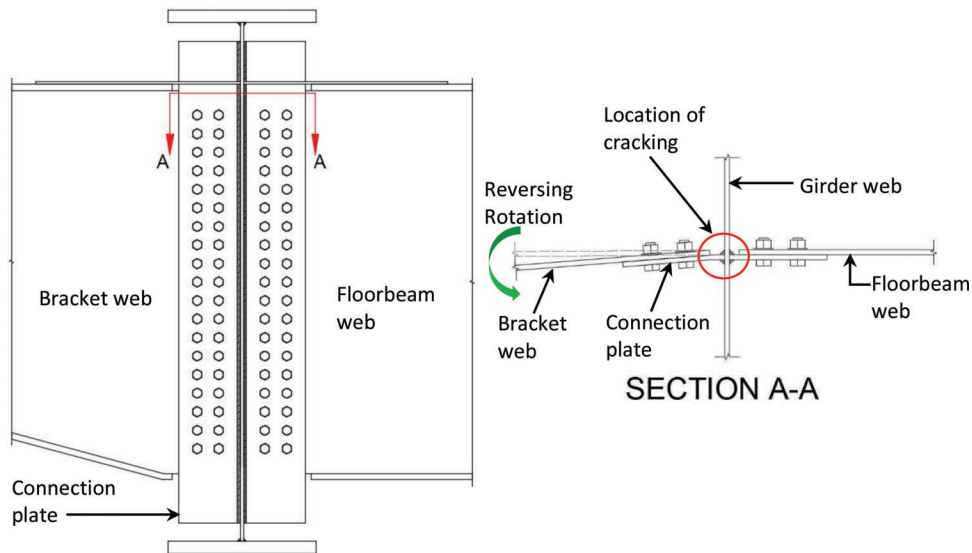
Figure 6.23 Sketch illustrating mechanism driving fatigue cracking of bracket connection plates.

Displacement incompatibility discussed in previous sections for floorbeam web gaps can also cause fatigue cracks in the connection angles and cantilever bracket webs. In the same way that a relative longitudinal displacement between the primary girder and the floor system can crack the floorbeam web near the floorbeam-girder connection, cantilevered brackets can develop cracks in the same location, as well as in their connection plates. Figure 6.23 illustrates the mechanism behind the fatigue cracking. During truck loading, compressive bending strains are developed in the primary girder top flange between the abutment and mid-span. The very stiff floor system (deck and stringers) restrains the top flange of the bracket while being displaced by the girder at the connection. This produces a relative longitudinal

displacement between the floor bracket and the primary girder, forcing bending stresses into the bracket web and connection. Similarly, this secondary action from the floor system acting on the bracket top flange can cause w-

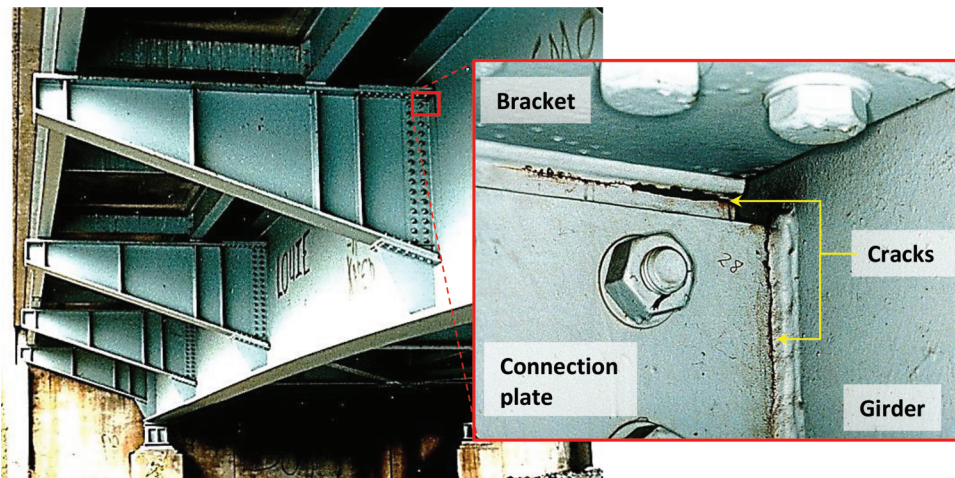
Figure 6.24 Cantilever floorbeam web gap and connection plate cracks.

eb gap cracking between the bracket flange and the connection plates. Figure 6.24 shows an example of a bracket with distortion-induced fatigue cracks in the bracket web gap, as well as the bracket connection plate.

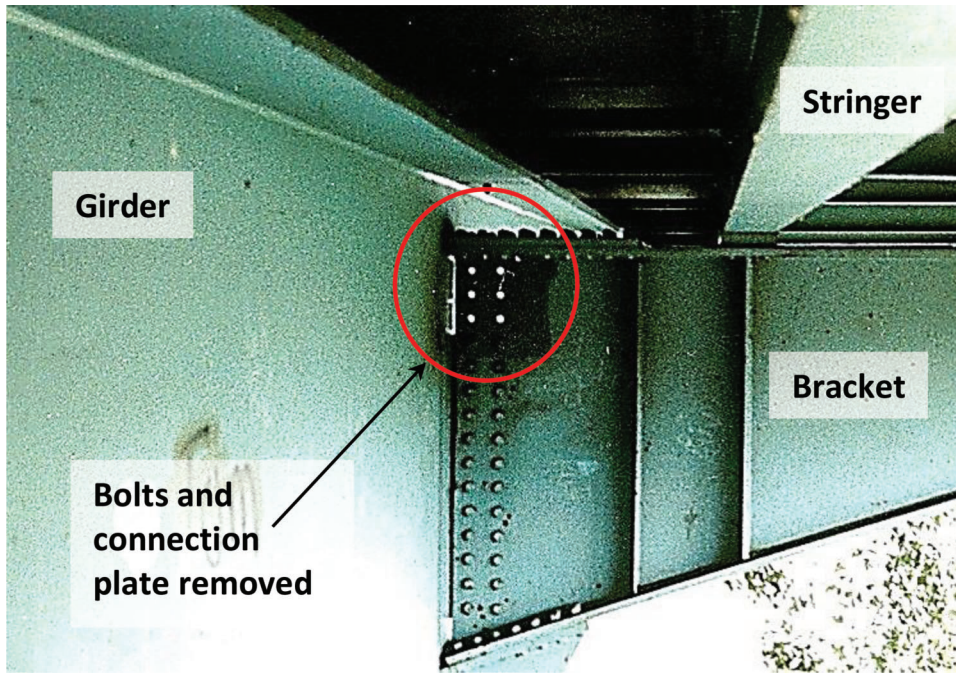
Figure 6.25 Softening retrofit on floor bracket connection plates showing removal of bolts and plate (Demers & Fisher, 1990).

The most economical and equally effective retrofit strategy for floor bracket connection plates is to soften the detail. Like the other fatigue problems caused by the global displacement incompatibility, stiffening against the global behavior at a local detail would require the addition of heavy structural sections. This can become very costly when implemented bridge-wide. Softening the detail has been implemented successfully by removing top rows of fasteners, drilling a hole through the connection plate just above the last row removed, and then cutting the upper, unconnected portion of the connection plate out of the connection. Figure 6.25 shows a softening retrofit that was installed on a floor bracket connection plate on the I-84 bridge over the Housatonic River in Connecticut (Demers & Fisher, 1990). Daylight can be seen shining through the locations where bolts were removed and the top portion

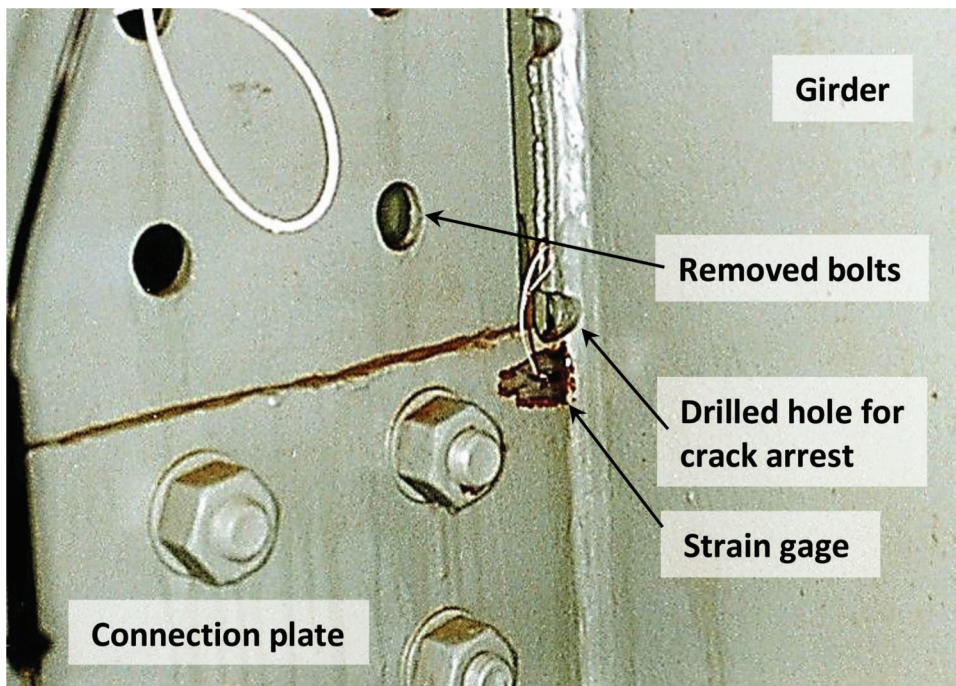
Figure 6.26 Close up showing softening detail with crack arrest hole (Demers & Fisher, 1990).

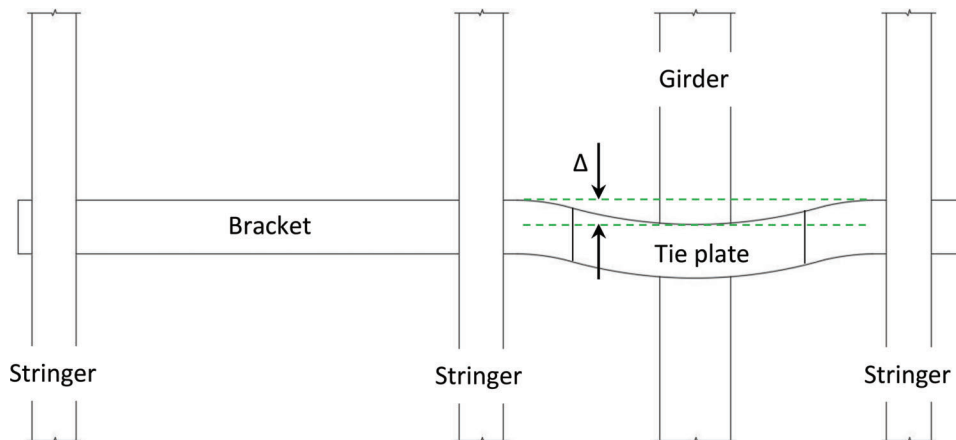
Figure 6.27 Illustration of cantilever tie plate distortion.

Cantilever bracket tie plates have been used for continuity across intersecting girders for floorbeam and cantilever bracket moment transfer. In design the tie plate is thought to carry only tensile forces as it restrains rotation of the top flanges of the floorbeam and floor bracket. However, secondary stresses have been measured in some tie plates where global displacement incompatibility exists between the bridge floor system and primary girders. The mechanism that drives this problem is related directly to that which drives the floorbeam web gap fatigue crack and the cantilever bracket connection plate fatigue crack discussed in previous sections. The primary girders move longitudinally relative to the very stiff deck and stringer system during truck loading. If the tie plate has any kind of connection to the girder top flange (e.g., rivets, bolts, tack welds, corrosion, etc.), then it becomes displaced by the girder while being restrained by the floor system. This concept is exaggerated in Figure 6.27, which shows a plan view of a generic superstructure and an out-of-plane bending of the tie plate.

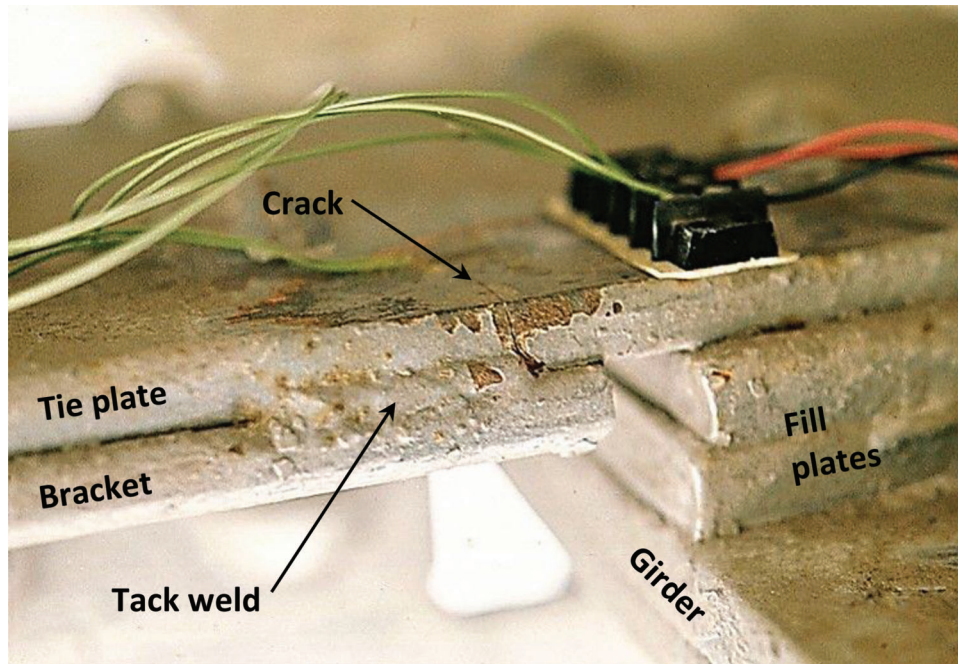
Figure 6.28 Fatigue crack emanating from tack weld on a tie plate (Photograph courtesy of John Fisher).

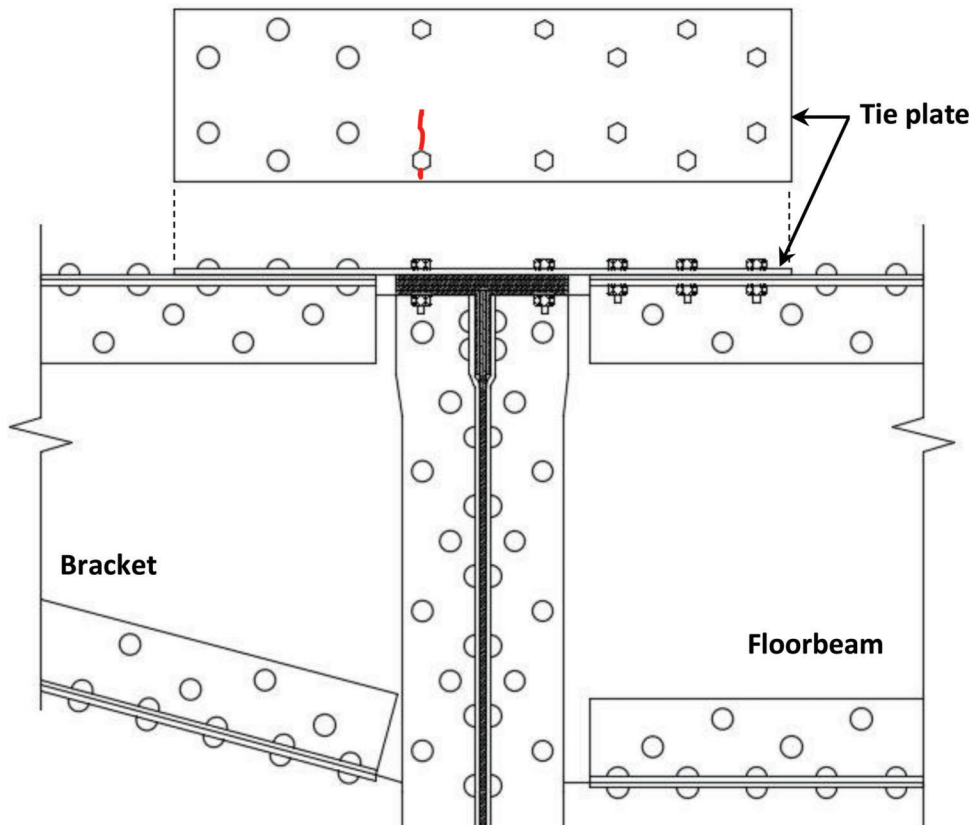
Figure 6.29 Typical tie plate detail prior to retrofit with common crack location highlighted.

Figure 6.29 shows a typical section cut at a tie plate detail with a built-up riveted main girder and a riveted and bolted connection between the tie plate and floorbeam and bracket. This figure also illustrates a typical 10 inch wide tie plate in plan-view, with a common fatigue crack location drawn in red. A redesigned tie plate cross section with reduced center width is shown in Figure 6.30.

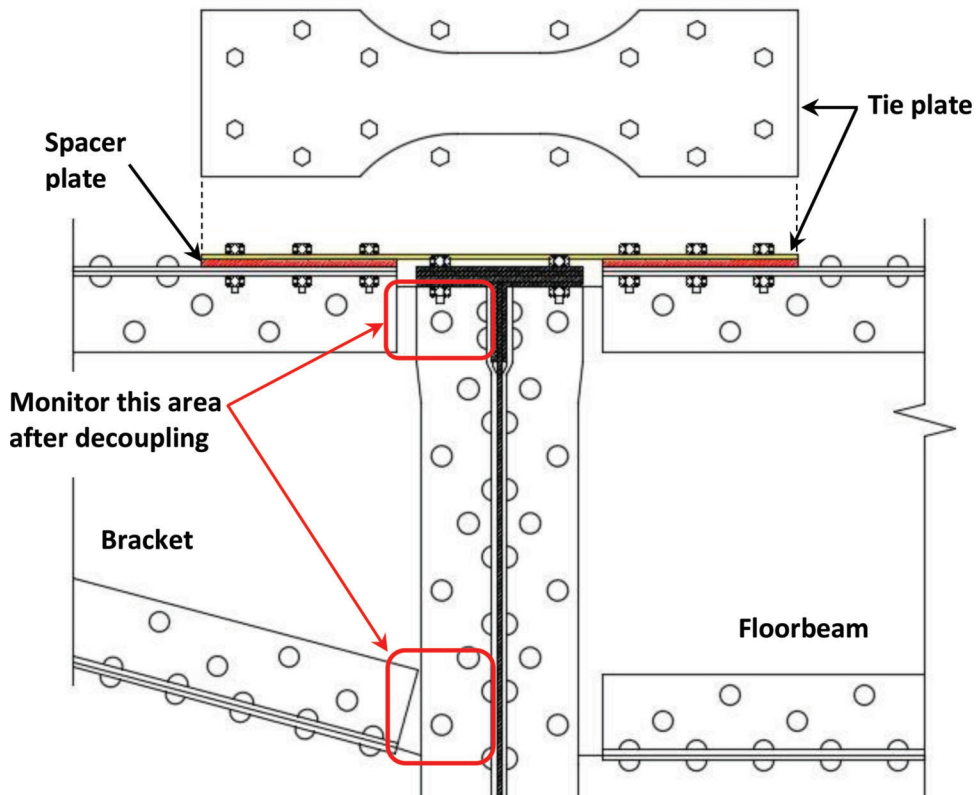
Figure 6.30 Tie plate retrofit showing reduced plate width and decoupling from girder.

unbolted to the main girder and using spacer plates at the floor bracket and floorbeam creating a gap between the tie plate and main girder. This complete retrofit is shown in Figure 6.30 where the new tie plates are highlighted in yellow and the spacer plates are highlighted in red.

Note: The web gap region with highest potential for a new fatigue problem in the floor bracket web has been circled in Figure 6.30. This area is recommended for monitoring during the prototype phase of the retrofit in addition to the tie plate itself.

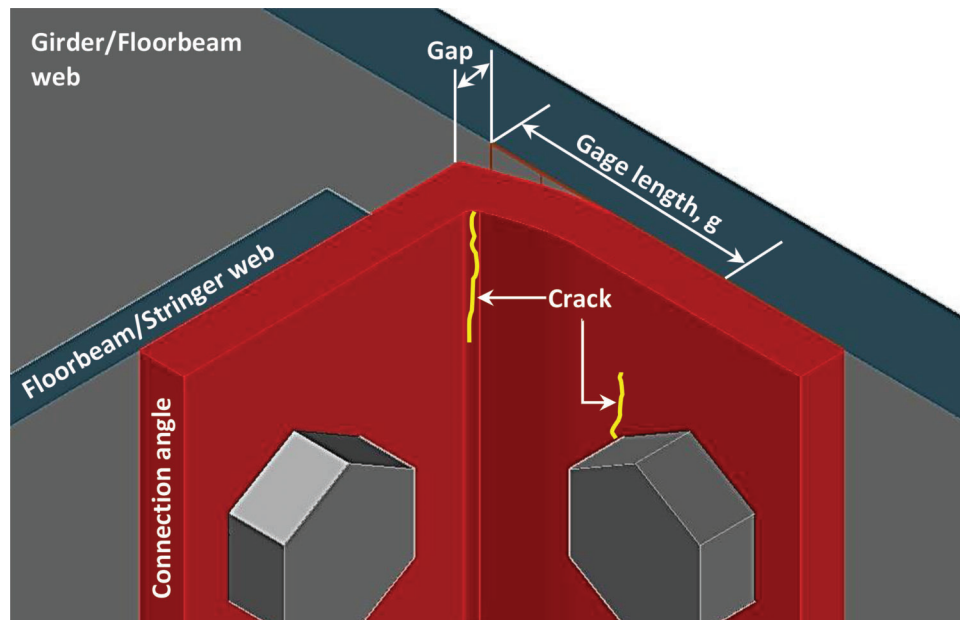
Figure 6.31 Common locations for fatigue cracks in connection angles.

Inspection of connections using angles should focus at the top or bottom of the angles in the fillet and at the edge of the fasteners, as indicated in Figure 6.31. Diaphragm connection angles prone to fatigue cracking could be located anywhere on the structure, but may be focused between interior and exterior girder lines. For stringer end connections, the most likely cases will be located at the interior stringers and at exterior floorbeams (stringers located toward the ends of spans). These locations typically experience the largest secondary effects from relative global displacements.

where g is the gage of the outstanding leg of the angle (shown in Figure 6.31), L is the length of the floorbeam, stringer or diaphragm, t is the thickness of the angle, and K is a constant, $K = 8$. This equation was used to determine the maximum angle leg thickness to ensure sufficient compliance and mitigate fatigue cracks.

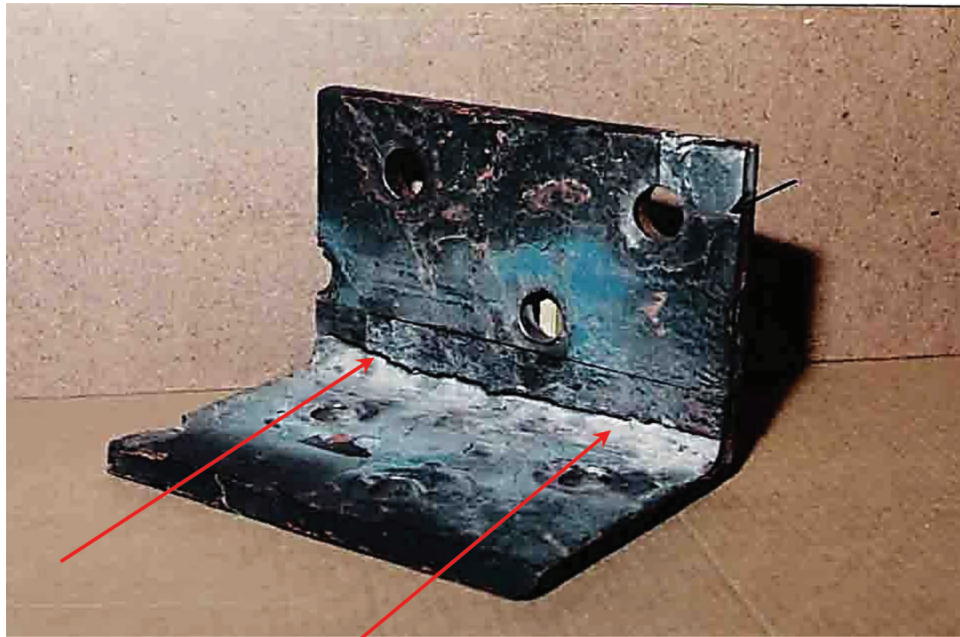
Figure 6.32 Cracked connection angle fillet (Photograph courtesy of John Fisher).

two locations. Figure 6.32 shows a stringer connection angle removed from the Burlington Northern Railroad Bridge 196.0 in Bismarck, North Dakota. Several such connection angles were found by inspectors with cracks ranging from 4 to 27 inches in length. Fractographic examination revealed fatigue and fracture surfaces (Steel Bridge Fatigue Knowledge Base, 2008). Another example of connection angle cracking is shown in Figure 6.33 taken from the Mexican Hat Bridge in Utah. These are two of many bridges where connection angles have experienced fatigue cracking.

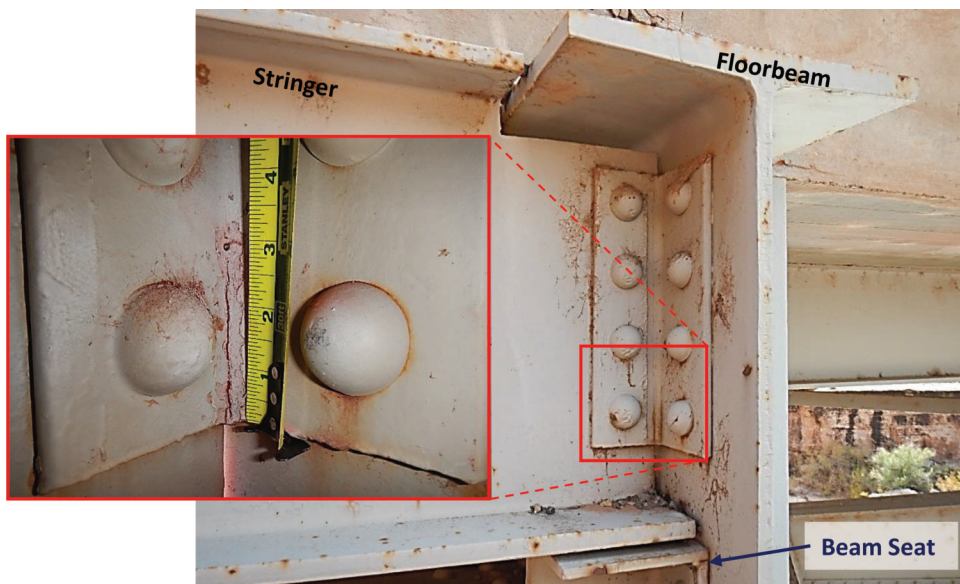
Figure 6.33 Example of fatigue crack located at the bend of a connection angle (Photograph courtesy of Utah DOT).

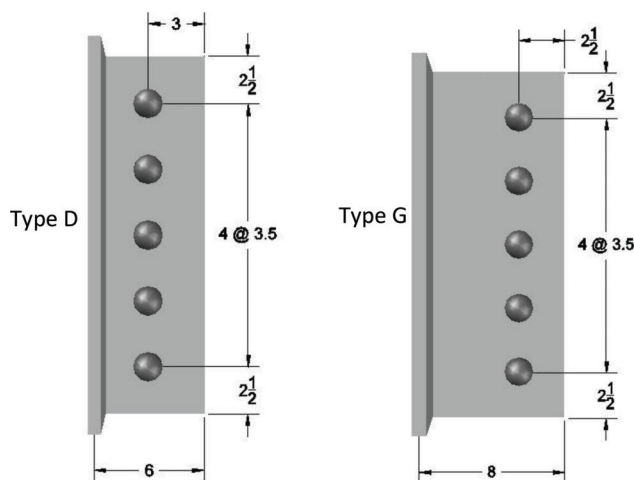
Figure 6.34 Rendering of connection angles used by Cousins *et al.* (1998).

replacement angles and monitored, revealing that the thinner angle (Type D) was more susceptible to fatigue cracking than the thicker angle (Type G) with the longer leg dimension. Figure 6.34 shows the two angles used. The Type D angle was a L6 x 6 x 3/8 inch and the Type G was a L8 x 6 x 1/2 inch. This suggests that when increasing the leg dimensions is possible, it may improve performance more than simply replacing with a thinner angle. However, it may not be feasible to replace angles with ones having longer leg dimensions since it would require new holes, or a slight side shift of the connected element to reuse existing fastener holes, in the floorbeam or girder web plates. Typically, new holes would not be a problem, but this should be checked by a qualified engineer. Paasch and DePiero (1999) found that increasing the angle leg from 4 inches to 6 inches (i.e., increasing the gage length on the outstanding angle leg), reduced the stress range in the angle by 40 percent.

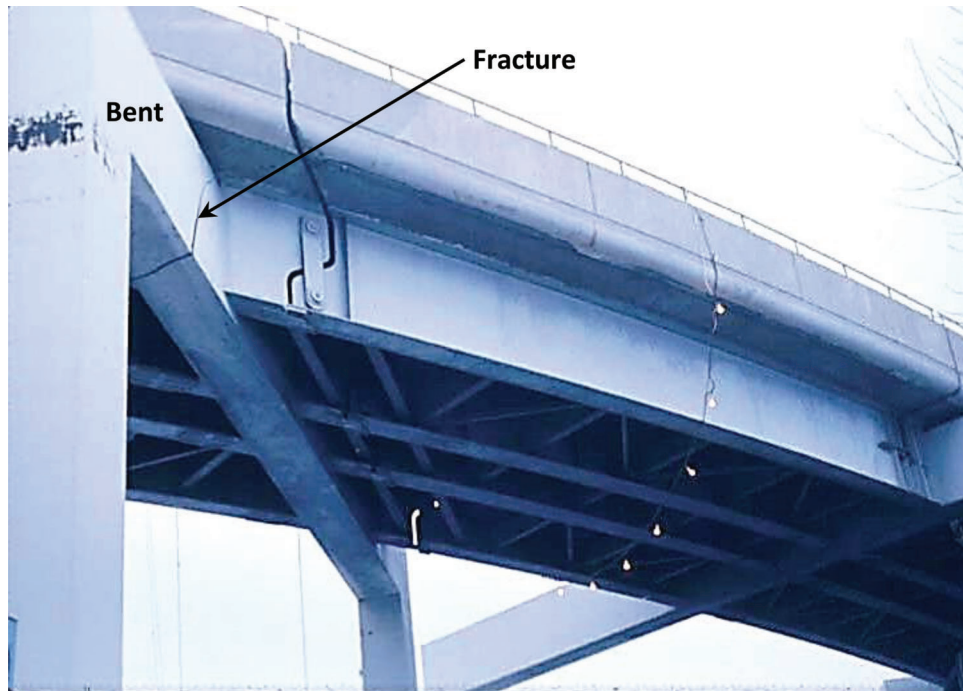
Figure 6.35 Dan Ryan Expressway with fractured cross girder.

In 1978 two bridges were found to have fatigue cracks and brittle fractures emanating from some of the cross girder web penetrations. The first was the Dan Ryan Expressway in Chicago, IL. Three bents were found to have fatigue cracks that led to brittle fracture. Figure 6.35 shows a picture of one of the fractured bents. Fractographic analysis revealed that the cracks initiated as fatigue at the partially welded junction of the plate girder flange tips to the cross girder (bent) side plates. Paint was also observed on the interior surface near the crack, suggesting poor fabrication of the detail

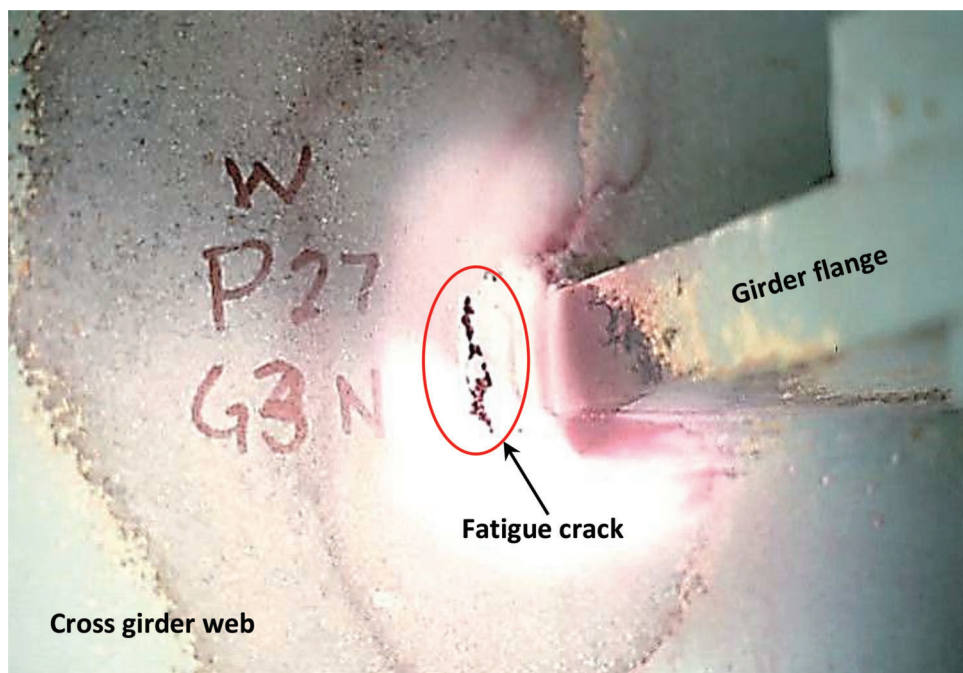
Figure 6.36 Fatigue crack enhanced with PT at girder flange tip and cross girder web.

fatigue cracks were located in at least one girder flange tip in each pier cap. An example of one of the cracks enhanced with dye penetrant is shown in Figure 6.36. The cracks consistently developed at the weld toes on the flange tip-to-cross girder web welds. The bridge had only been in service for two years in 1978 with a “relatively modest level of average daily truck traffic” (Fisher, 1978).

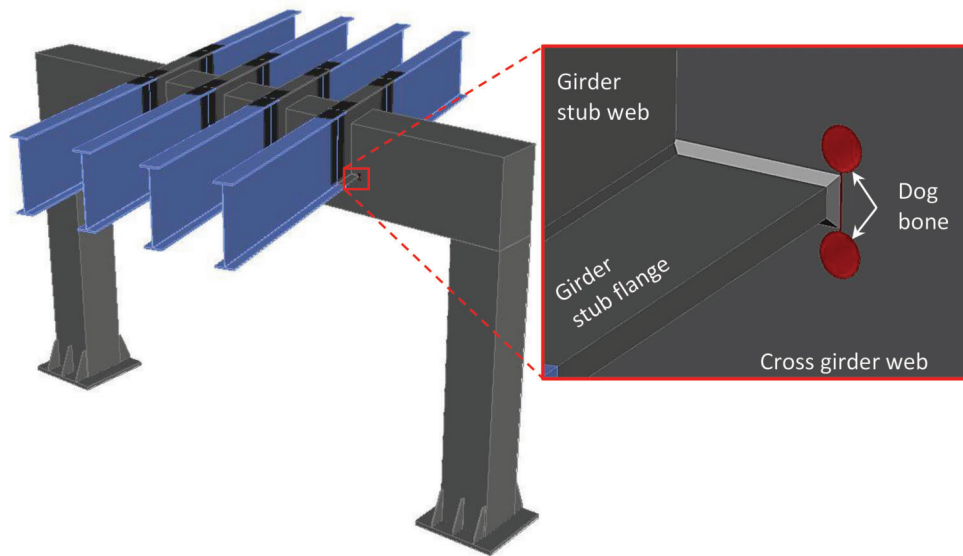
Figure 6.37 Cross girder structure with dog bone retrofit at the web penetration (deck removed for clarity).

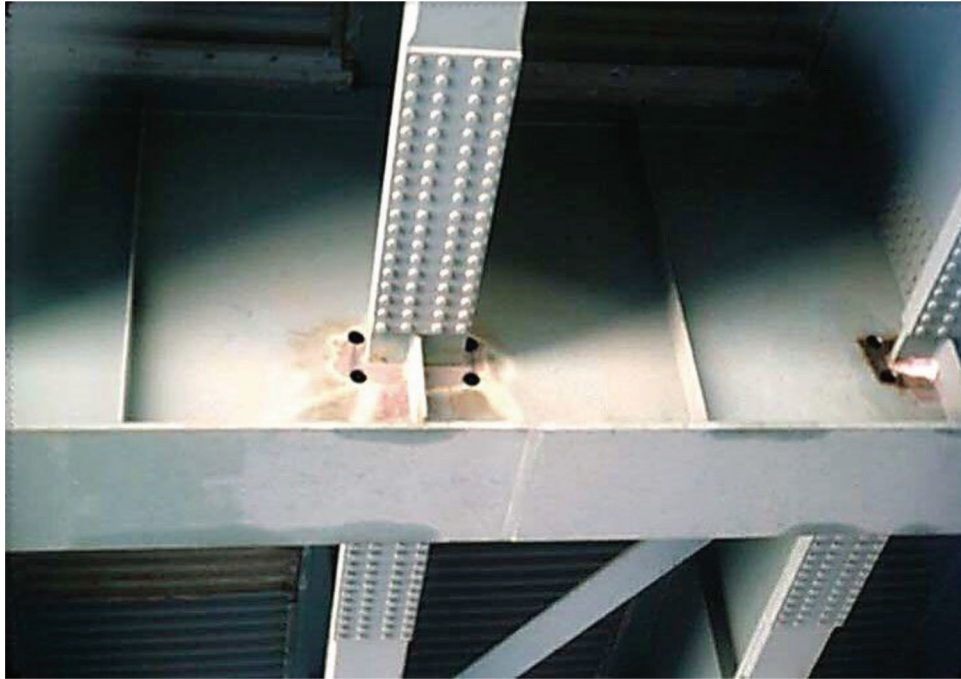
Figure 6.38 Completed dog-bone retrofit on a web penetration detail.

4. Connect the centers of the two drilled holes by cutting vertically up/down the web plate using an angle grinder with cutoff wheel or a controlled thermal cutting process such as plasma cutting. If possible, make the vertical cut between the two holes pass through the flange tip weld toes. This will remove any existing cracks, as well as relieve the detail of locked-in welding residual stresses. Refer to Figure 6.37 for illustration of this detail. See Figure 6.38 for an example of the dog bone retrofit installed on the Girard Point Bridge.

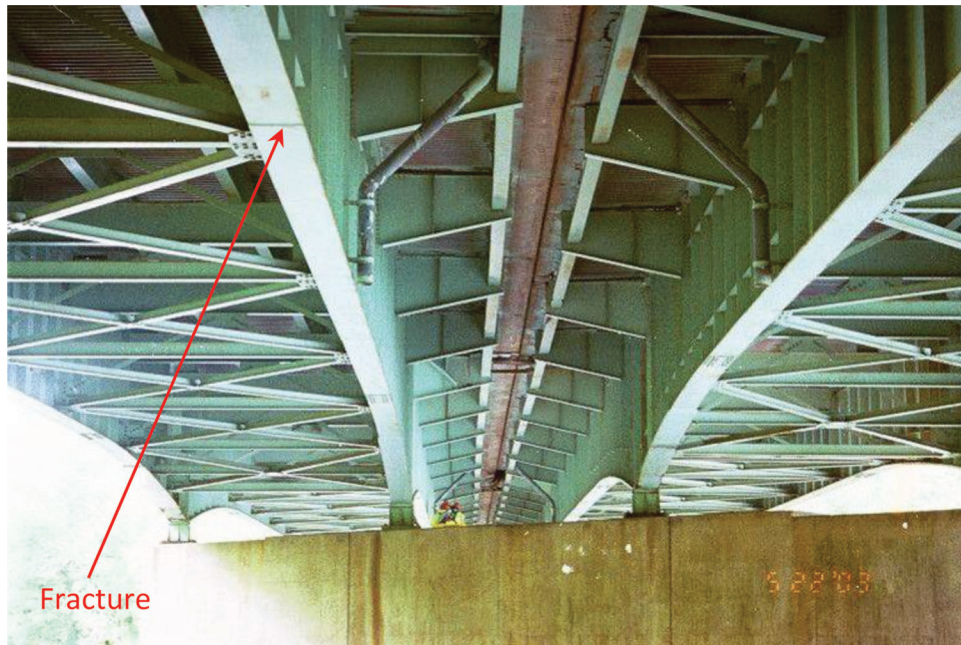
Figure 7.1 US 422 Bridge fracture discovered in 2003 during retrofitting.

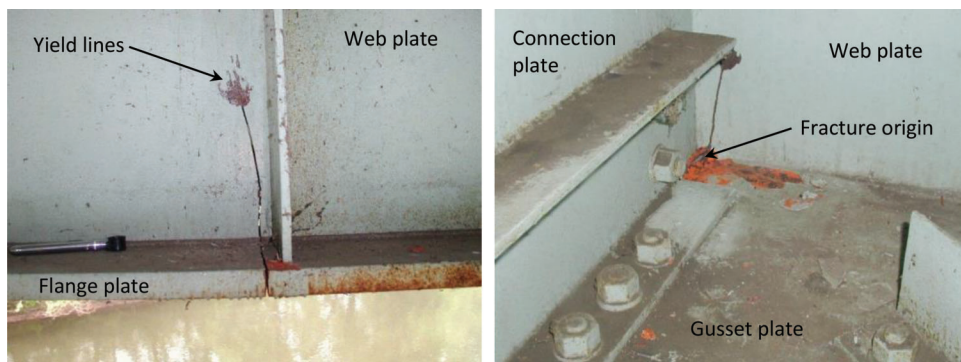
Figure 7.2 US 422 Bridge fracture that arrested in the web.

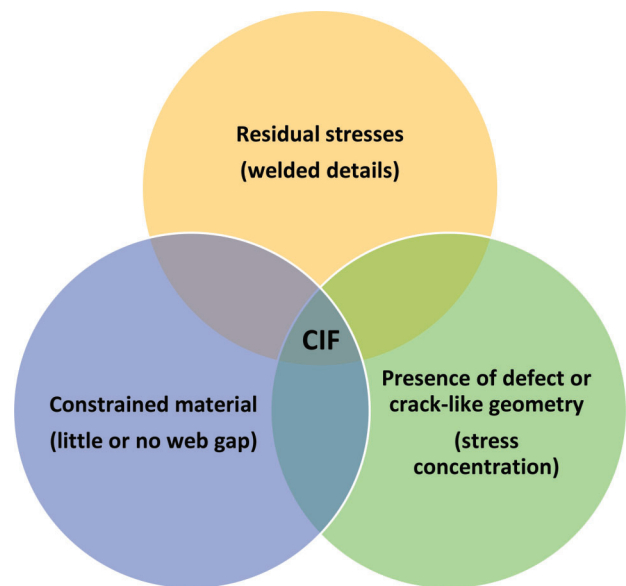
Figure 7.3 Defining characteristics of CIF details.

There are three contributing elements to constraint-induced fracture, characteristic of all CIF-prone details, which when any one of the elements is missing, the likelihood of constraint-induced fracture drops dramatically. Figure 7.3 illustrates these elements, conceptually showing that the risk of CIF exists at the intersection of the three elements.

1. There needs to be a localized area of stress concentration that intensifies the dead and live load stress level. The presence of defects within the weld, as well as certain geometry of the connection can both act as discontinuities that interrupt stress flow and cause concentrations.
2. The joint must be highly constrained, resulting in a three dimensional state of stress that prevents plastic flow, as would occur in a simple uniaxial stress state.
3. There must be an elevated level of tensile residual stresses locked into the local area. While the dominating contributor are residual stresses from welding, other factors contribute to a lesser degree, such as dead load and erection stress. As is well documented, residual stresses due to welding can easily reach the yield strength of the base metal.

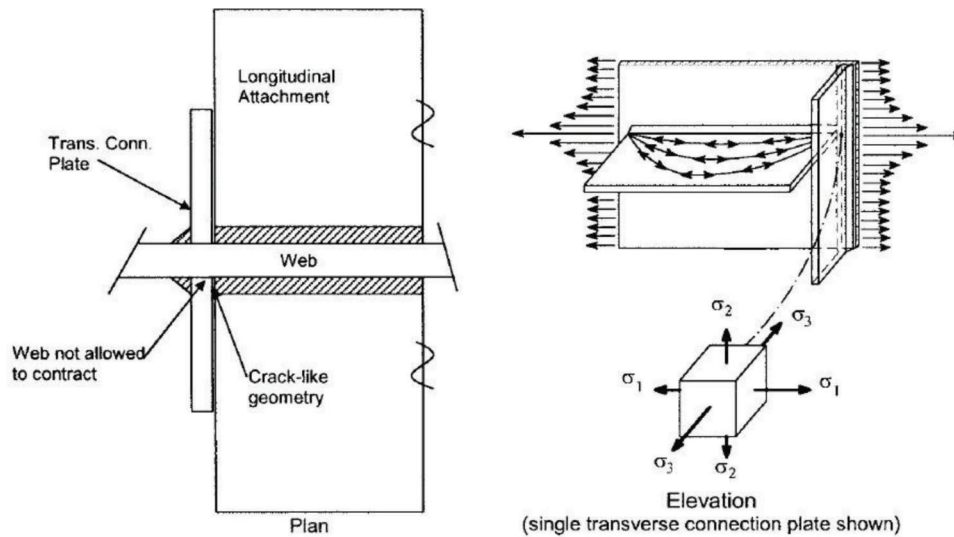
Figure 7.4 Illustration of effect of web gap size and constraint on the stress condition at the weld termination with the web gap (Connor *et al.*, 2007).

Figure 7.4 provides an illustration of the mechanics behind the three contributing elements for CIF. This figure shows a plan view and elevation view of a welded detail where the longitudinal attachment to the web plate intersects with the transverse plate. Little or no web plate gap exists between the weld intersections. Due to the welded construction, high residual tensile stresses are present. Crack-like geometry amplifies stress concentrations by disrupting stress flow between the longitudinal and transverse plates forcing those stresses back into the web plate through the small area of intersecting weld. With the stress condition at the yield strength of the web plate, the material would attempt to contract in the through-thickness direction under live loading in order to disperse stress (i.e., Poisson's effect). However, the longitudinal attachments constrain the plastic flow of the web material subjecting it to what is called a triaxial state of stress, or plain strain condition,

illustrated by the cube that represents an infinitesimal section of the web plate. The triaxial state of stress strain-hardens the material increasing its strength while decreasing its ductility. Once the localized stress condition exceeds the material tensile (ultimate) strength, brittle fracture ensues. This situation can be made more vulnerable when fracture toughness of the web material is reduced during cold temperatures.
