Maintenance Actions to Address Fatigue Cracking in Steel Bridge Structures

PROPOSED GUIDELINES AND COMMENTARY

NCHRP Transportation Research Board of
The National Academies

Robert J. Connor and Jason B. Lloyd
Purdue University
West Lafayette, Indiana

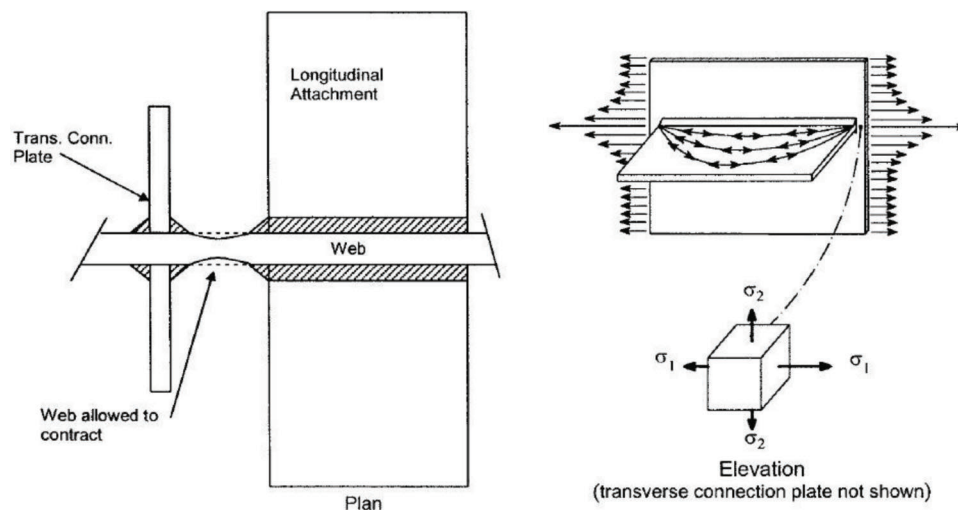
Figure 7.5 Illustration of effect of a sufficient web gap that removes constraint at the weld termination (Connor *et al.*, 2007).

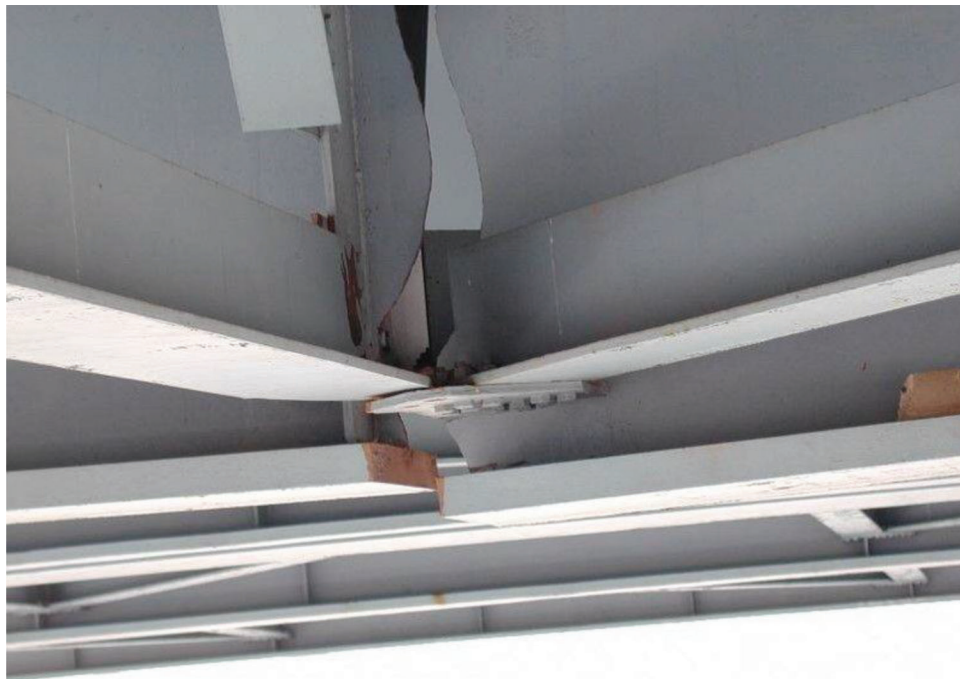
Figure 7.6 Hoan Bridge fracture showing the gusset detail of the interior girder.

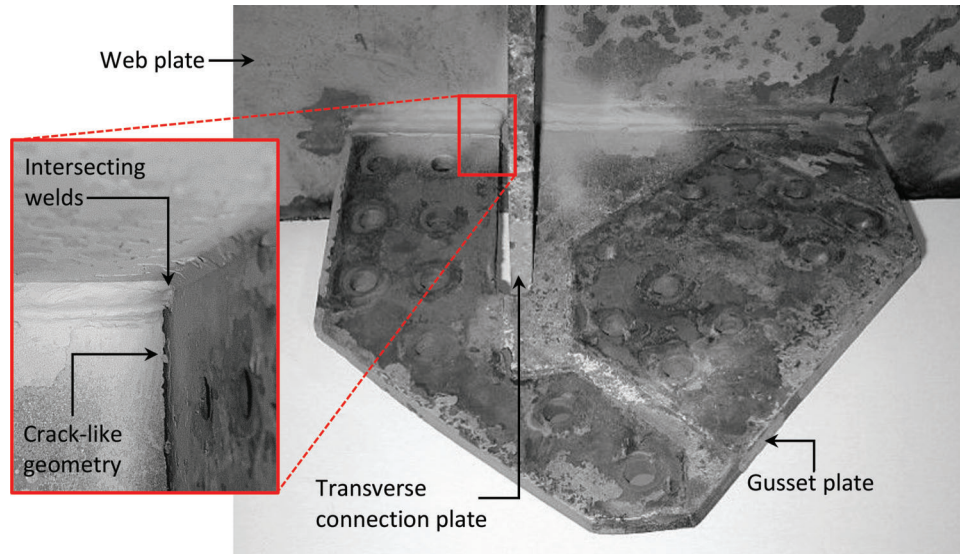
Figure 7.7 CIF detail located at the intersection of transverse and horizontal welds on the Hoan Bridge.

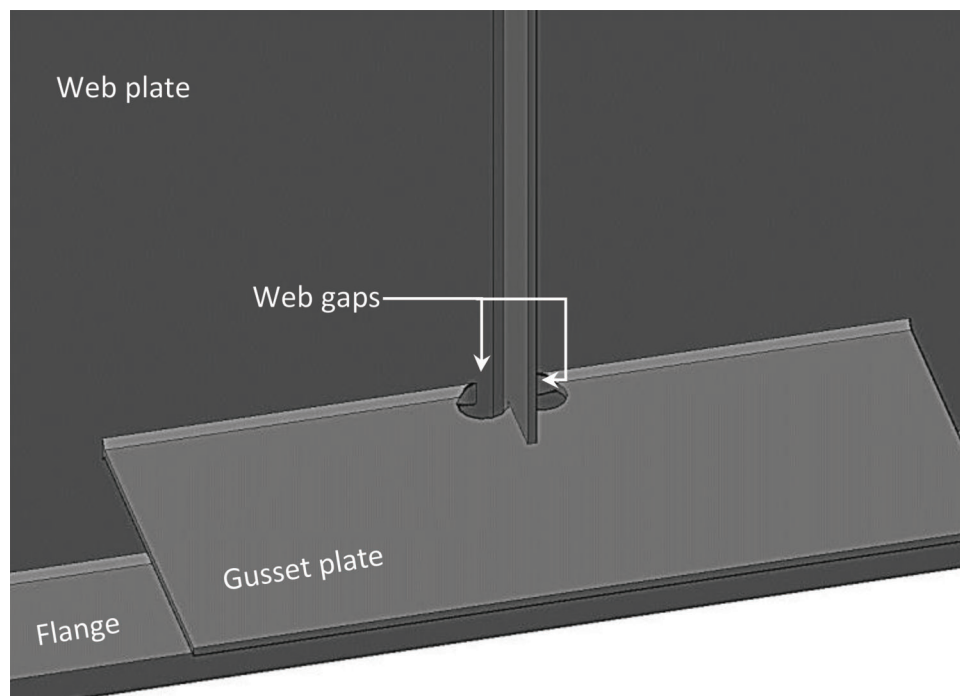
Figure 7.8 Gusset plate cope retrofit (secondary members removed for clarity).

(minimum of 1/4 inch of web exposed) to eliminate the localized constraint of the web plate. The retrofit is simple in concept, but can be challenging to implement based on the geometry of a detail. Figure 7.8 illustrates the simplest form of this detail with the secondary members removed for clarity, demonstrating the location of the copes adjacent to the transverse connection or stiffening plate.

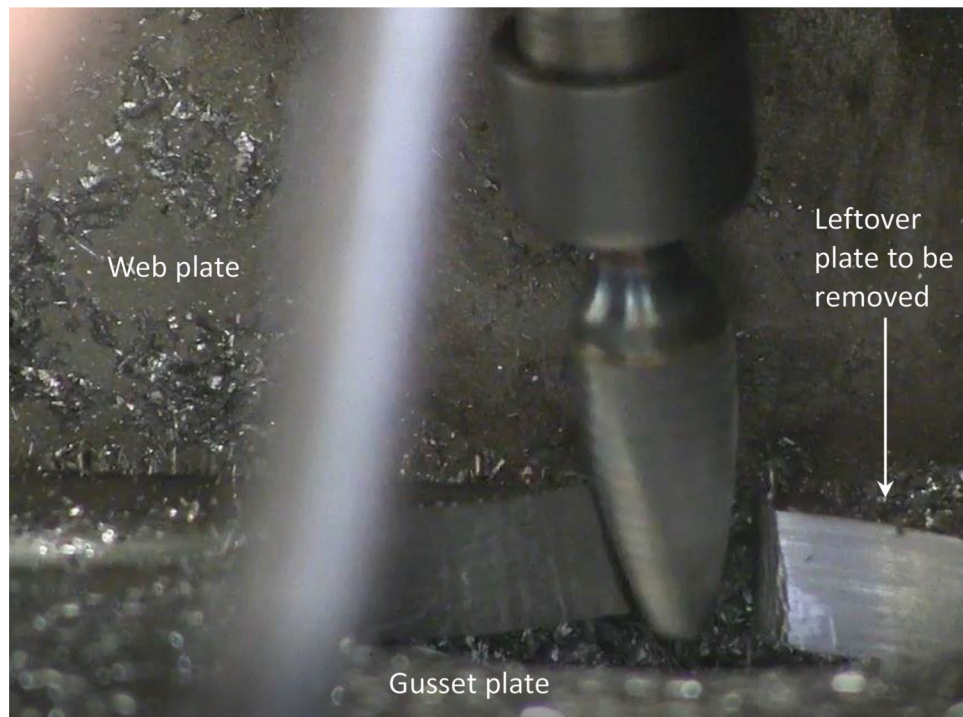
Figure 7.9 Burr grinder being used to remove leftover gusset plate and weld.

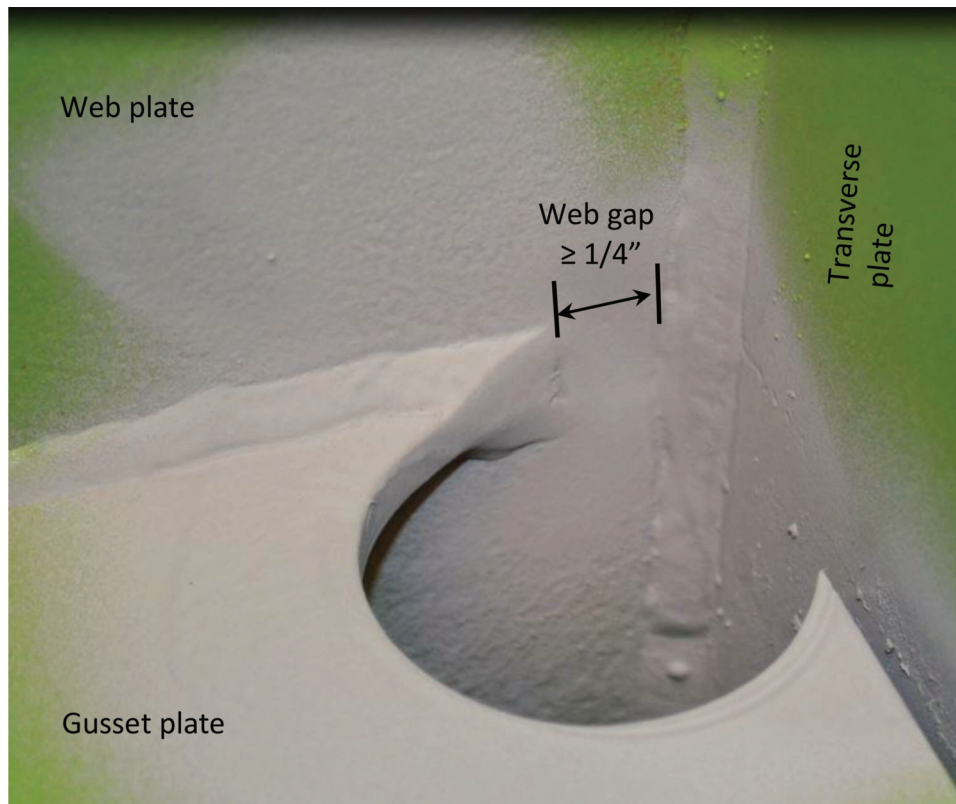
Figure 7.10 Completed gusset plate cope retrofit with 3/4 inch web gap.

Figure 7.10 shows an example of the completed retrofit on one side of the transverse plate. This same procedure must be repeated on the other side of the transverse plate for a completed retrofit. Notice the

smooth and gradual transition from the gusset plate to the web plate that helps to minimize stress concentrations at the weld termination, the preserved transverse weld, and the smooth 3/4 inch web gap exposed between weld toes.

Making a cope at the intersection of the lateral gusset plate and the transverse connection or stiffener plate creates a web gap, as labeled in Figure 7.10. This is desirable for mitigation of CIF, however, it is worth mentioning that the detail is still susceptible to distortion-induced fatigue if the gusset plate and transverse plate are not positively connected. Fisher *et al.* (1990) found that structures with lateral bracing attached to the girder webs by gusset plates, along with transverse connection plates for floorbeams or diaphragms, were susceptible to web distortions in the gaps between the gusset plate and transverse connection plate. They found that the lateral gusset plate web gaps demonstrated a fatigue resistance equivalent to an AASHTO Category C. During the experimental laboratory research, cracking only occurred along the web at the weld toe of the transverse connection plate. As a result, it is recommended that future inspections of the CIF retrofit detail (that does not connect the gusset plate to the transverse connection plate) include careful observation at the transverse weld toe inside the newly created web gap region. Field testing of this area could also be performed at a few locations on the bridge following retrofitting to determine if stress ranges in the gap are large enough to cause fatigue cracking at the Category C detail under

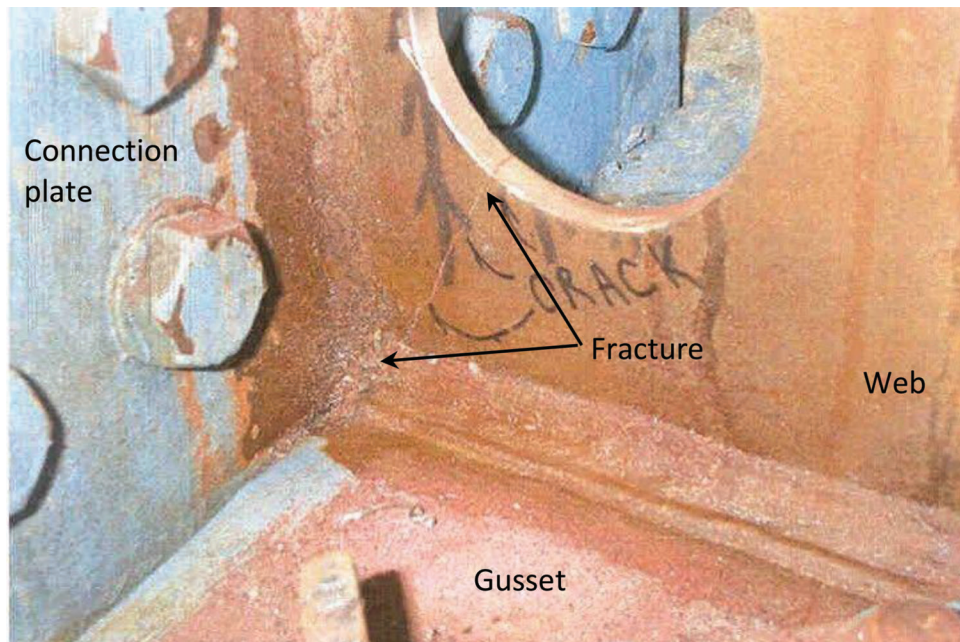
Figure 7.11 CIF arrested in one of the Hoan Bridge web isolation holes shortly after installation (Photograph courtesy of Phil Fish).

7.1.2.2 Web Plate Isolation Holes Retrofit. Unlike the gusset plate cope retrofit that removes one of the contributing factors for constraint-induced fracture, namely the constraint, the web plate isolation hole retrofit simply installs a mechanism to arrest a fracture immediately after it initiates, isolating the web plate and flanges from further fracture propagation. The local conditions of the detail that make it susceptible to CIF are not altered, leaving the potential for fracture unchanged. However, the risk of the fracture is essentially eliminated by arresting it before it can cause damage to the girder. This retrofit was the first retrofit put in place on the Hoan Bridge following the brittle fracture of the three approach span girders. During retrofitting operations, workers completed a CIF retrofit and had moved to the next location when they heard a loud noise. Returning to the previously retrofit detail to investigate they discovered that the CIF detail had fractured and the retrofit performed as designed immediately arresting the crack in the newly installed isolation holes. Figure 7.11 is a photograph of that fracture showing that it arrested into the retrofit hole.

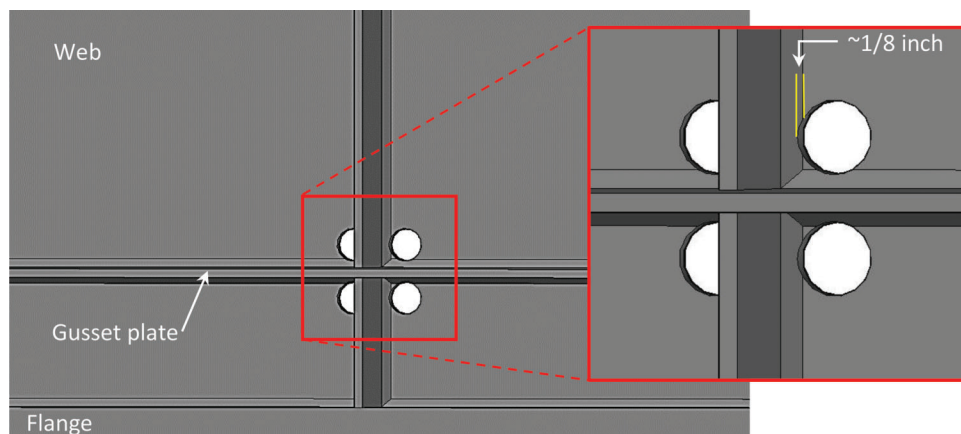
Figure 7.12 Web plate isolation holes retrofit for CIF details.

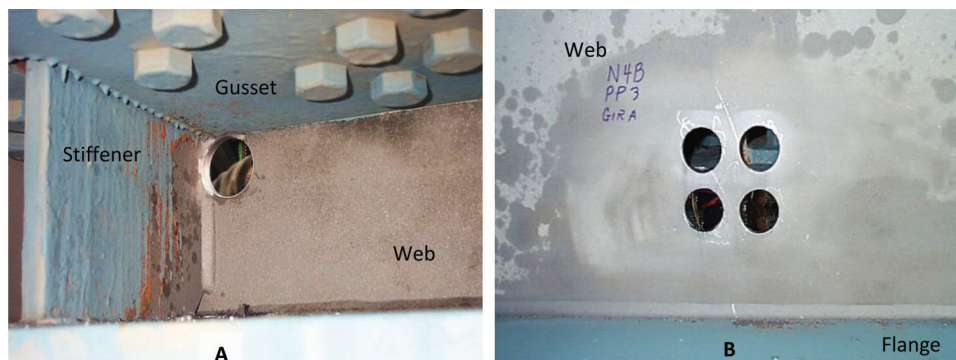
Figure 7.13 Web isolation holes retrofit on the Hoan Bridge (A) beneath the gusset, (B) opposite side of gusset (Photographs courtesy of Phil Fish).

2. Drill the hole. *Caution: tie off the mag-based drill to the girder using sturdy clamps and chainrope in the event of power loss. This will help prevent injury or damage to equipment. Note: Carbide-tip annular cutters are recommended when the cut penetrates welds or heat-affected zones due to increased hardness of the material.*
3. Inspect the hole placement to confirm that it intercepts the vertical weld at least 1/8 inch. If the hole misses the vertical weld toe, use a carbide rotary burr bit with a die grinder to widen the hole toward the vertical weld toe. Grind until the weld toe has been sufficiently disconnected and there is no longer a continuous path for a fracture to bypass the isolation hole. Figure 7.13 shows this retrofit on the Hoan Bridge.

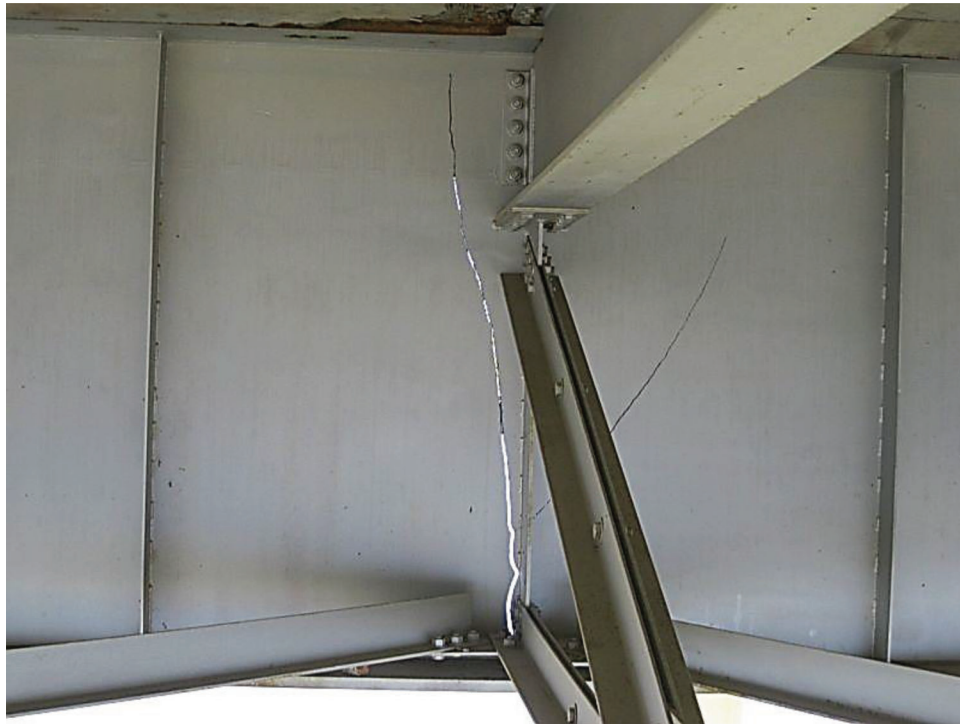
Figure 7.14 Diefenbaker Bridge fracture originated at CIF detail.

The ball end mill retrofit was implemented in 2012 on the Diefenbaker Bridge located in Prince Albert, Saskatchewan, Canada, over the Saskatchewan River. The twin, two-girder bridges were built in 1959 using continuous, welded plate girder construction. In August 2011, a nearly full-depth brittle fracture was found in one of the two steel girders of the southbound bridge. Figure 7.14 shows the bifurcated fracture that arrested just a few inches from the compression flange. The fracture-critical bridge continued to carry traffic with very little deflection until the fracture was discovered and traffic was diverted. Figure 7.15 shows the completed retrofit looking from the back side of the web plate, through the milled hole, with the vertical connection

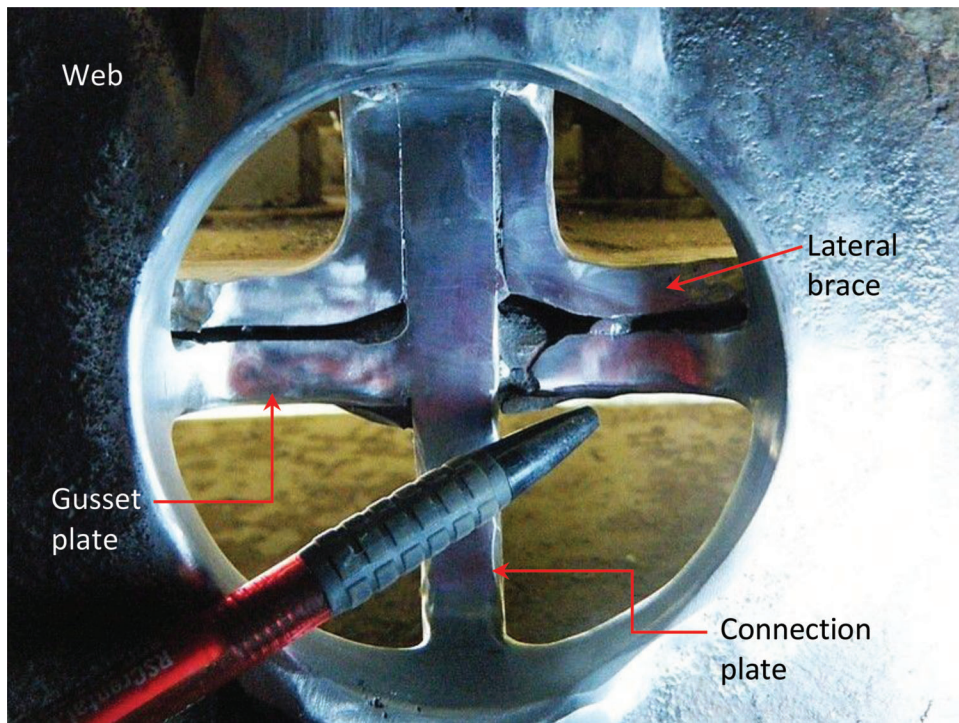
Figure 7.15 Ball end mill retrofit on Diefenbaker Bridge.

plate and the horizontal gusset plate crossing through the middle of the hole. The retrofit revealed that the gusset-to-connection plate groove welds had substantial incomplete fusion in a large number of the connections

suggesting that the risk of a repeat CIF would have been high had the repairs not been implemented bridge-wide (Ellis *et al.*, 2013). The lack of fusion is evident in Figure 7.15.

3. Inspect the hole placement to confirm that it removed all of the weld intersection. If the hole misses any part, use a carbide rotary burr bit with a die grinder to widen the milled hole. An open gap should be achieved on all sides of the intersection, as is seen in Figure 7.15 and Figure 7.16.

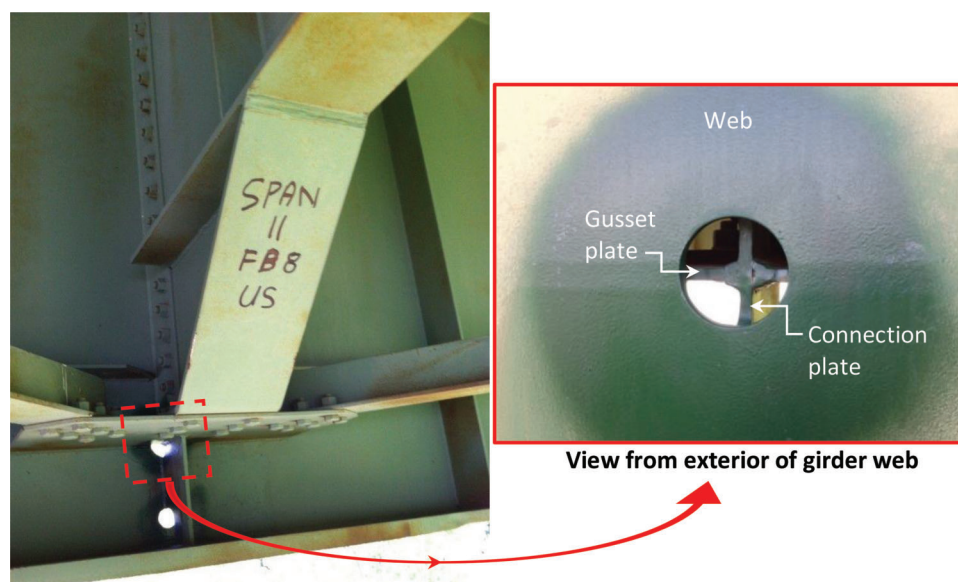
Figure 7.16 Matthew E. Welsh Bridge CIF ball end mill retrofit (Photograph courtesy of Indiana DOT).

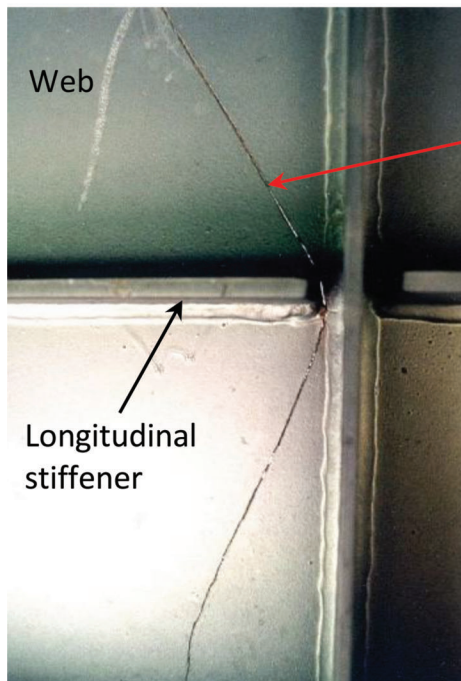
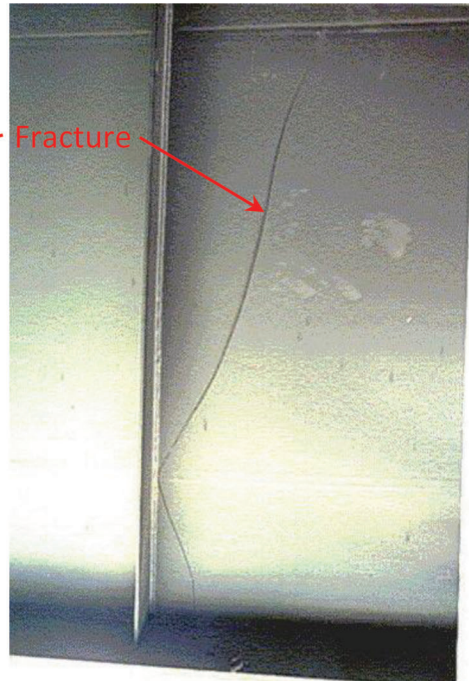
Figure 7.17 CIF at a longitudinal stiffener.

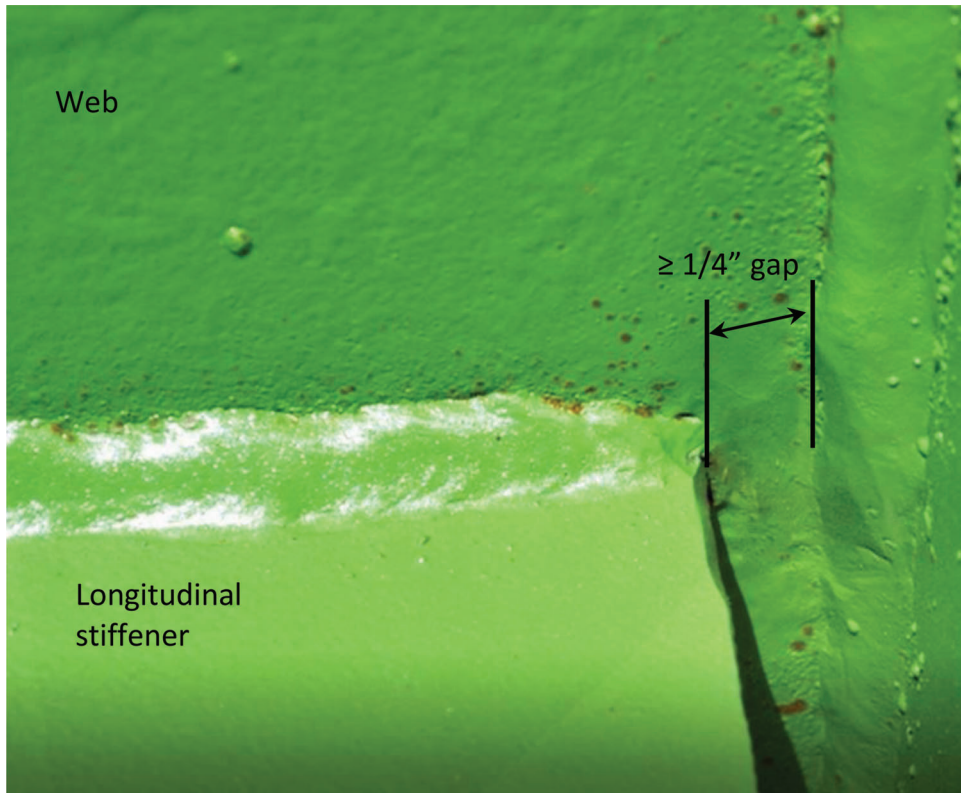
Figure 7.18 Example of CIF retrofit on longitudinal stiffener providing necessary 1/4 inch web gap.

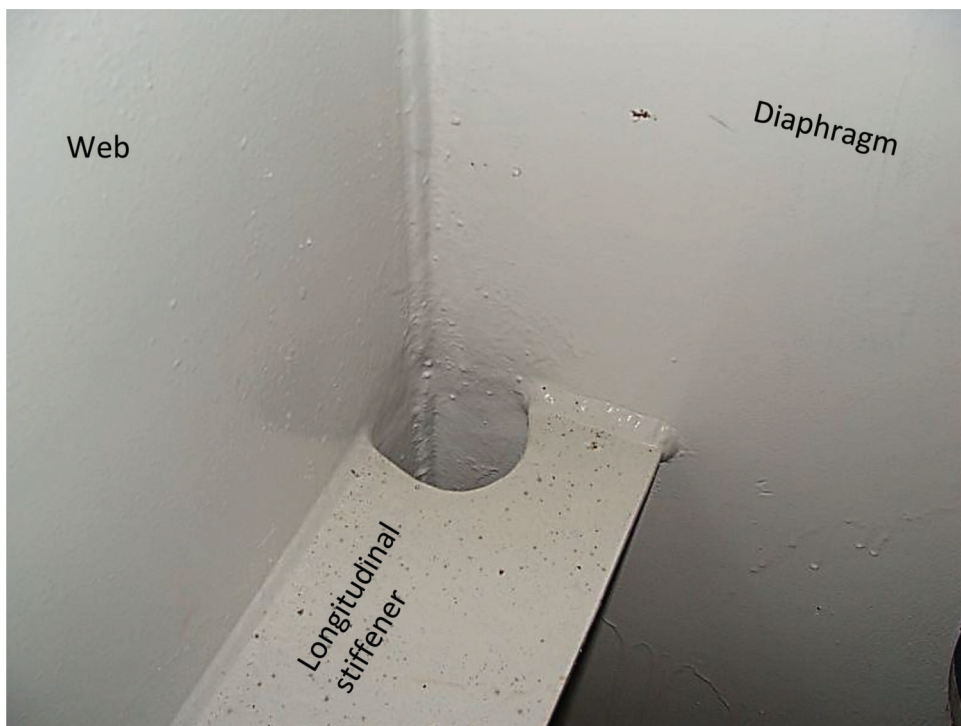
Figure 7.19 Hoan Bridge longitudinal stiffener CIF retrofit.

Section 7.1.2.1 where coring and grinding are used to create the cope at the corner of the intersecting plates. An example of this is shown in Figure 7.19; taken from the Hoan Bridge inside the tie girder span.

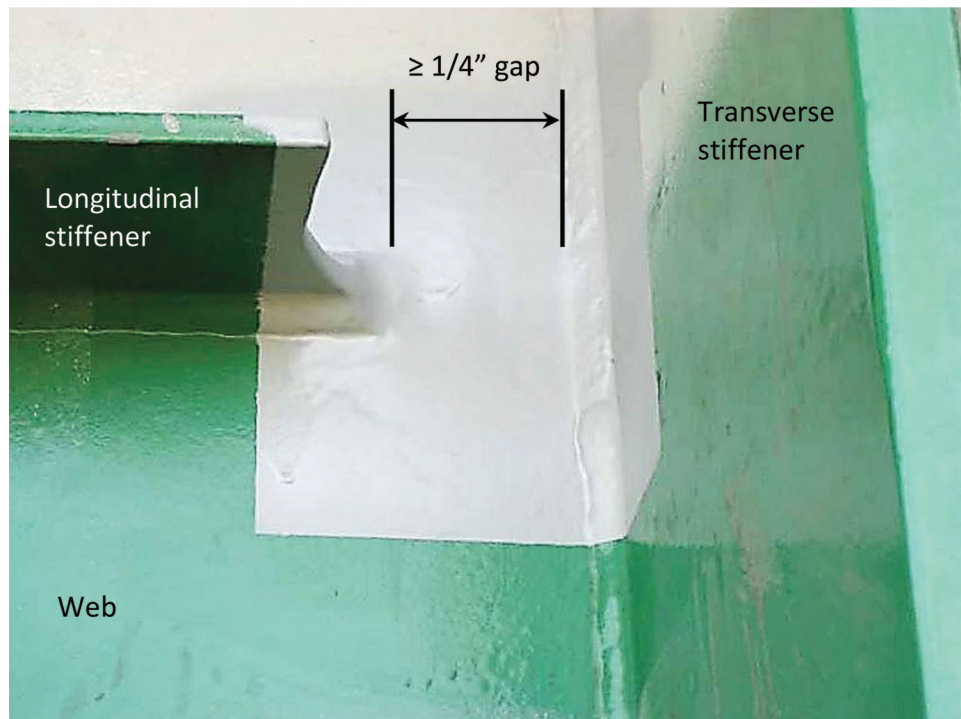
Figure 7.20 CIF retrofit at a longitudinal stiffener (Photograph courtesy of Iowa DOT).

Figure 7.20 shows another approach to the same retrofit that is often used. This image was taken of CIF retrofit work performed on the I-80 Spring Street Bridge over the Missouri River near Council Bluffs, IA. This bridge had several locations in the negative moment regions where the longitudinal stiffener welds intersected the bearing stiffener welds creating potential for CIF. The cutback method produces a large web gap region removing the risk for CIF. By cutting the stiffener plate back, ample room is provided to ensure quality finish work can be accomplished within the new gap region. Additionally, increasing the radius at the end of the plate to 2 inches or greater will improve the fatigue resistance of the longitudinal weld termination, accordingly. This is an added benefit to the overall retrofit that adds very little cost.

4. With the web plate exposed within the new gap, check the gap dimension between the longitudinal and transverse weld toes (see Figure 7.20). *This gap must be a minimum of 1/4 inch, however, more is better.* If the gap is less than 1/4 inch, additional grinding with the carbide rotary burr bit and die grinder will be necessary.

7. Paint the repair area using recommendations provided in Section 4.2.
8. Figure 7.20 shows an example of the completed retrofit on one side of the transverse plate. This same procedure must be repeated on the other side of the transverse plate for a completed retrofit. Notice the smooth and gradual transition from the longitudinal plate to the web plate that helps to minimize stress concentrations at the weld termination, the preserved transverse weld, and the large, smooth web gap exposed between weld toes.

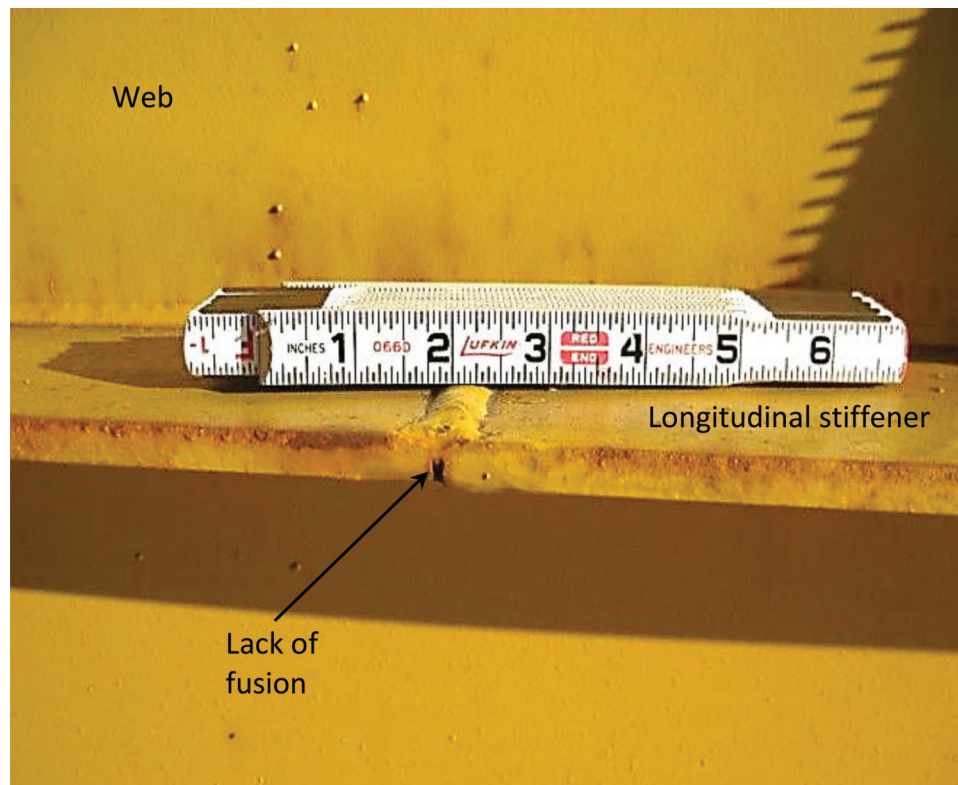
Figure 7.21 Example of poor quality longitudinal stiffener butt splice weld.

As stated, in the past these welds were not always considered to be of real importance since the stiffener was not viewed as part of the primary member, but rather, simply an ancillary attachment. As a result the quality would occasionally be overlooked. Figure 7.21 shows an example of this type of weld where the lack of fusion between the plates is clearly seen from the edge. In this case the plates do not appear to have been beveled, suggesting that they were simply butted flat together, welded to the web, and then fillet welded. These poor quality welds, particularly when located in stress reversal or tensile zones, are not only prone to fatigue, but there have also been fractures that have initiated without apparent fatigue cracking. Figure 7.22 shows another example of a poorly welded longitudinal stiffener splice. Here it appears that essentially no fusion was made in the splice, as if it were not welded at all. This configuration (as well as that seen in Figure 7.21) creates a crack-like geometry, much like what was discussed for Hoan details in Section 7.1, wherein the dead and live load stresses are forced around the

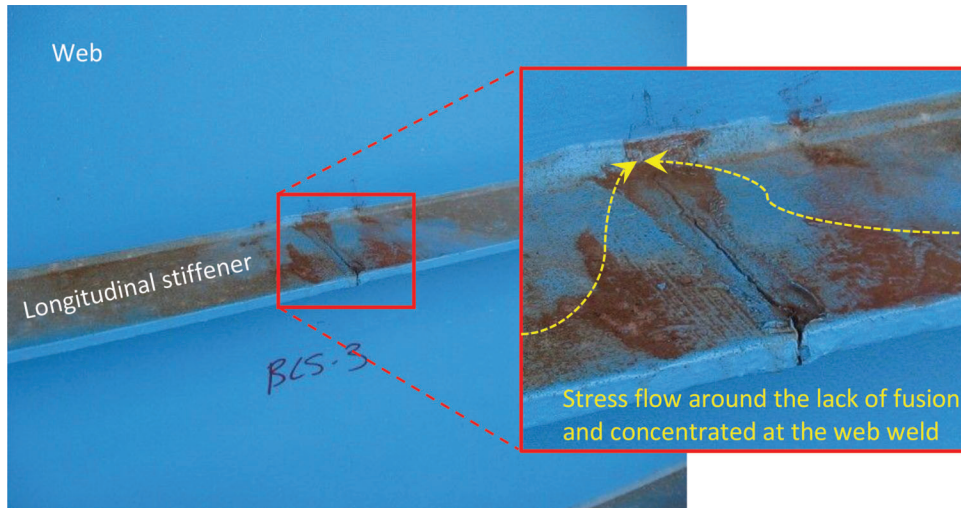
Figure 7.22 Poor quality longitudinal stiffener splice (shown before retrofit).

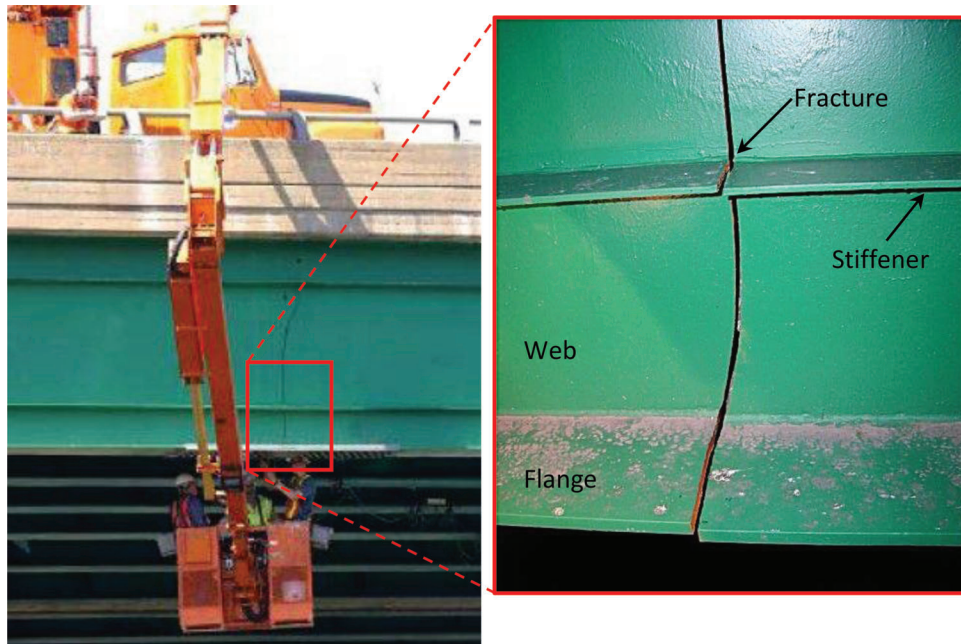
Figure 7.23 I-95 Bridge over Brandywine River in Delaware with fracture initiated at the longitudinal stiffener butt splice (Chajes *et al.*, 2005).

The I-95 Bridge over the Brandywine River is a continuous, three-span, twin structure with six plate girders each, built in 1963. In April of 2003, a bird watcher observed a large crack on one of the fascia girders. Officials were called on scene and found that the northbound bridge had a near full-depth fracture that originated in a welded butt splice of the longitudinal stiffener in the tension zone. It was determined by the investigation team that a combination of cool temperatures (near freezing), increased live loads on the shoulder of the bridge due to ongoing maintenance, and a lack of fusion zone at the butt splice contributed to the fracture. Evidence collected by investigators suggested that the fracture was relatively recent and that the crack progressed rapidly due to brittle fracture and not due to fatigue (Chajes *et al.*, 2005). Figure 7.23 shows a couple of pictures where the fracture can be seen running through the tension flange, stiffener, and most of the web. A bolted splice was installed at the location of the fracture. Thorough inspection of similar details on the Brandywine River Bridge revealed a wide range of weld quality and workmanship, as well as a few more cracks in the butt splices. All of the longitudinal butt

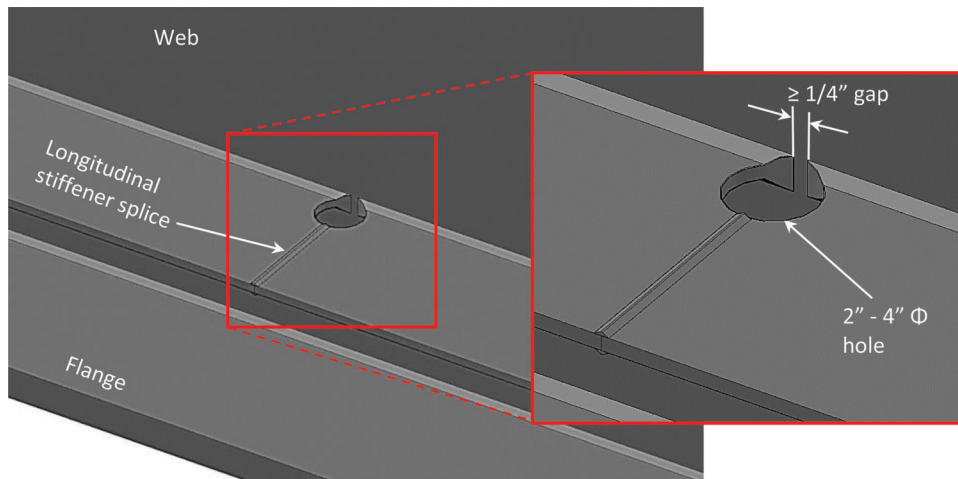
Figure 7.24 Illustration of the longitudinal stiffener core retrofit.

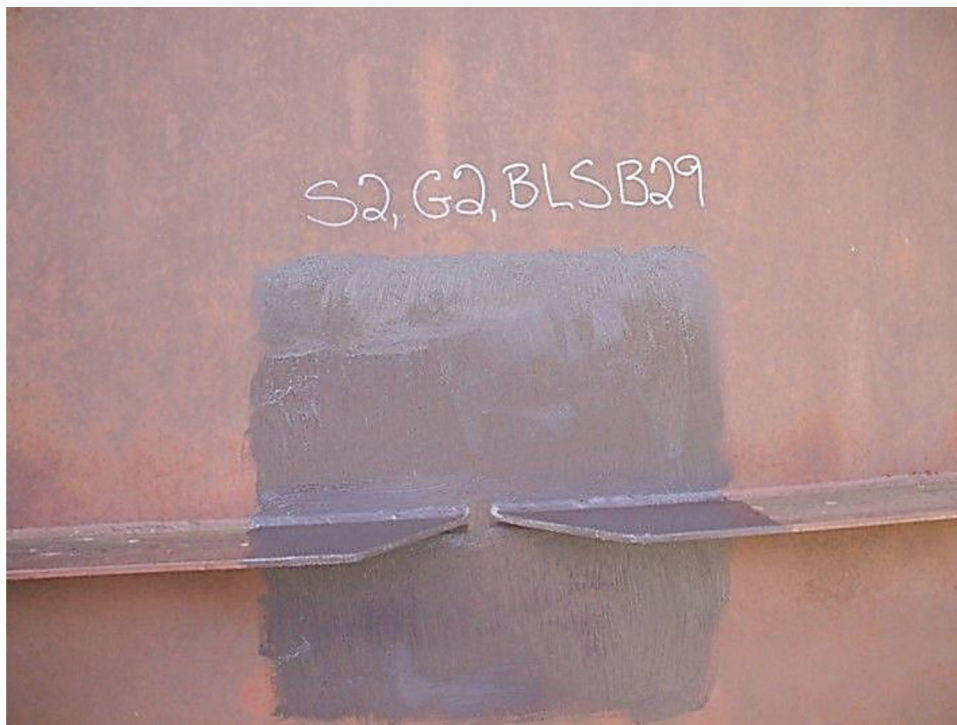
Figure 7.25 Alternate version of the longitudinal stiffener core retrofit with the stiffeners plates cut back in addition to the drilled hole.

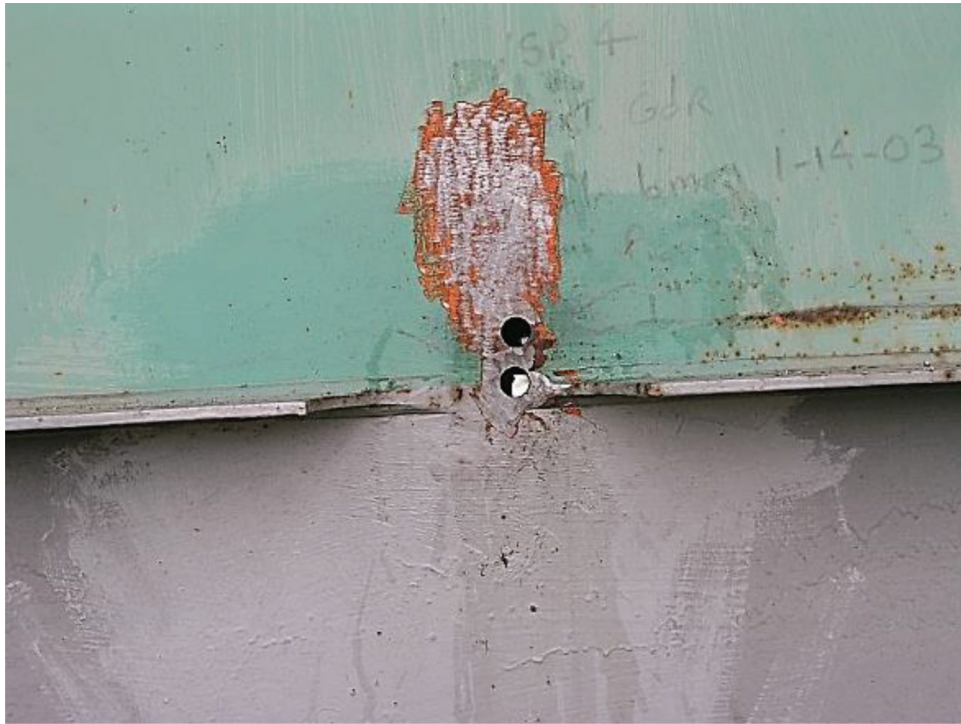
Figure 7.26 Longitudinal stiffener core retrofit showing drilled holes in the web plate for crack arrest (Photograph courtesy of Kansas DOT).

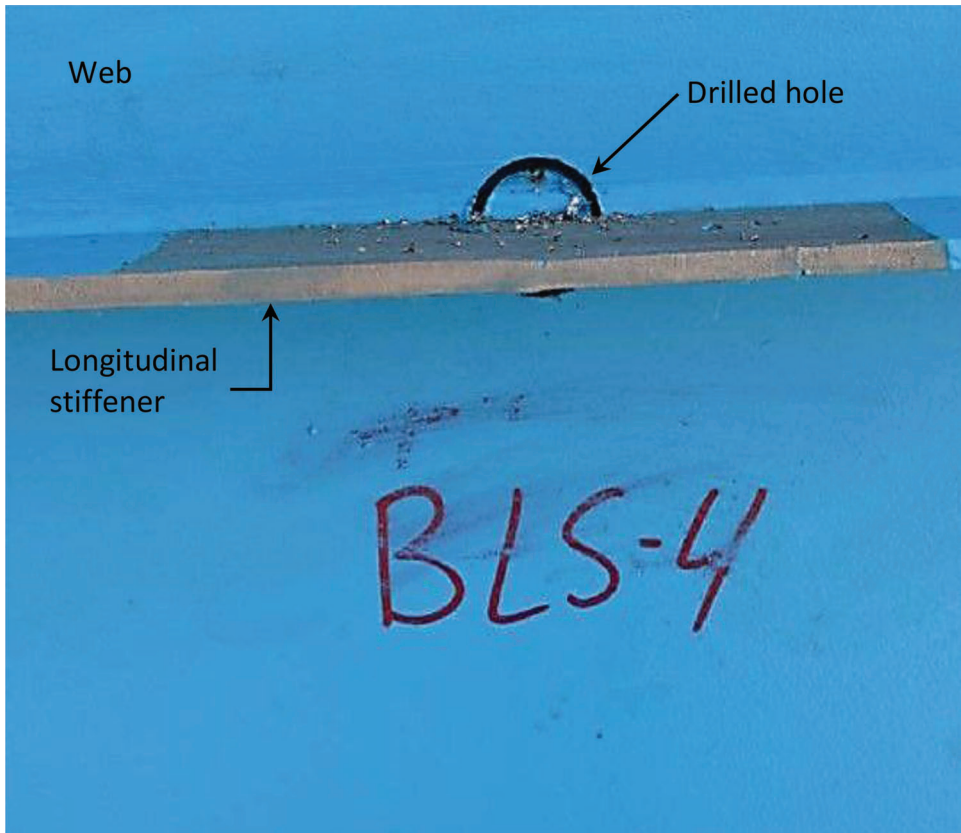
Figure 7.27 Hole drilled in web for web core retrofit.

5. Using a mag-based drill with annular cutter, drill a hole through the web plate and partially into the longitudinal stiffener plate, as shown in Figure 7.27. It is recommended to use a 2 to 4 inch diameter cutter to help reduce stress concentration and improve finish work.
Caution: tie off the mag-based drill to the girder using sturdy clamps and chainrope in the event of power loss.

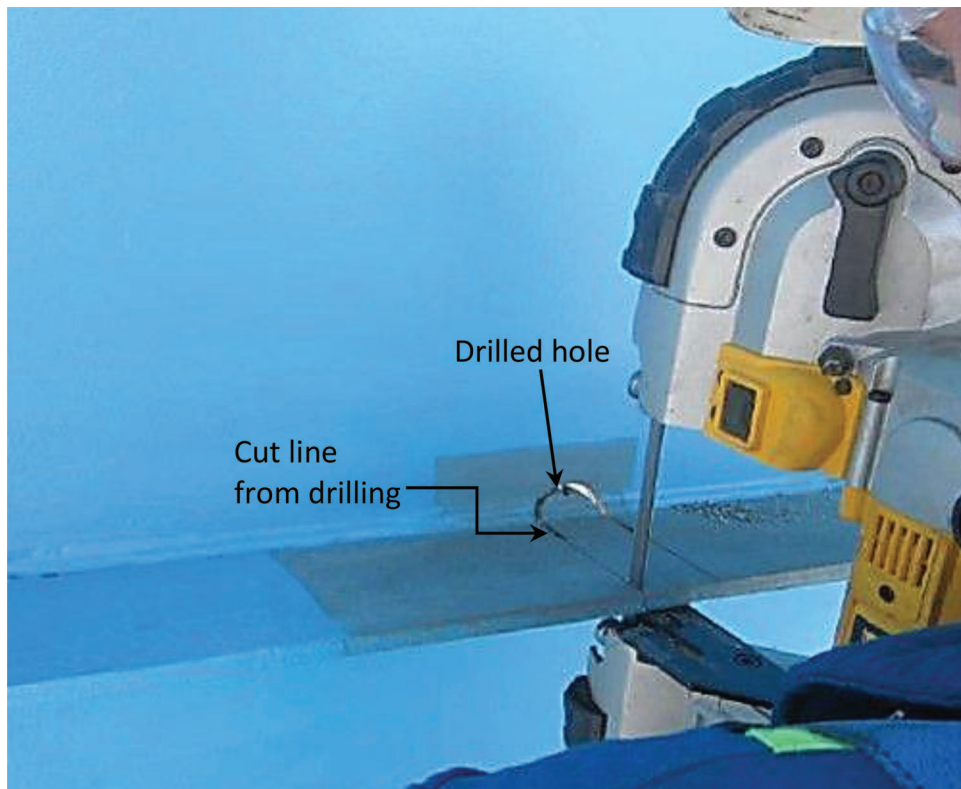
Figure 7.28 Removal of butt weld and drilled core for web core retrofit.

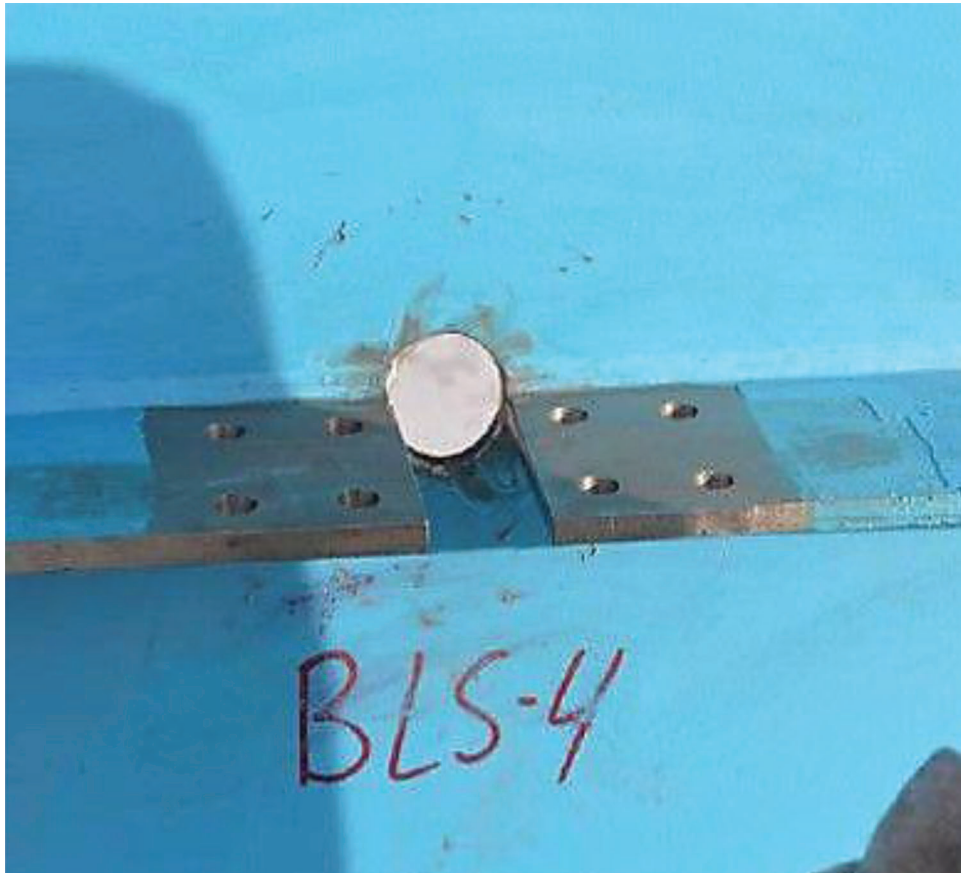
Figure 7.29 Finished retrofit with drilled holes for optional bolted splice.

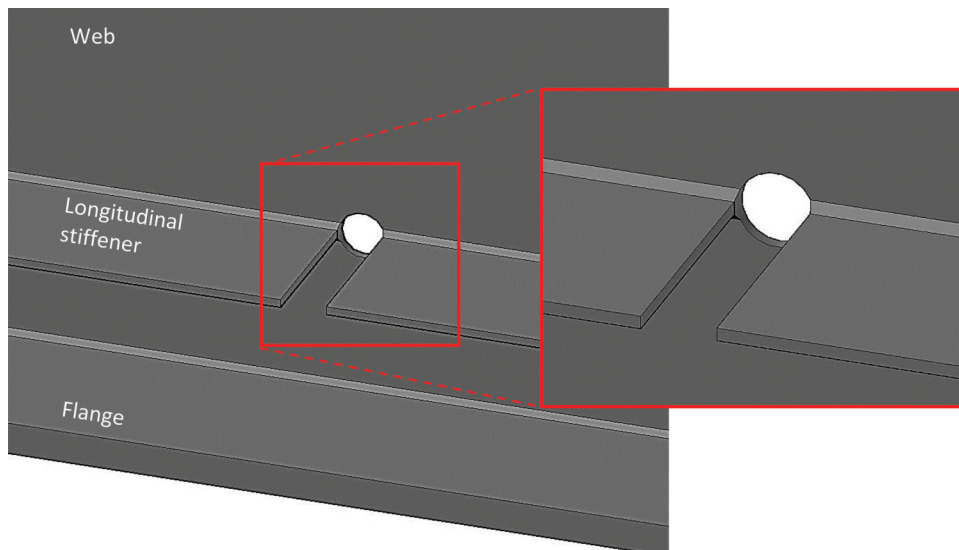
Figure 7.30 Illustration of the web plate core retrofit for longitudinal stiffener splices.

Figure 7.30 shows the completed web plate core retrofit (minus the bolted splice) for poor longitudinal stiffener butt splice details. The fatigue resistance of the new detail is governed by the drilled hole since the longitudinal welds terminate at the edge of the hole. The hole is at a minimum an AASHTO Category D detail, but may likely perform better if high quality edge conditions are put in place. Adding a bolted splice on

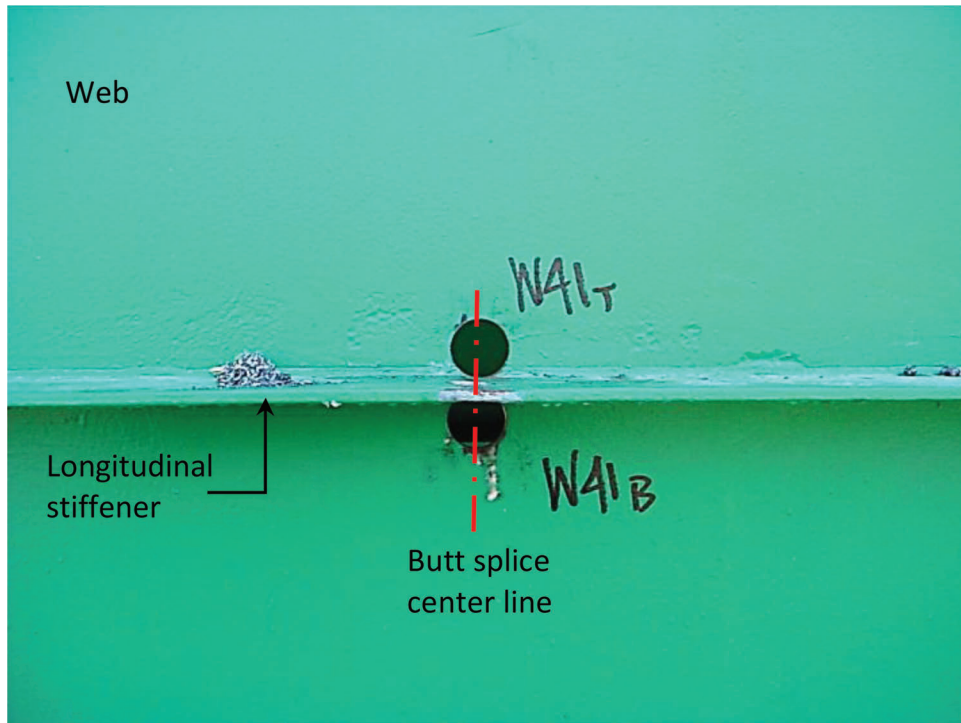
Figure 7.31 Alternate version of the web plate core retrofit (Chajes *et al.*, 2005).

the web plate directly above and directly below the longitudinal stiffener splice to arrest fracture if it occurs. The same sanding finishes would be recommended once the two holes are drilled. Although this retrofit may not be as aesthetic, it would effectively perform the intended function, is very economical, and could be installed even at locations with stiffeners on both sides of the web plate.

Additionally, Figure 7.31 demonstrates a very simple alternative. This method uses isolation holes drilled in

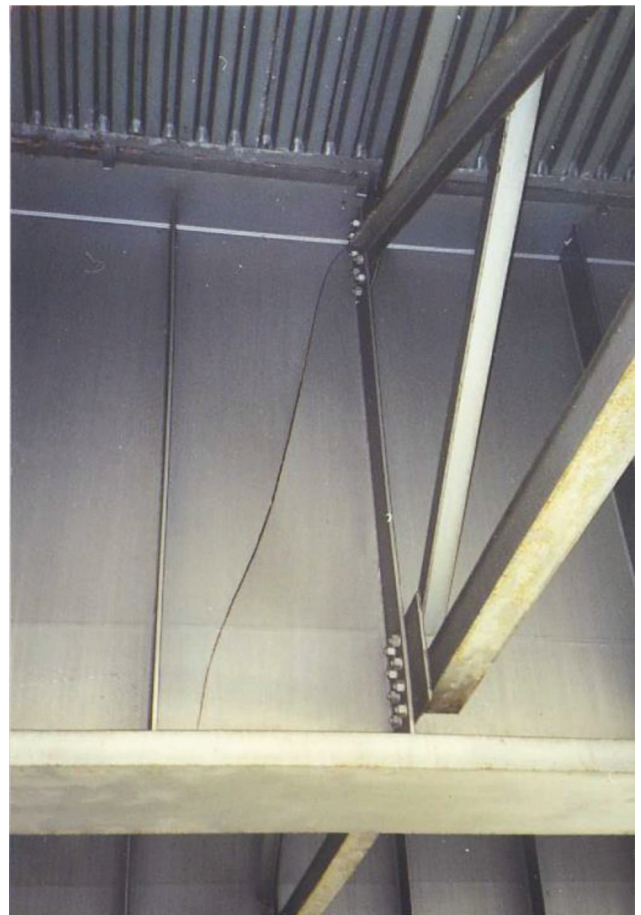
Figure 7.32 Fracture initiated at stiffener in negative moment region (Photograph courtesy of Y. Edward Zhou).

Several cases of brittle fracture initiating at the top of a bearing stiffener (or sometimes from connection plates) in a negative moment region of continuous spans have been observed. Figure 7.32 shows one such example from a bridge carrying I-495. This type of fracture, however, is much less common and there may be a number of undocumented cases. The actual cause of the fracture, meaning the characteristics that make one detail more prone than another, have not been well quantified by research or field studies. It is believed that some contributing factors are those that would contribute to a triaxial stress state at a subsurface microscopic flaw, such as the thickness of the stiffener element, the size of the longitudinal and vertical welds, the quality of the welds, and the size of the web gap. It is worth noting that no such fracture is known to have occurred when the stiffener/connection plate or bearing stiffener was welded to the flange.

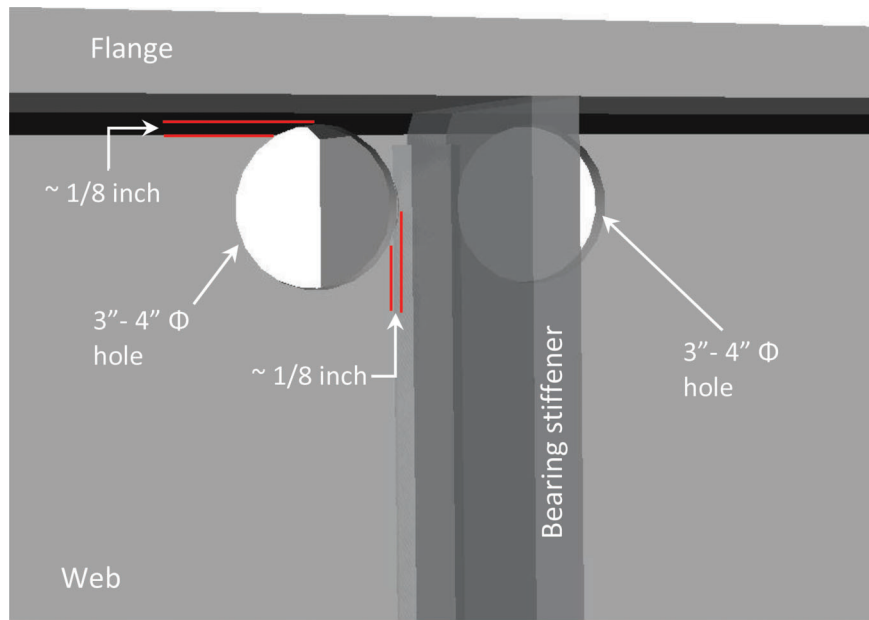
Figure 7.33 Illustration of Large-hole retrofit at bearing stiffener (shown with transparent stiffener to show second drilled hole).

3. Determine the correct placement for the annular cutter ensuring that the drilled hole will intercept the bearing stiffener-to-web (vertical) weld toe and the flange-to-web (horizontal) weld toe about 1/8 inch, as illustrated in Figure 7.33. It is recommended that the cutter used be at least 3 inch to 4 inch in diameter.
