Maintenance Actions to Address Fatigue Cracking in Steel Bridge Structures

PROPOSED GUIDELINES AND COMMENTARY

NCHRP Transportation Research Board of
The National Academies

Robert J. Connor and Jason B. Lloyd
Purdue University
West Lafayette, Indiana

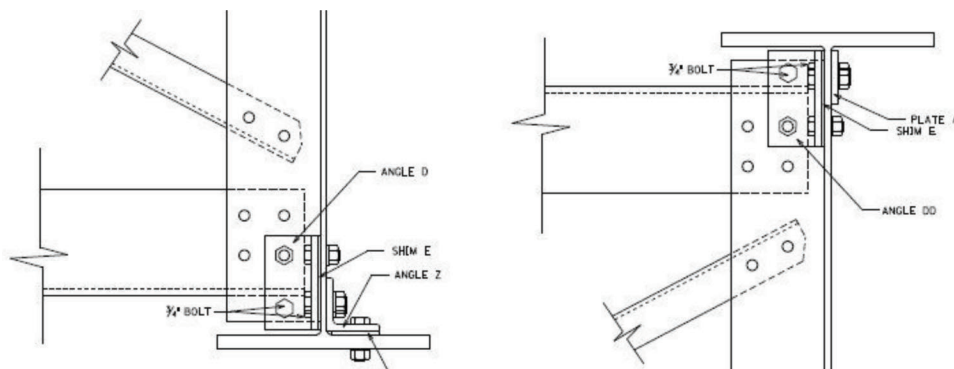
Figure 8.1 Example details of doubler plate stiffening for distortion-induced fatigue (Source anonymous).

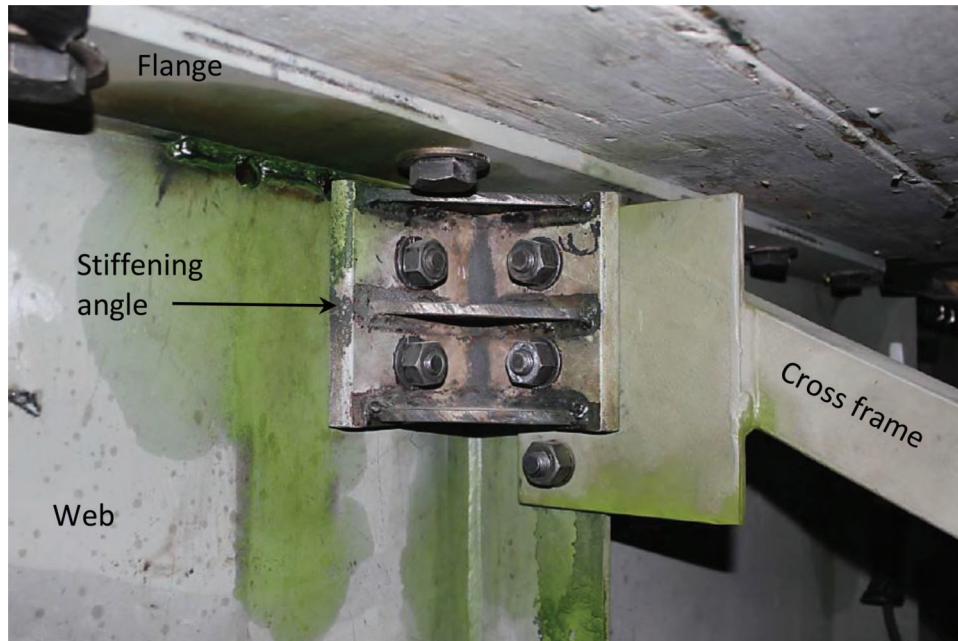
Figure 8.2 Stiffened-angles-with-plate retrofit (Taken from Bennett *et al.*, 2014).

The doubler plate-angle type retrofit has potential to work well in some applications when meticulously designed and installed. Bennett *et al.* (2014) found some positive results with highly stiffened angles and backer plates (see Figure 8.2). However, they also concluded that it was not as effective at mitigating crack initiation and propagation at the flange-to-web welds as connecting the stiffening component directly to the flange. This is because as mentioned above, the loads are still transferred through the web into the flange. Although the cost benefit of this type of retrofit is that the deck

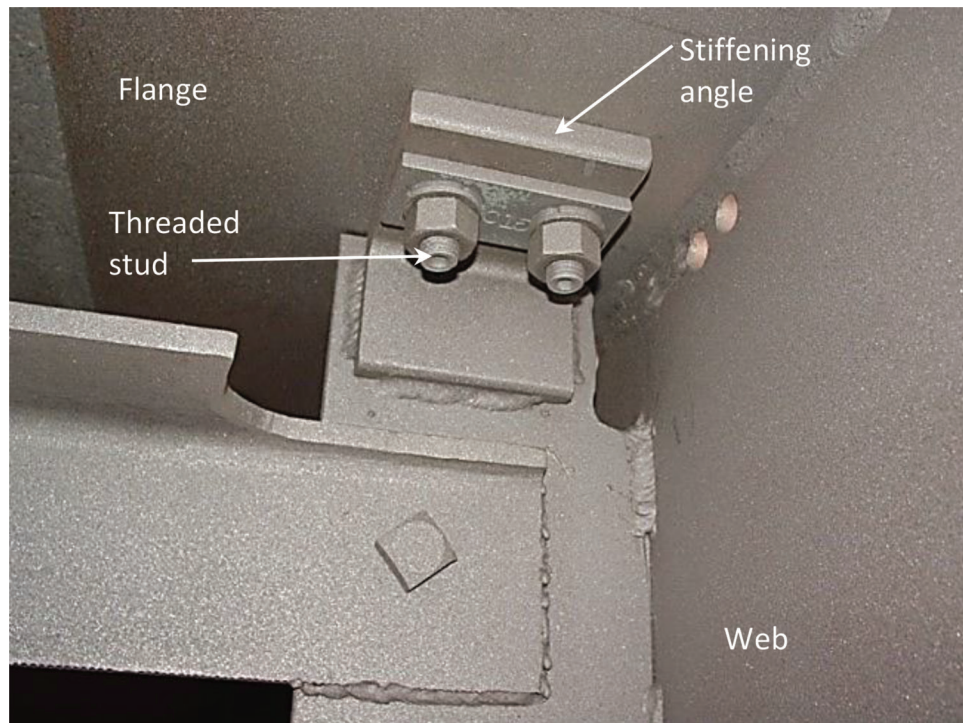
Figure 8.3 Example of fusion welded threaded stud retrofit shown blast cleaned in preparation for painting (Photograph courtesy of Kansas DOT).

Figure 8.3 shows an example of this type of retrofit that has been blast cleaned in preparation for painting. The threaded studs look like bolts from one side. In this example, the owner correctly drilled holes at the crack tips to arrest propagation and welded the stiffening angles to the connection plate providing a very stiff connection. The threaded stud connection to the flange, however, would not provide comparable stiffness, particularly because only two studs were used per angle. The threaded studs can be found commercially produced up to 1 inch diameter. However, the studs are not of comparable yield strength to the high strength structural bolts used for slip critical connections. Currently,

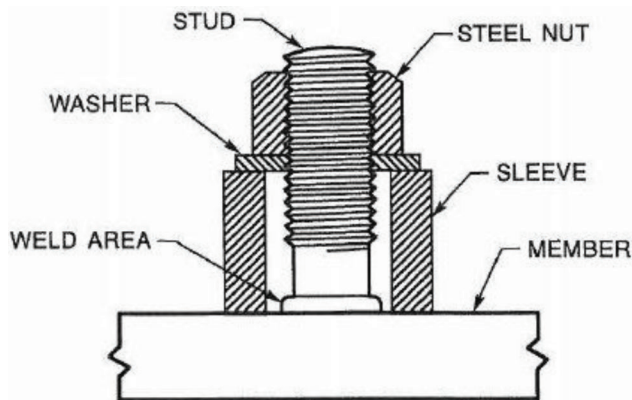
Figure 8.4 Torque testing arrangement (AWS, 2015).

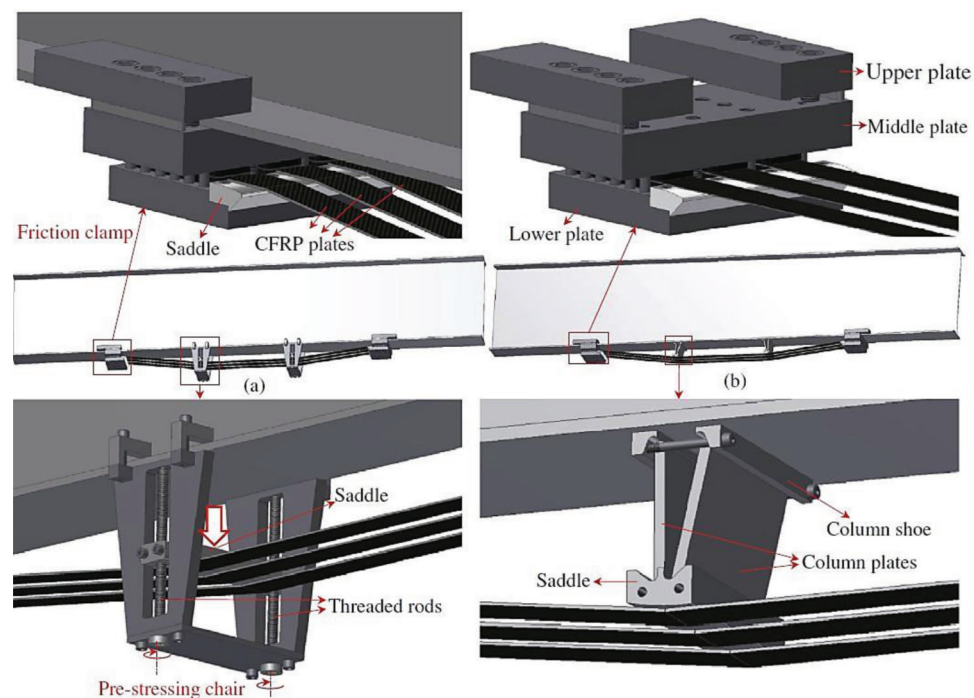
Figure 8.5 Components of the PUR system (Taken from Ghafoori *et al.*, 2015).

Of particular interest for this guideline was a study by Ghafoori *et al.* (2015) that installed a pre-stressed un-bonded reinforcement (PUR) CFRP system on a 120-year-old railway bridge in Switzerland. The concept of the study was to install a form of CFRP that would not require preparation of the steel surface for an adhesive bond layer, reducing installation efforts. The PUR system uses an applied pre-stress force to reduce the mean stress and shift an existing fatigue detail from the “at risk” finite life regime to the “safe” infinite life regime, functioning much like external post-tensioning. Figure 8.5 is an illustration that comes directly from Ghafoori *et al.* (2015) showing the components of the PUR system; the friction clamp that holds the ends of the CFRP plates, pre-stressing chair used to pre-stress the CFRP plates and create an eccentric load (and induced negative moment) on the existing steel member, and the column plates used to hold the CFRP plates in position once they are pre-stressed. An added benefit to the system is that it can be installed between rivets without needing to drill holes or remove coatings. The actual

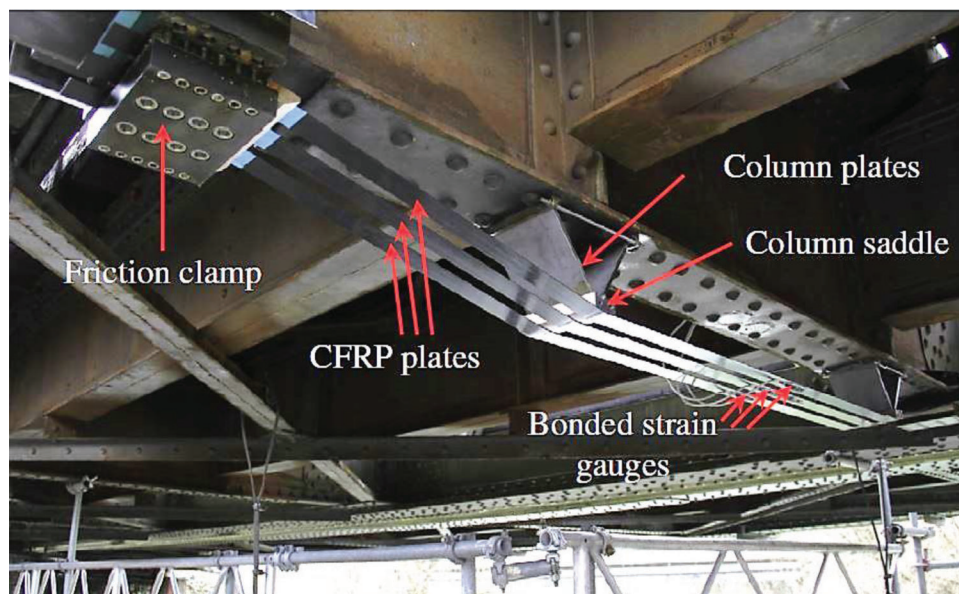
Figure 8.6 Strengthened floorbeam using PUR system (Ghafoori *et al.*, 2015).

system installed is shown in Figure 8.6, showing the three CFRP plates and other PUR system components.

Strain gages, as well as sensors for monitoring relative humidity and temperature, were installed on the bridge. They observed the following during the short-term field testing:

1. The mean stress was reduced putting almost the entire floorbeam live load stress cycles into compression.
2. Due to low thermal expansion of the CFRP plates, an increase in temperature resulted in an increase in the pre-stress in the CFRP.
3. Humidity did not affect the performance of the CFRP plates.

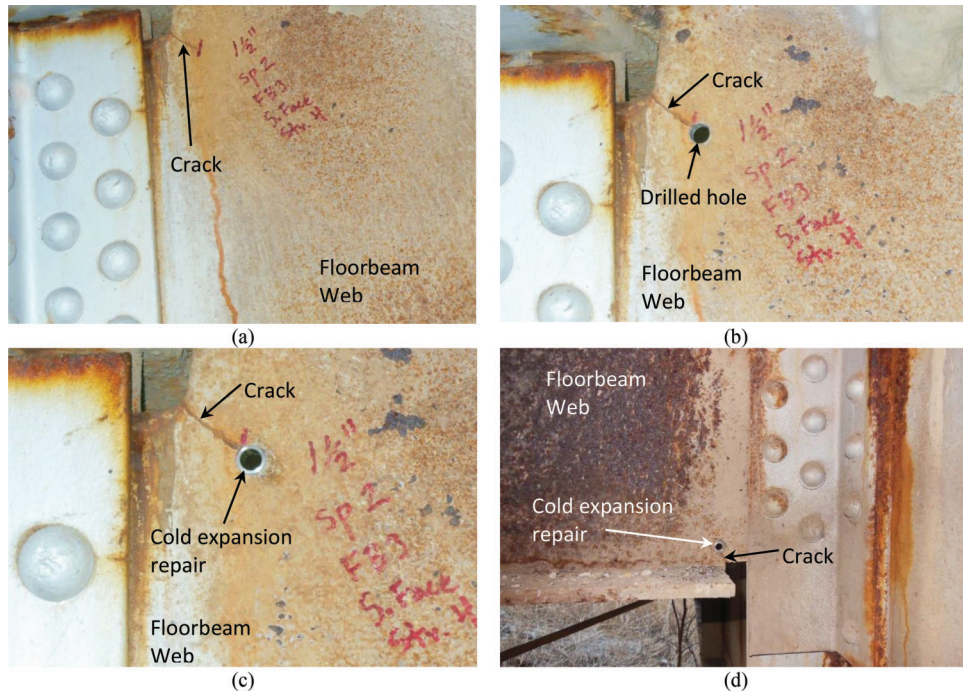
Figure 8.7 Cold expansion of crack arrest holes (a) floorbeam cope cracking, (b) drilled hole at the crack tip, (c) & (d) finished repairs with expansion sleeve (Photographs courtesy of Oklahoma DOT).

Figure 8.7 shows the progressive steps of installing one of the cold expansion sleeves at floorbeam cope details that have fatigue cracked. Notice that the expansion sleeve is left behind providing a direct interception as the base material attempts to rebound, or spring back, helping to lock in the residual compressive stress at the edge of the hole. Although this method shows promise for bridge repair applications and is being implemented by a few states, the repair has not yet been in service long enough to determine its long-term effectiveness.
