Lecture # 42

Prof. John W. Sutherland

Chapter 14

- **Press 120 -- Injection Molding case study
(Saline plant: Bob Deacon & Ray Newton)**
- **Accounts Payable case study**

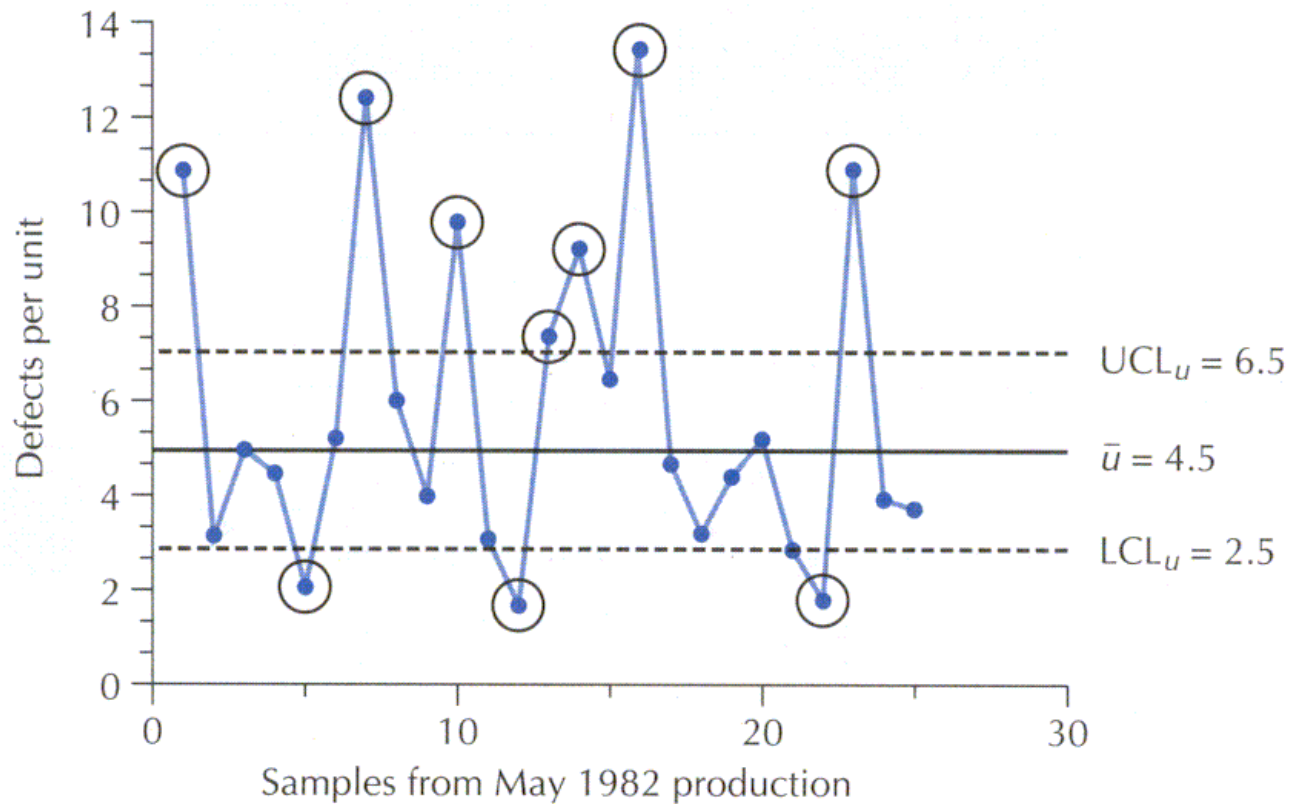
Figure 14.1 Initial Control Chart (u Chart) for All Defects from the Press 120 Molding Process

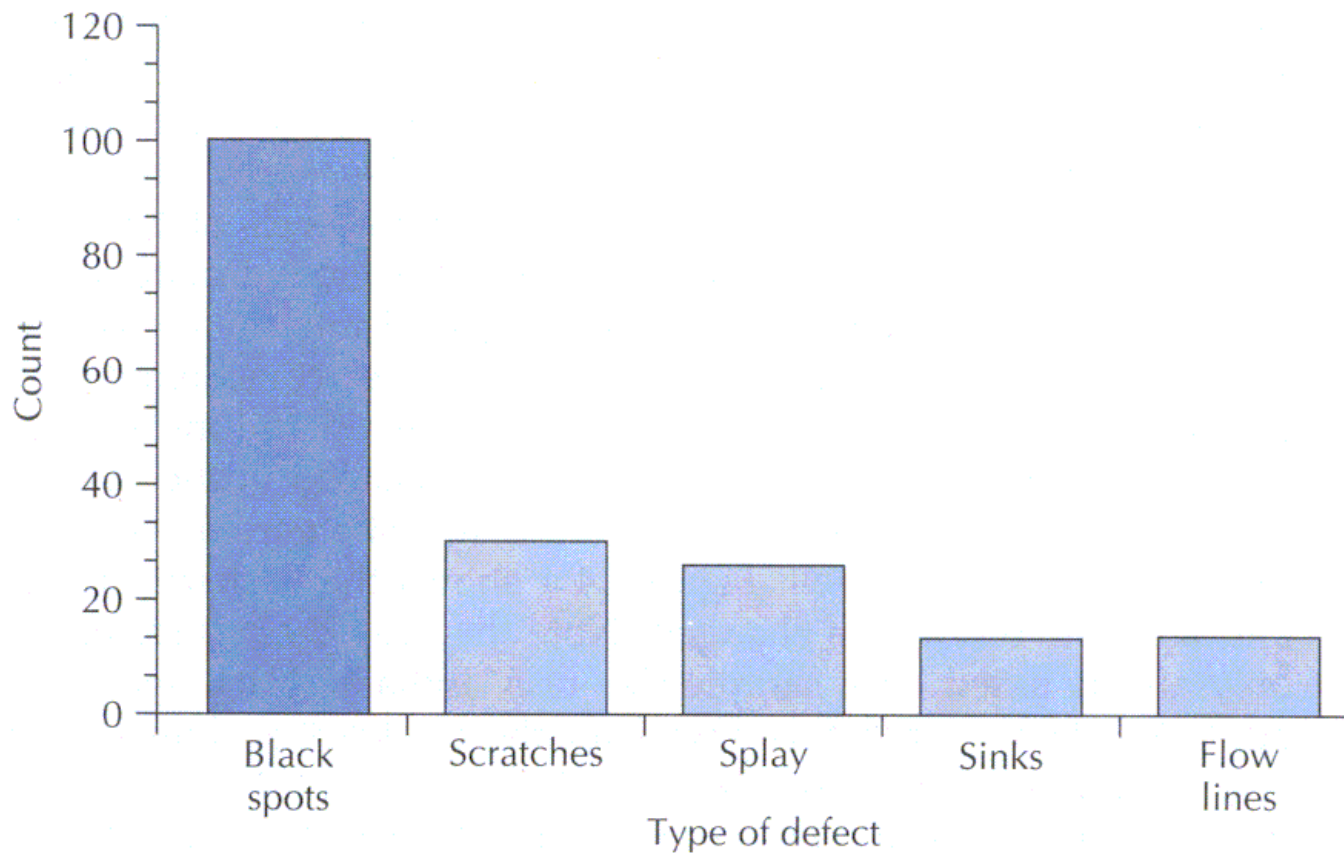
Figure 14.2 Pareto Diagram for Defects on Radiator Grille

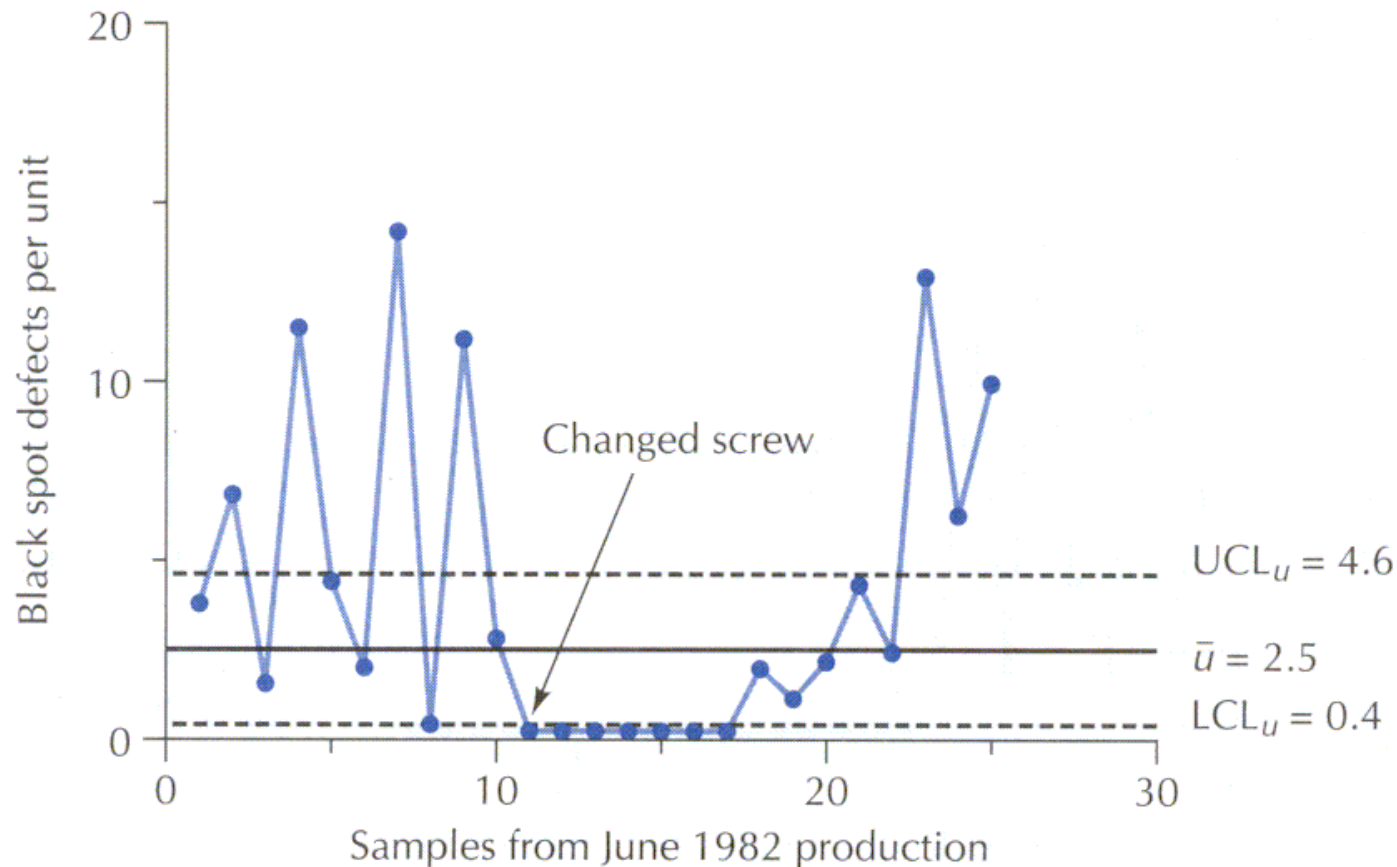
Figure 14.4 Continuation of Press 120 u Chart Showing the Effect of Changing the Screw

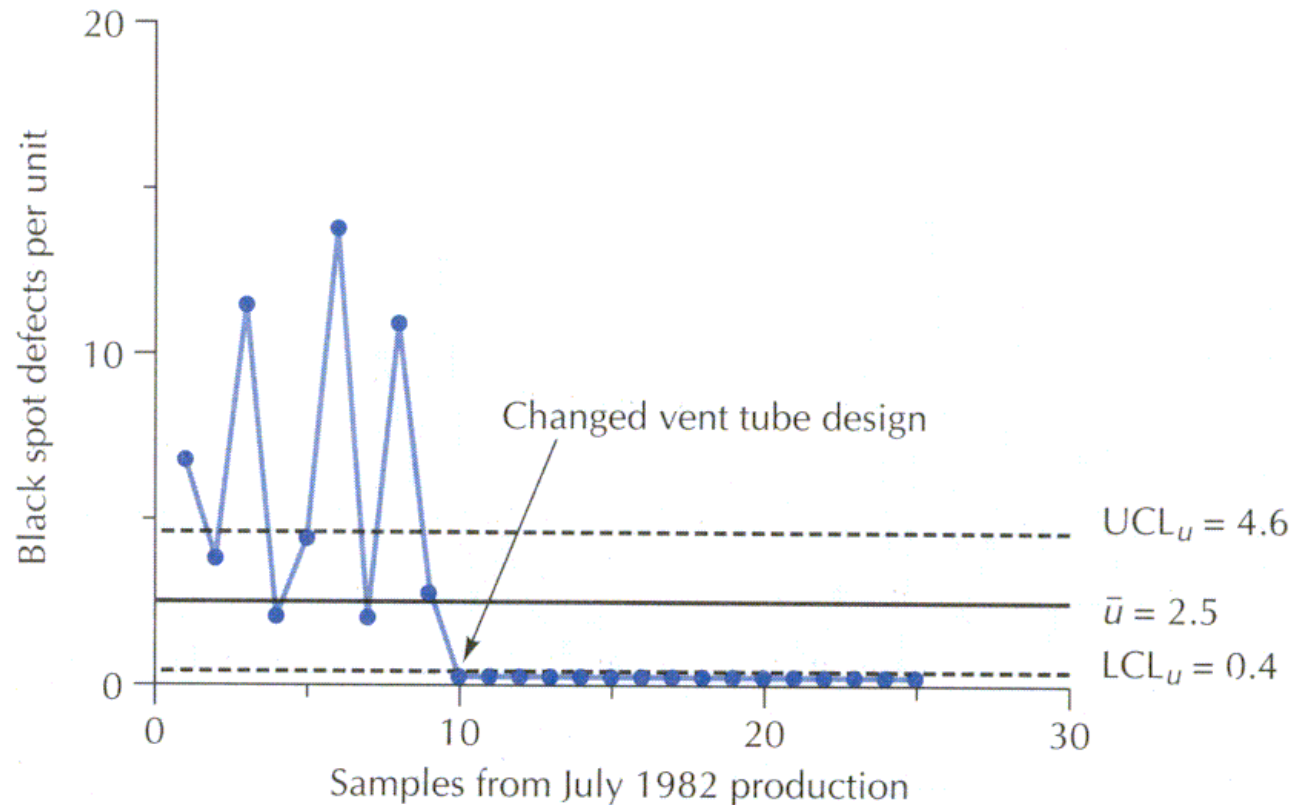
Figure 14.5 Continuation of the Press 120 u Chart Showing the Effect of the New Vent Tube Port Design

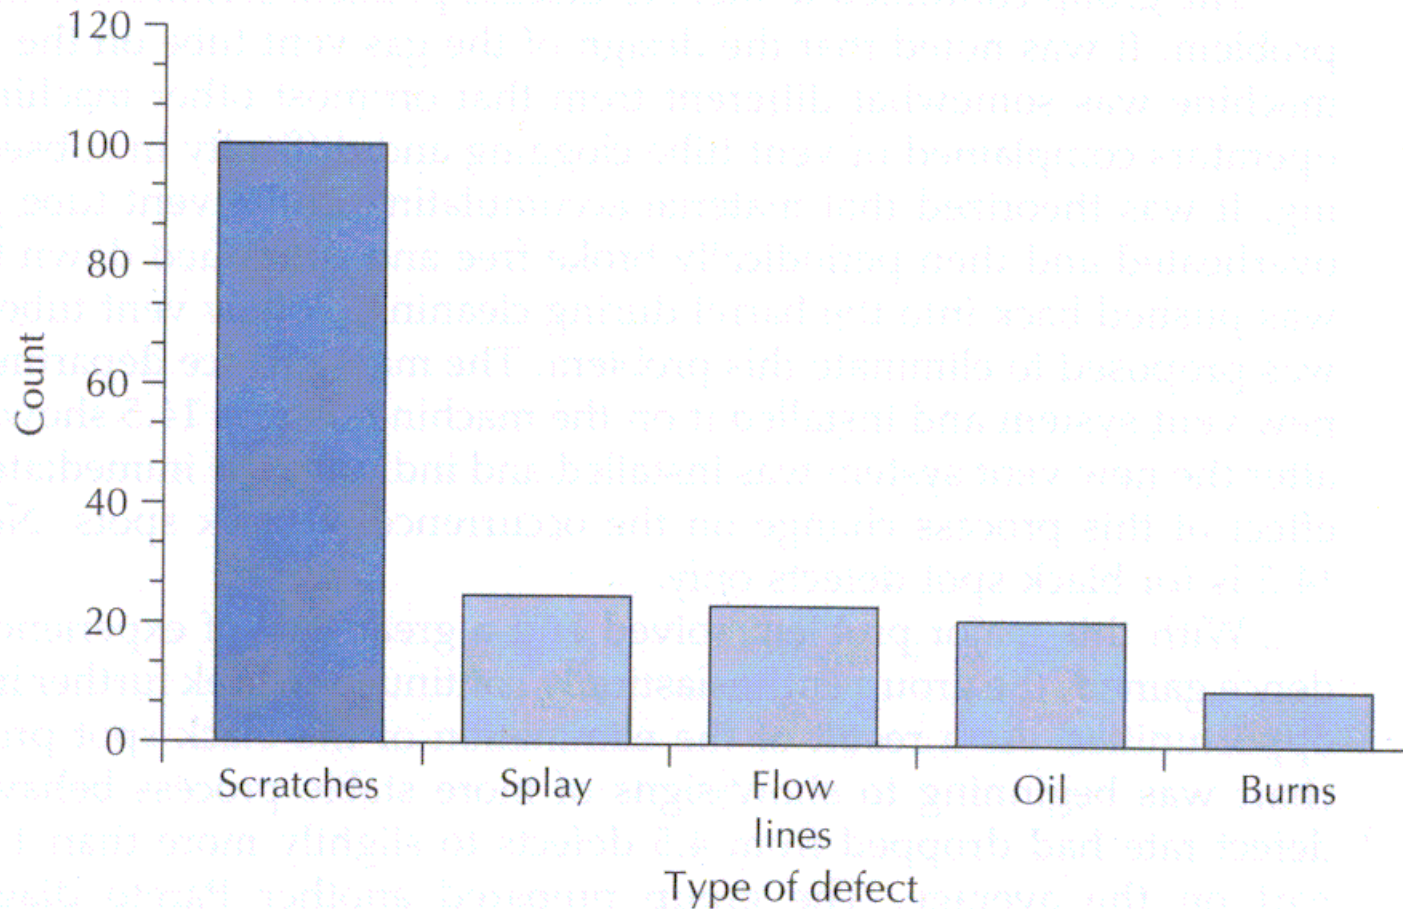
Figure 14.6 Pareto Diagram for Defects on a Radiator Grille After the New Vent Tube System Was Installed

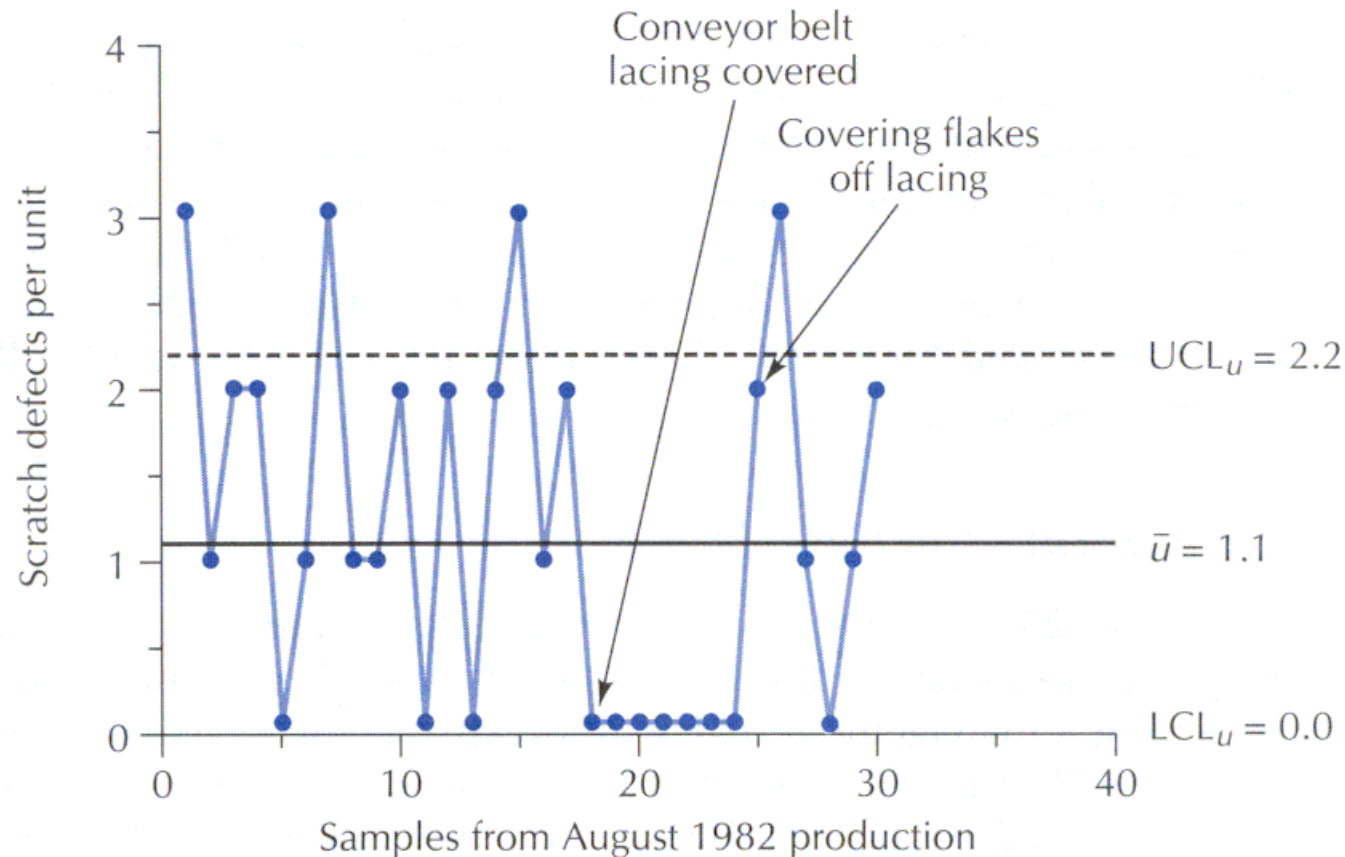
Figure 14.7 Control Chart for Scratch Defects Before and After Latex Coating Was Applied to the Belt Lacing

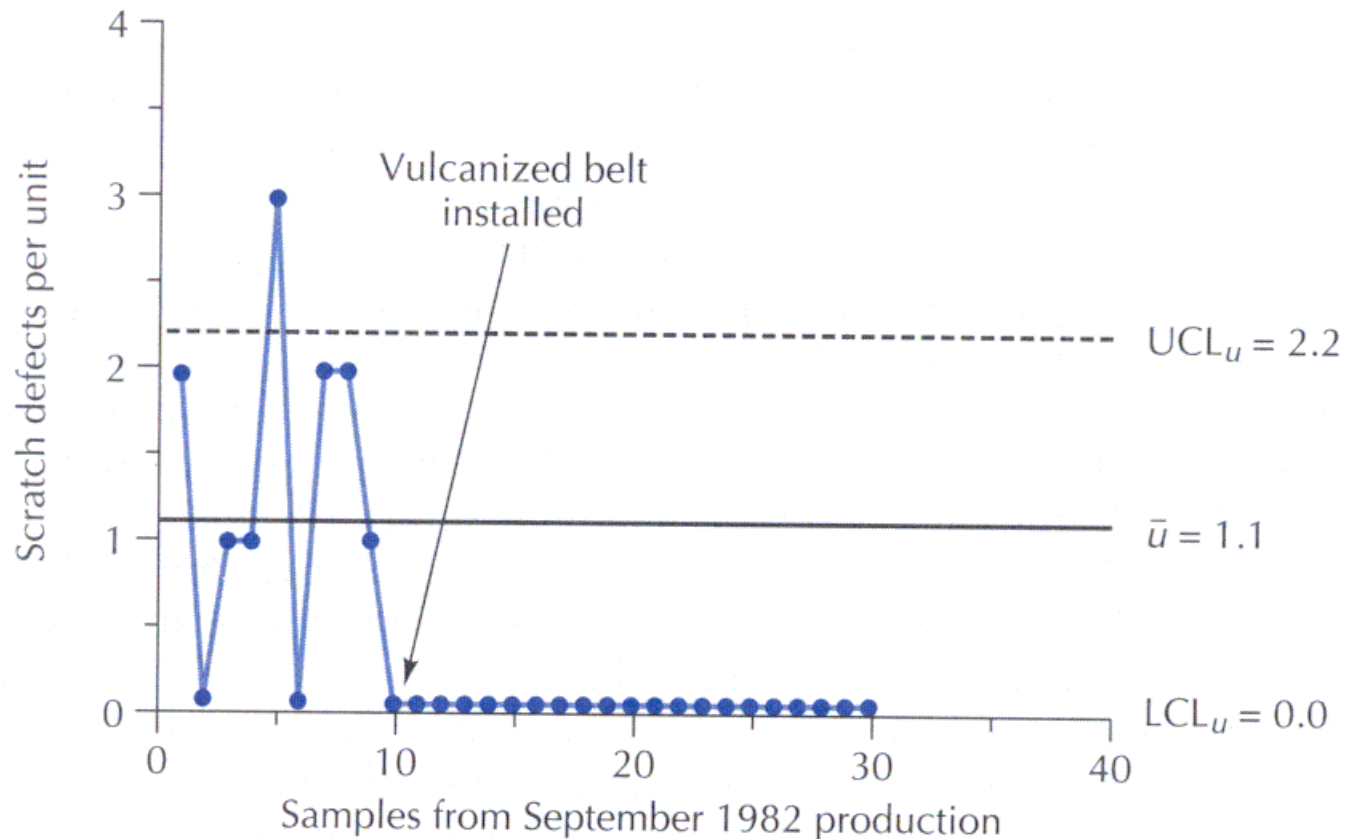
Figure 14.8 Control Chart for Scratch Defects Before and After the Bonded Belt Was Installed
