Optimizing the Additive Repair of Turbine Blades Using Directed Energy Deposition

Student Names: Hannah DeBoer, Adam Katz, James Ro, Lauren Washington Faculty Advisor: Prof. Matthew Krane

School of Materials Engineering

This work is sponsored by Rolls-Royce

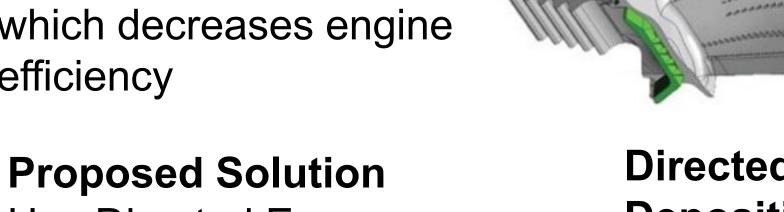
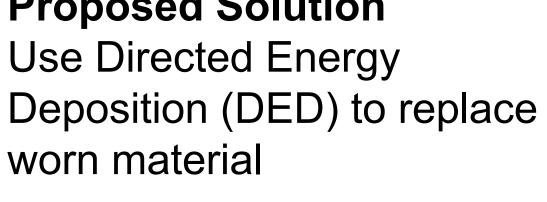
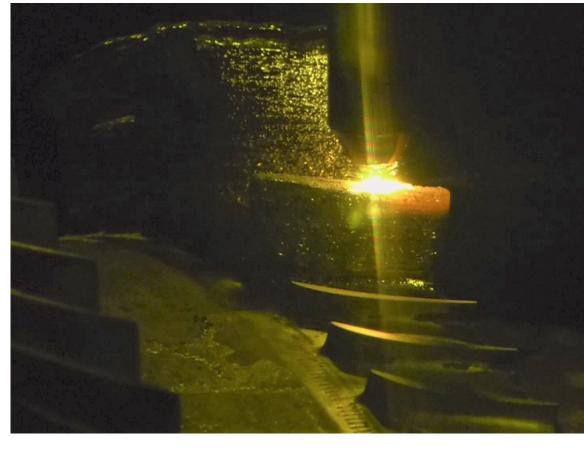
Tips of CMSX-4 turbine blades wear during use, which decreases engine efficiency

Additive manufacturing process used to selectively add material onto an existing part

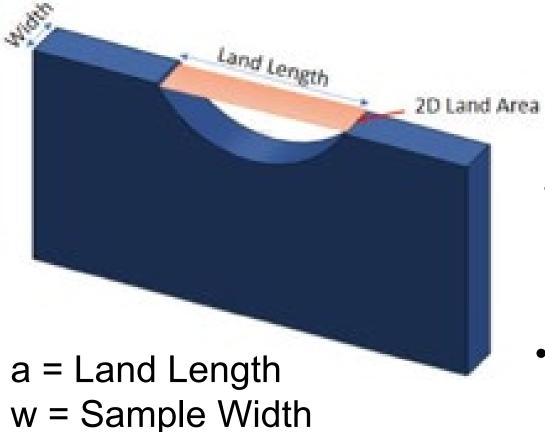
- Coupons worn with a ceramic rod at a specified load
- Two wear tests were performed on each sample

Land length was measured periodically during each 2hour test

Worn volume calculated from measured land length and width

R = Ceramic Rod Radius Volume Removed = $w \left[\frac{1}{2} R^2 \left(\sin^{-1} \left(\frac{a}{2R} \right) \right) \right]$

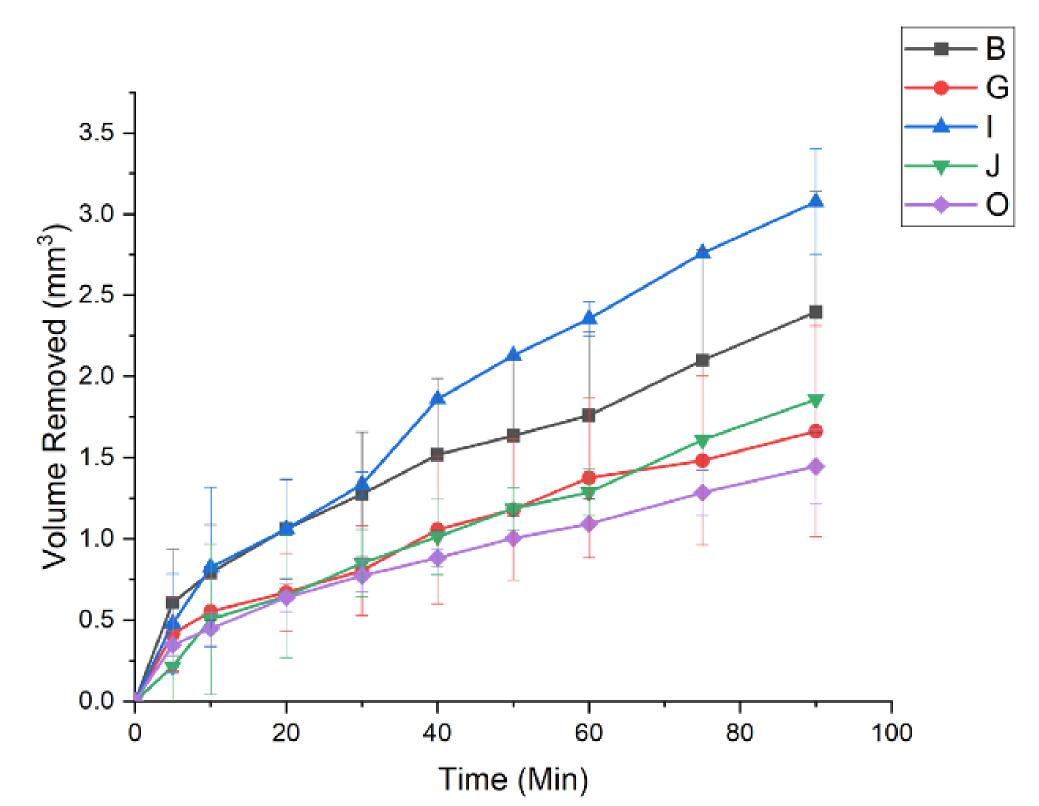
- The wear rate was fastest at the beginning of a test and decreased over time
- Sample O displayed the best wear resistance
- No statistically significant relationship between heat parameters was found

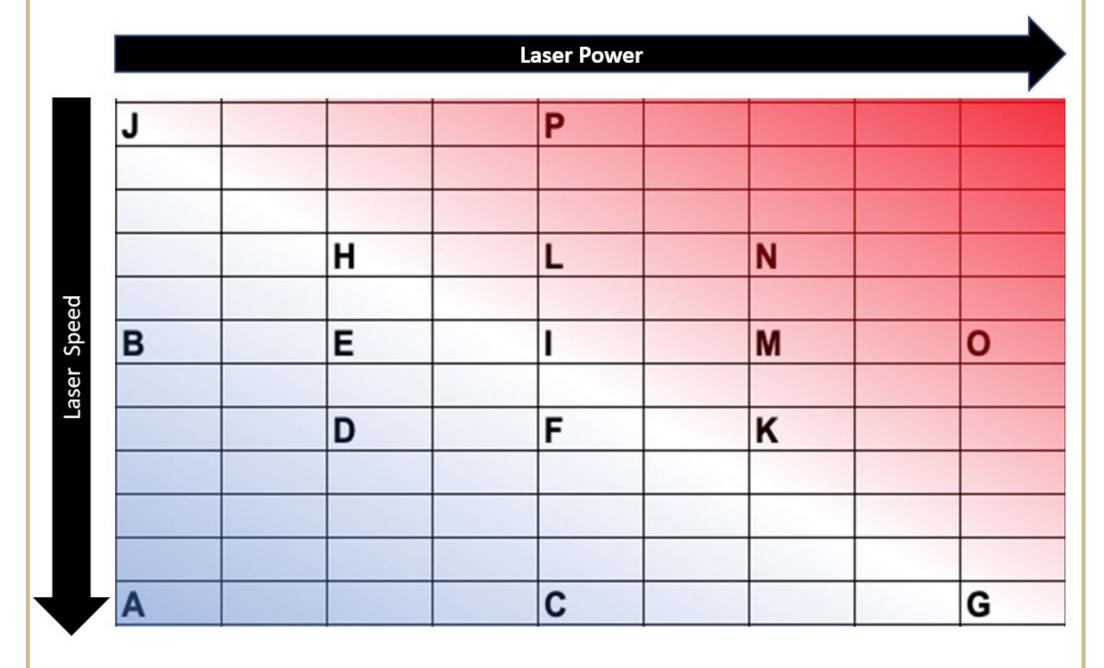
Samples were deposited at various power and speed values. Case I is the baseline case, suggested from a previous study

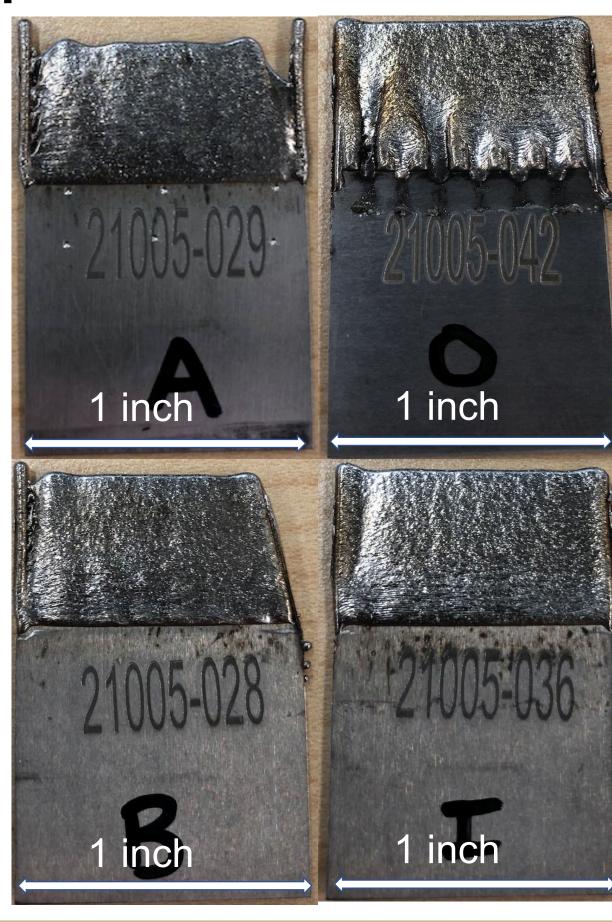
The process conditions produced different structures, with defects such as horns (in A) and waves (in O)

The samples were then subjectively ranked from best to worst build based on these characteristics

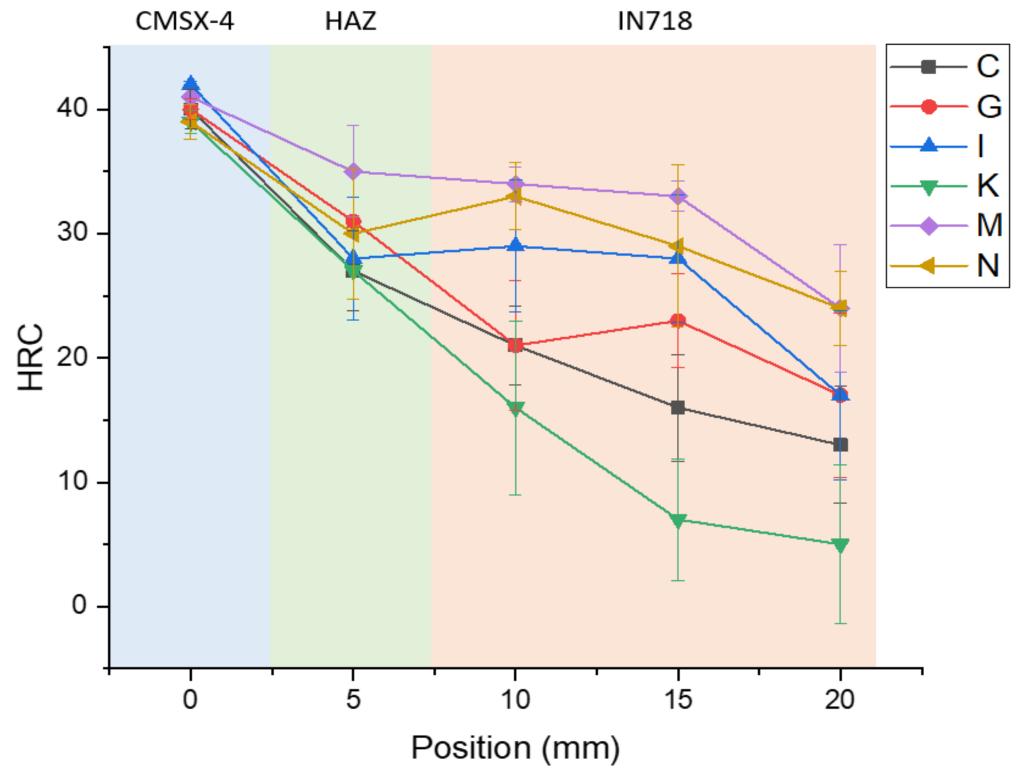
Hardness profiles (HRC) were taken near the repair interface, through CMSX-4, Heat Affected Zone, and deposited IN718-RAM3

- Sample M had the highest hardness values
- The top of the IN718-RAM3 build showed the lowest hardness values across all samples
- Hardness decreases in the HAZ as the heat from the deposition affects the single crystal microstructure

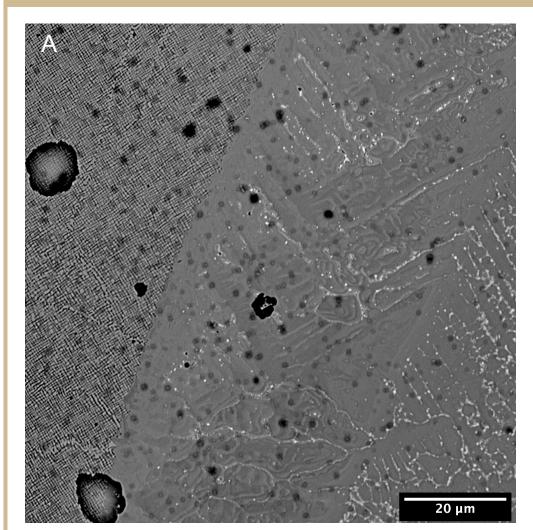
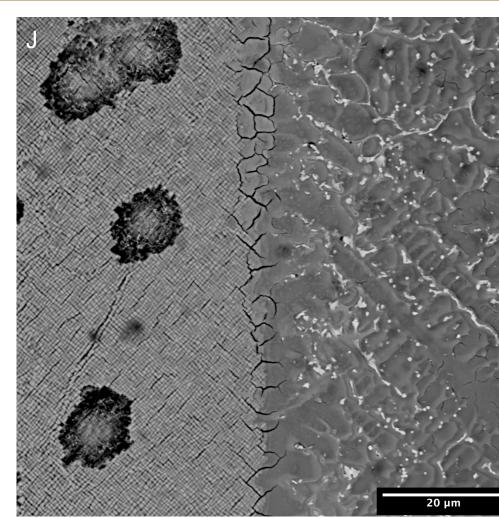
- Sample A has minimal cracking compared to the abundance of cracks all along the interface in sample J
- More pronounced cracks and other defects are observed at the IN718-RAM 3 & CMSX-4 interface as the overall heat input increases

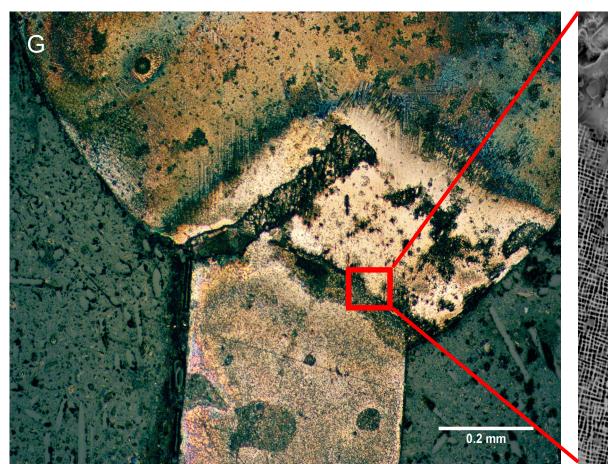
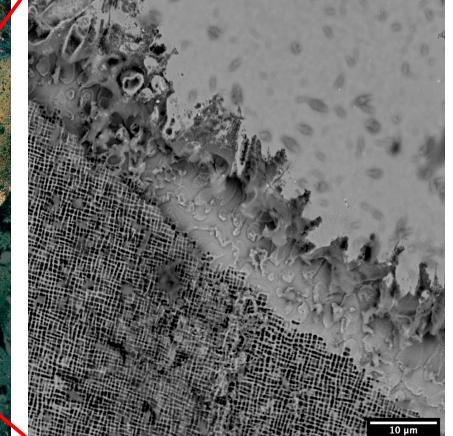
- Porosity was found at all of the interfaces regardless of the heat parameters
- All samples show columnar dendrites in the IN718-RAM3
- Size of the dendrites increase as the laser speed decreases

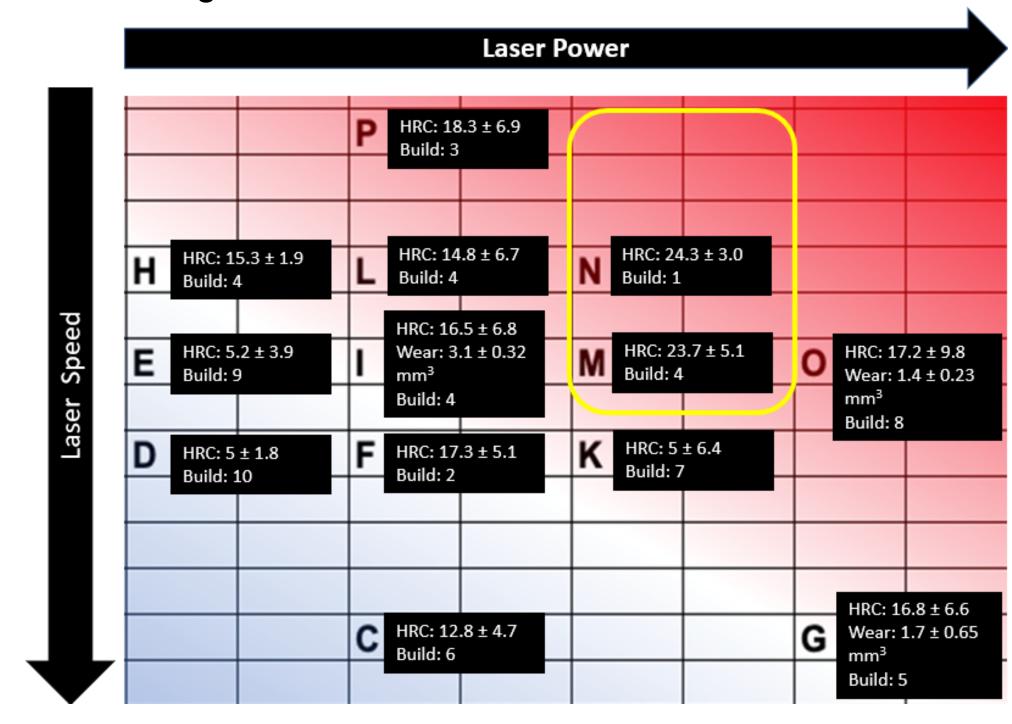
Desired: high hardness, low wear, and low build defects

- Samples N & M show the best results, as they have the highest hardness values, few or no structural defects, and are near the sample with the lowest wear (O)
- Compared to the base case (I), increasing power and having the same or lower speed provides better deposition
