Effect of Spray Angle on the Microstructure and Mechanical Properties of Suspension Plasma Sprayed Dense Vertically Cracked Yttria-Stabilized Zirconia Thermal Barrier Coatings

Student Names: Raina Shreiner Barger, Stephen Para, and Erin Verbrugge

Faculty Advisors: Professor Rodney Trice

Industrial Sponsors: Dr. Molly O'Connor*, William Jarosinski*, Dr. Stephanie Gong#, Dr. Robert Golden#

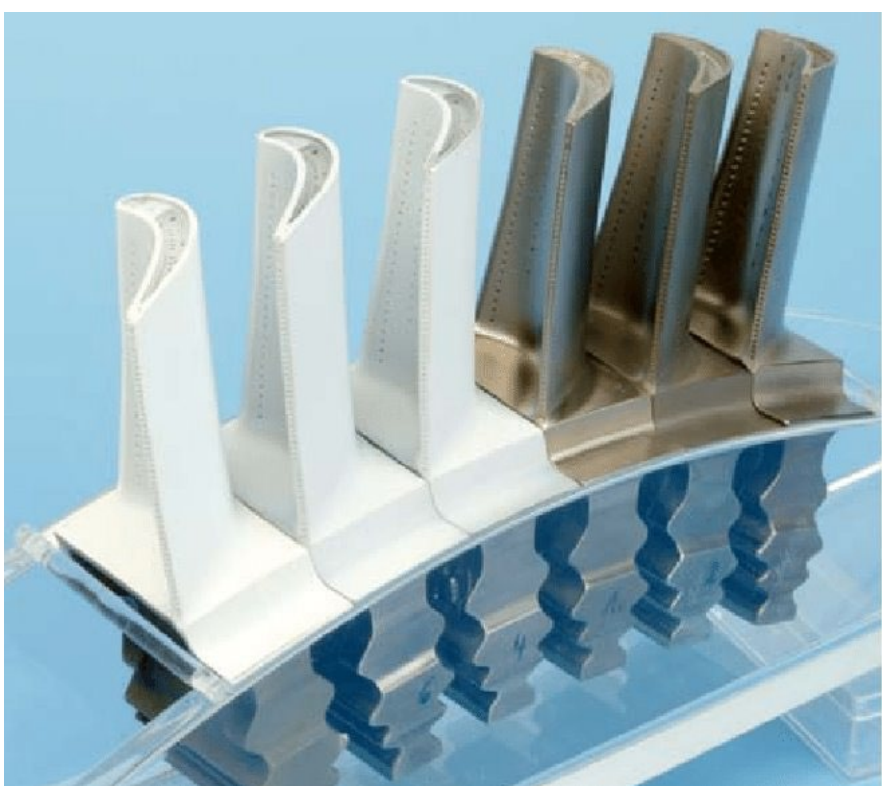
Fig. 1 Examples of coated (three blades on the left) and uncoated (three blades on right) gas turbine engine blades.

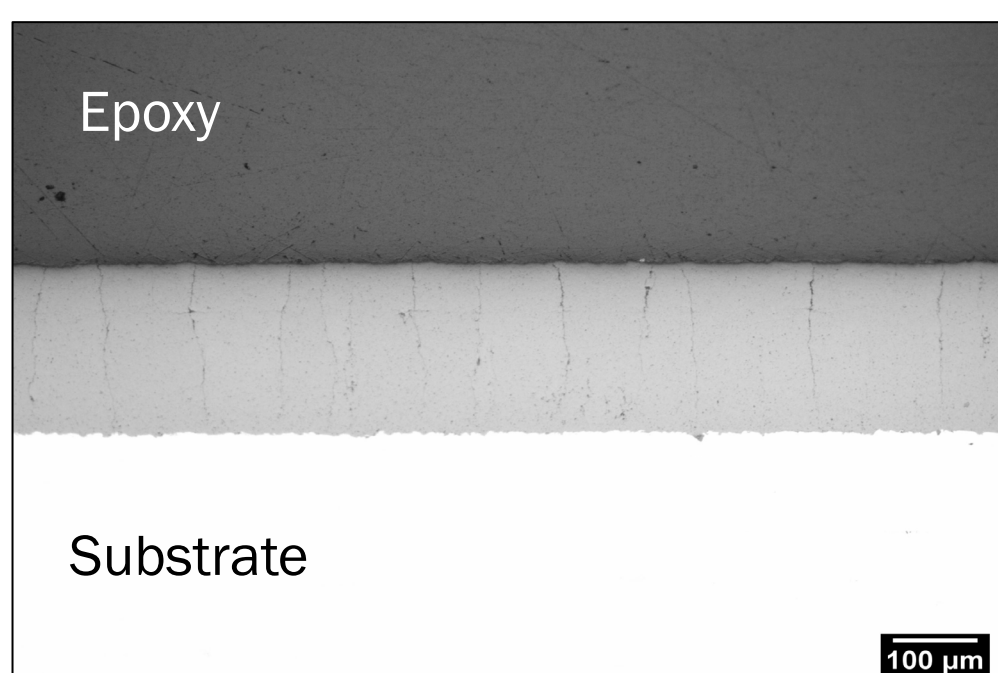
Fig. 2 Optical image of dense vertically cracked SPS YSZ coating sprayed at 90 degrees.

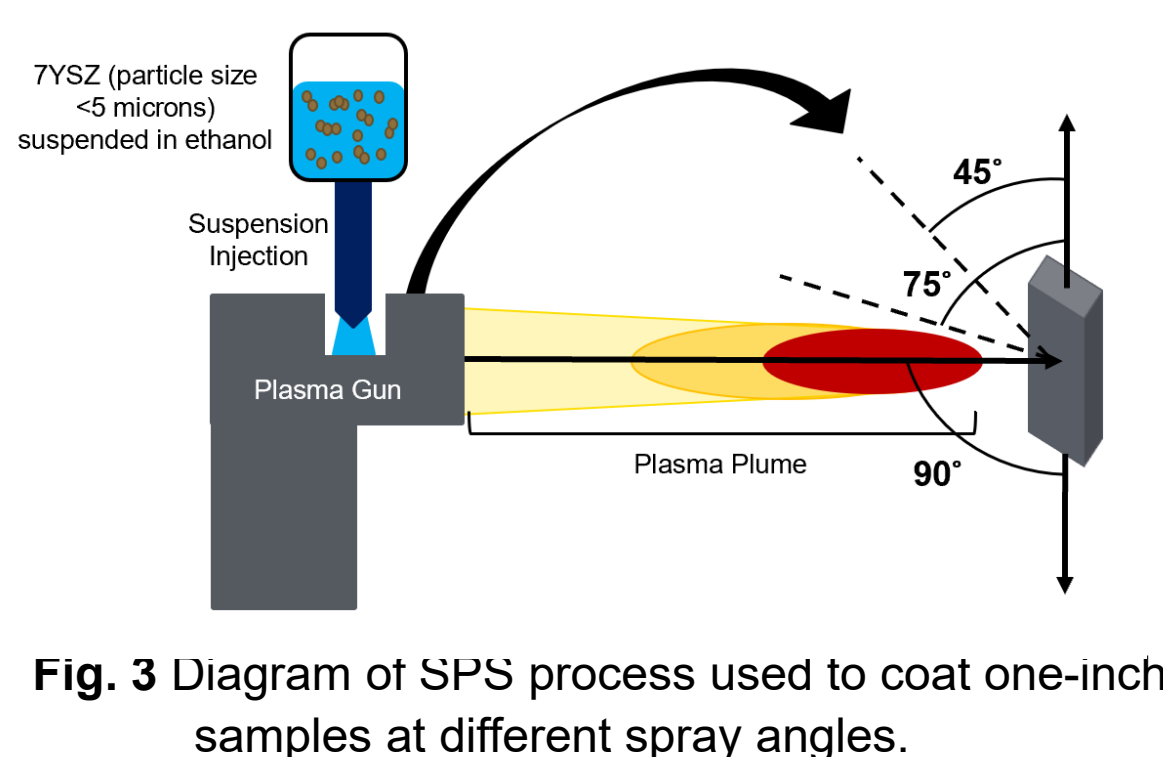
Fig. 3 Diagram of SPS process used to coat one-inch samples at different spray angles.

Sample Preparation: Test specimens were made by Praxair with a suspension plasma spray process. Particles of 7YSZ with diameters less than 5 microns were suspended in a colloidal suspension of ethanol. The solution is fed through a tube into a plasma stream of a specified velocity and power. The plasma stream vaporizes the ethanol, melts the powder into droplets and carries them to the substrate. Vertical passes were sprayed at a consistent stand-off distance onto 1"x1" tabs of a nickel superalloy at angles of 90, 75, 60, and 45 degrees, as seen in Fig. 3, to create the coatings. Eight coupons for each angle were sprayed simultaneously while rotating as shown in Fig. 7. Five coupons from each angle were mounted on their cross-section in epoxy and polished on a LECO GPX200 up to a 0.05 colloidal silica, as shown in Fig. 4. Three samples from each angle were left unmounted for surface imaging.

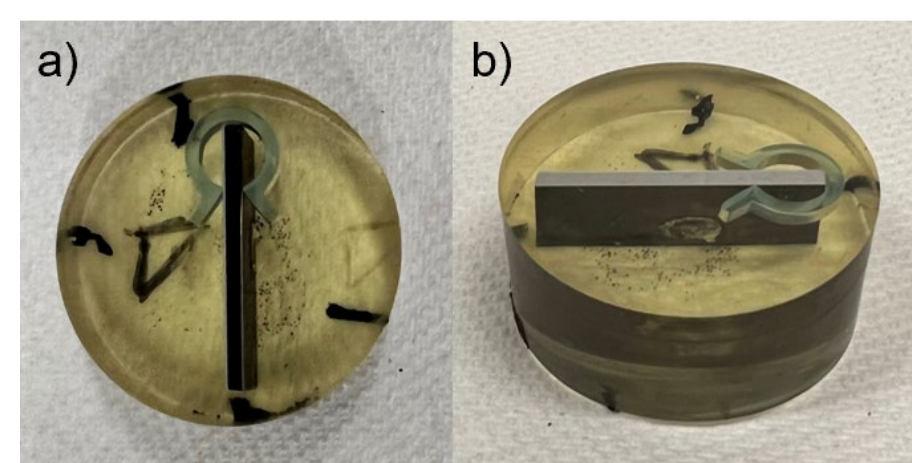
Fig. 4 Image of (a) top view and (b) side view of a mounted and polished sample.

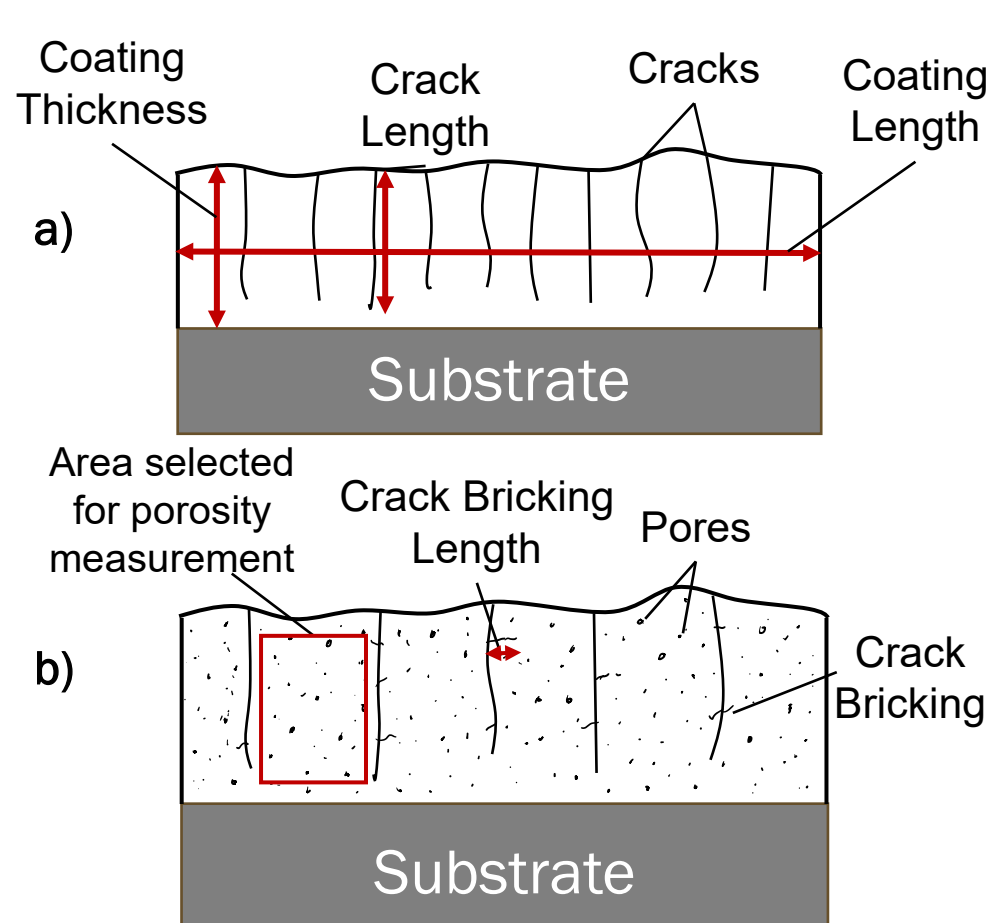
Fig. 5 Diagram of microstructural measurements taken from (a) optical images and (b) SEM images.

Microstructural Analysis: Microstructural properties including coating thickness, crack length, and crack density were measured on the optical images of sample cross-sections. Crack bricking length and porosity were measured on the SEM images. The porosity was calculated by adjusting the grayscale threshold on areas between cracks, as seen in Fig. 5, and using the particle analysis function in ImageJ. The mud cracking area was measured on the optical images of the unmounted sample surfaces. All measurements were taken using the ImageJ software.

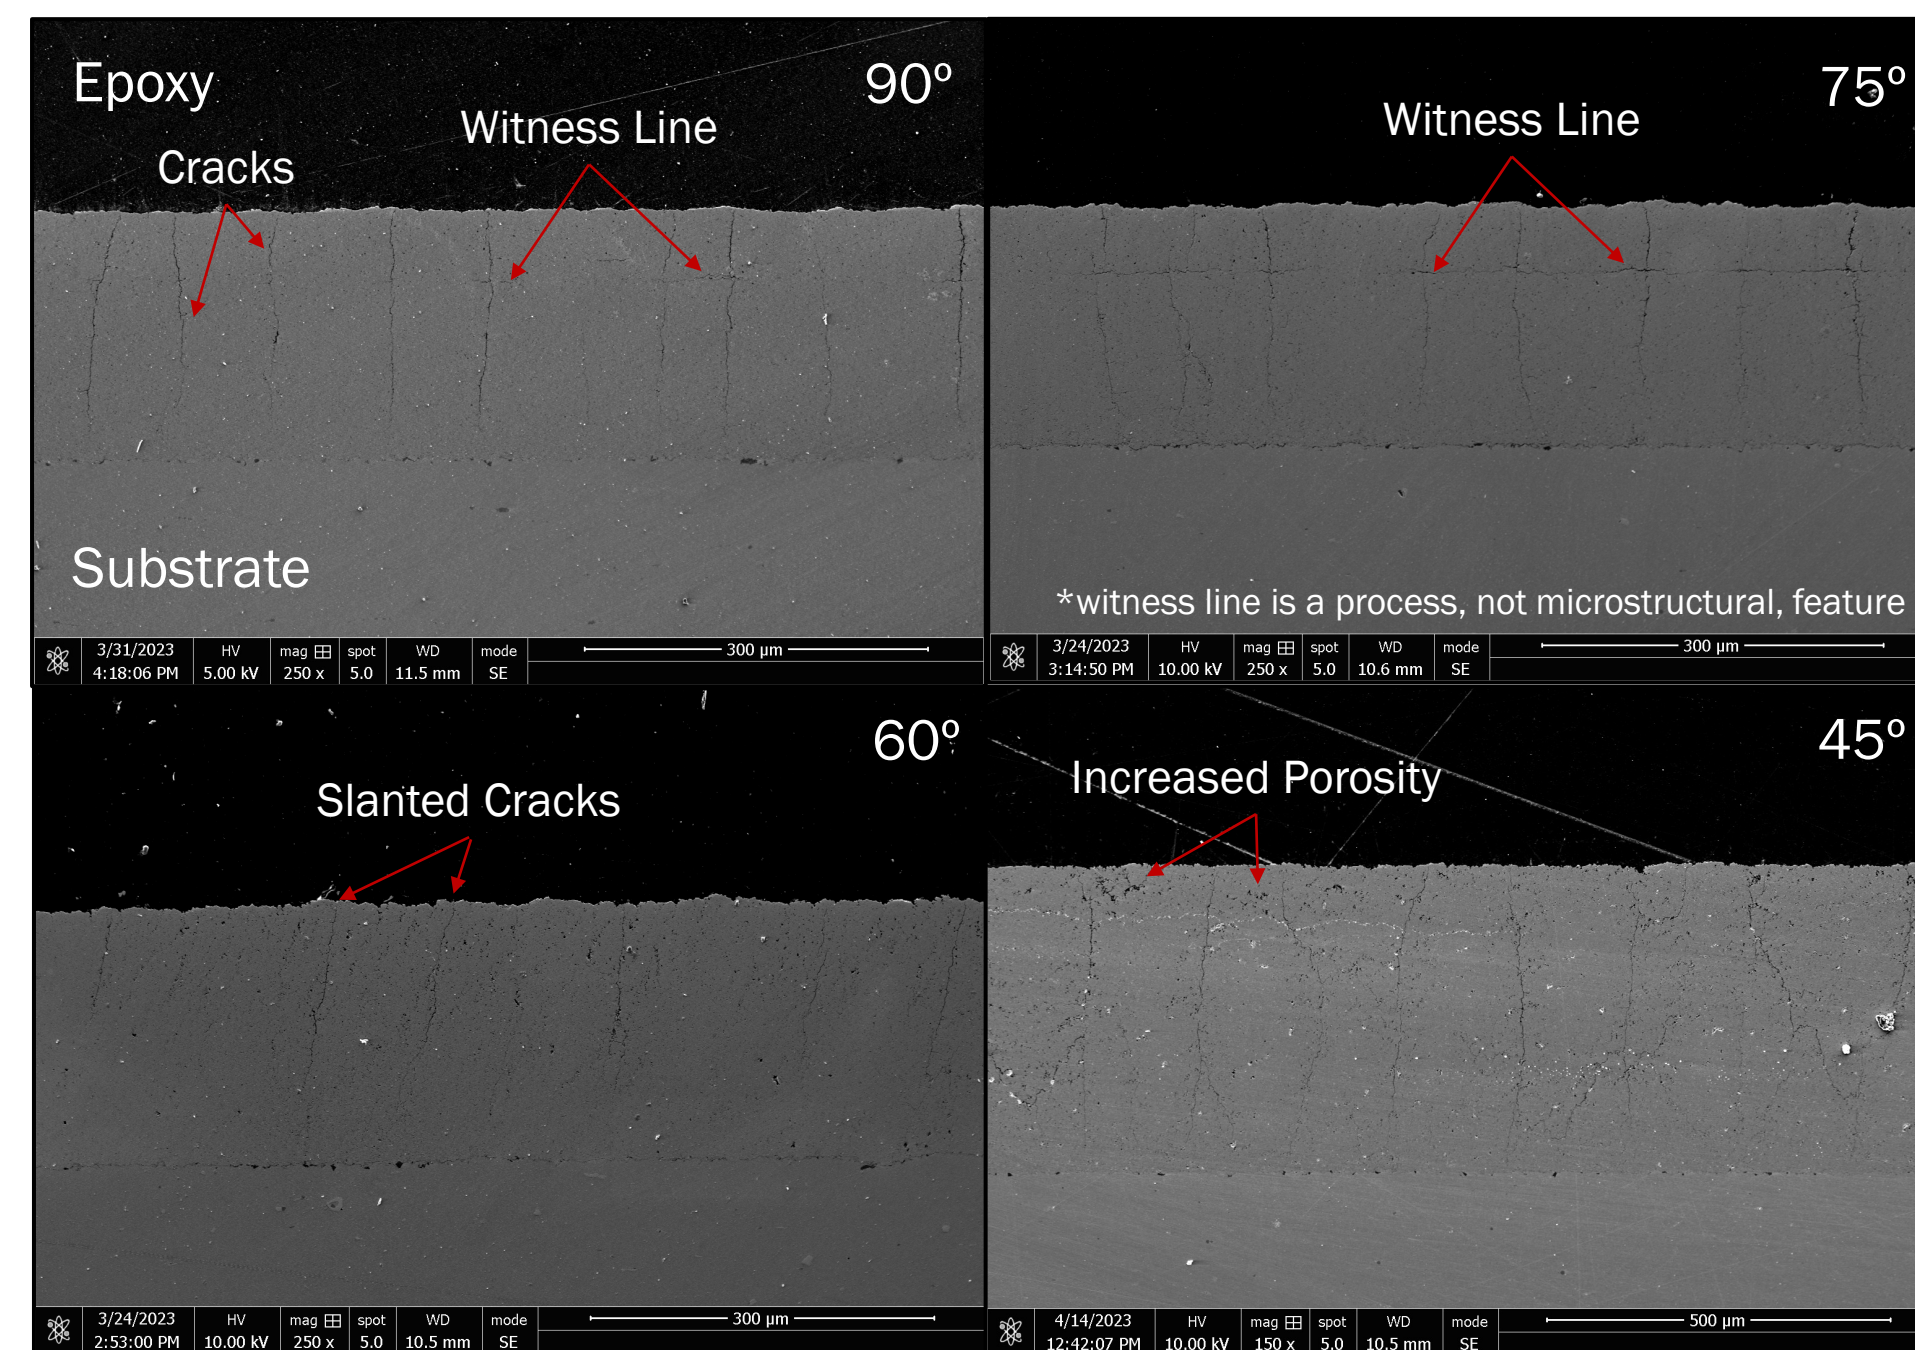
Fig. 6 SEM images of 90, 75, 60, and 45-degree spray angle coating cross-sections.

The cross-sectional SEM images shown in Fig. 6 demonstrate the dense vertically cracked microstructures observed in all respective samples sprayed at 90, 75, and 60-degrees. Observationally, the 60-degree spray angle coatings show a slight slant in the vertical cracks, decrease in crack density, and increase in porosity. The 45-degree spray angle coating also shows an increase in porosity.

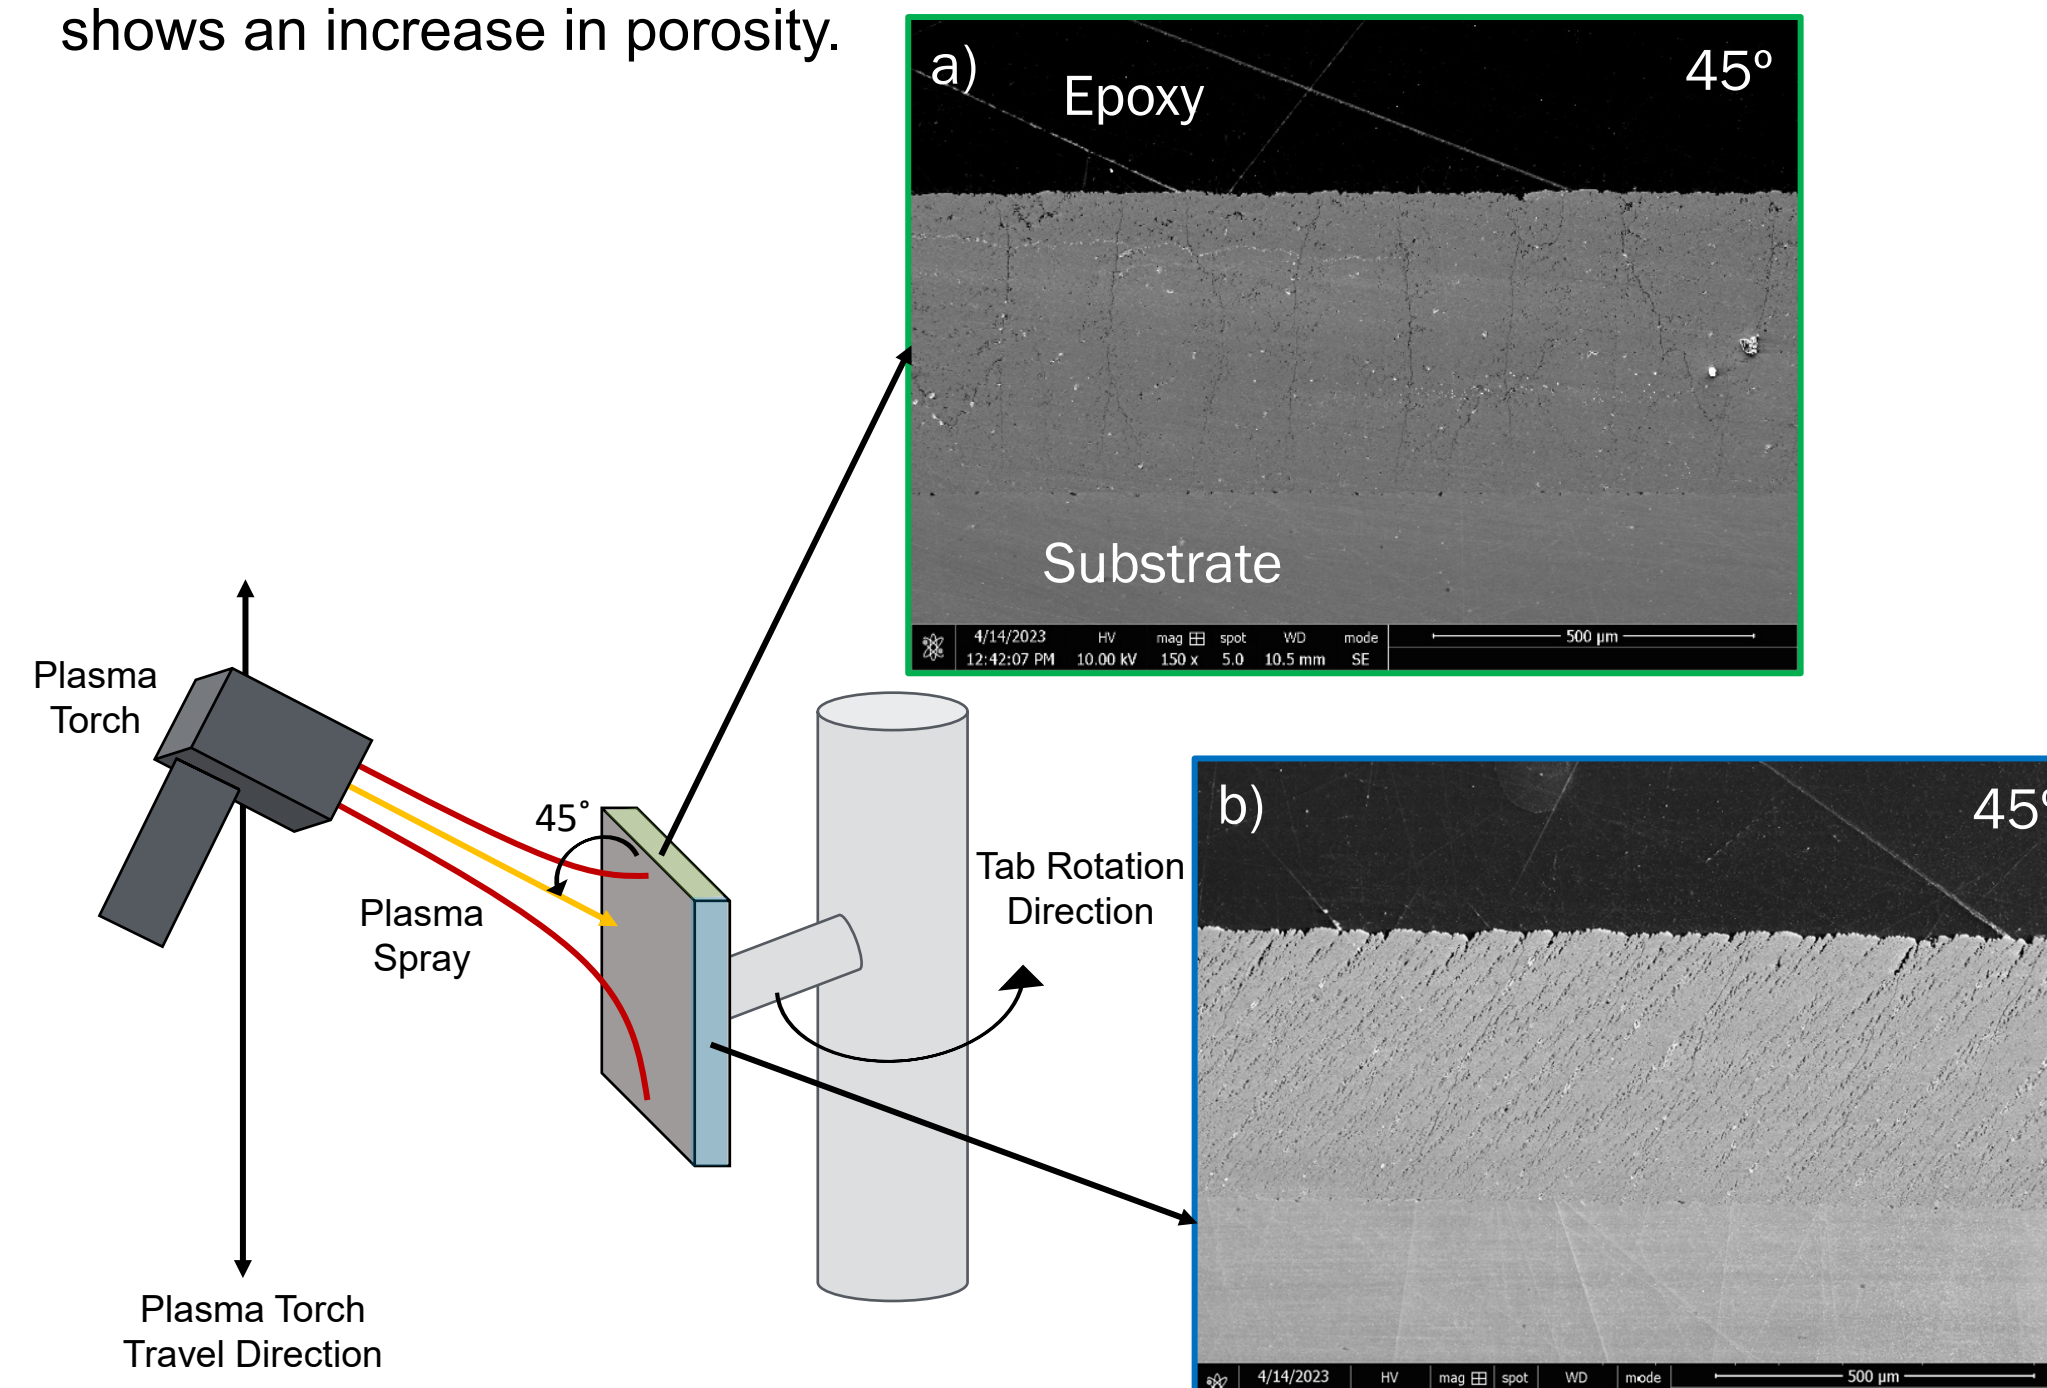
Fig. 7 Diagram of a sample sprayed at 45-degrees and the SEM images of taken of a 45-degree sample mounted on a cross-section (a) perpendicular to and (b) parallel to the plasma torch travel direction.

However, while the microstructure observed for the 90, 75, and 60-degrees was consistently DVC in all samples and locations, the observed microstructure in the 45-degree spray angle samples was dependent on the cross-sectional plane imaged. Samples mounted and imaged on a cross-sectional plane perpendicular to the axis of plasma torch travel demonstrate a DVC microstructure, shown in Fig. 7(a). Samples mounted and imaged on a plane parallel to this axis reveal a highly porous microstructure with a combination of DVC and columnar features, shown in Fig. 7(b). In this microstructure both cracks and dense areas separated by porous regions are present. The cracks and porous regions are slanted towards the spray direction.

The combination of a DVC and columnar microstructure suggests the samples sprayed at 45 degrees experienced different spray deposition behavior than the other spray angles. Possibly, at a 45-degree tilt, fewer melted droplets impacted the substrate surface with enough momentum to exit the plasma plume and adhere directly to the surface. Instead, plasma drag forces cause these droplets to travel parallel to the surface, where they impacted and grew at surface asperities. This deposition behavior could result in columns of dense and porous regions, slanted in the spray direction, within a dense vertically cracked coating.

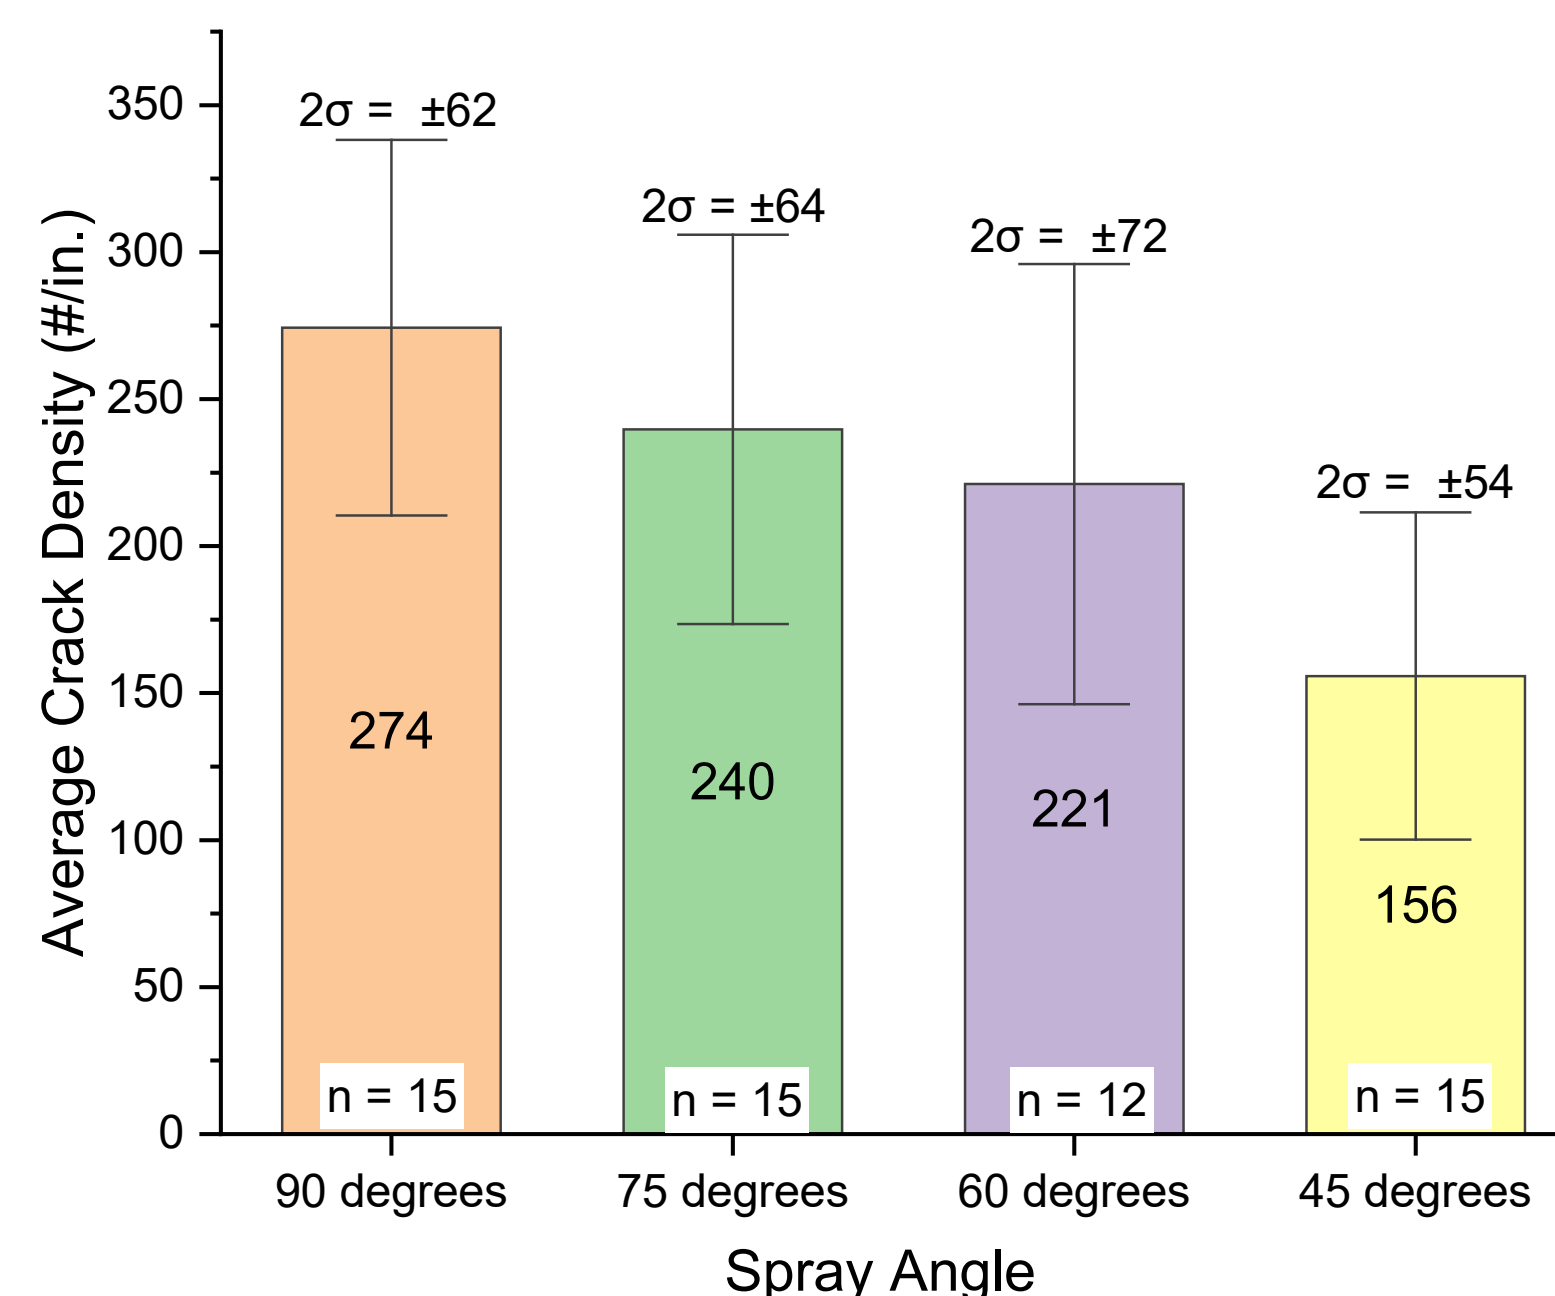
Fig. 8 Plot of average crack density versus spray angle with error bars representing two standard deviations.

Fig. 8 shows the continuous decrease in average crack density with spray angle, the largest drop being at 45-degrees. Potentially, as the angle of incidence becomes shallow enough to introduce a high amount of porosity, as seen in the 45-degree samples, the porous regions prevent the growth of cracks during coating cooling. A lower crack density may limit the strain tolerance of coatings during thermal expansion of the substrate.

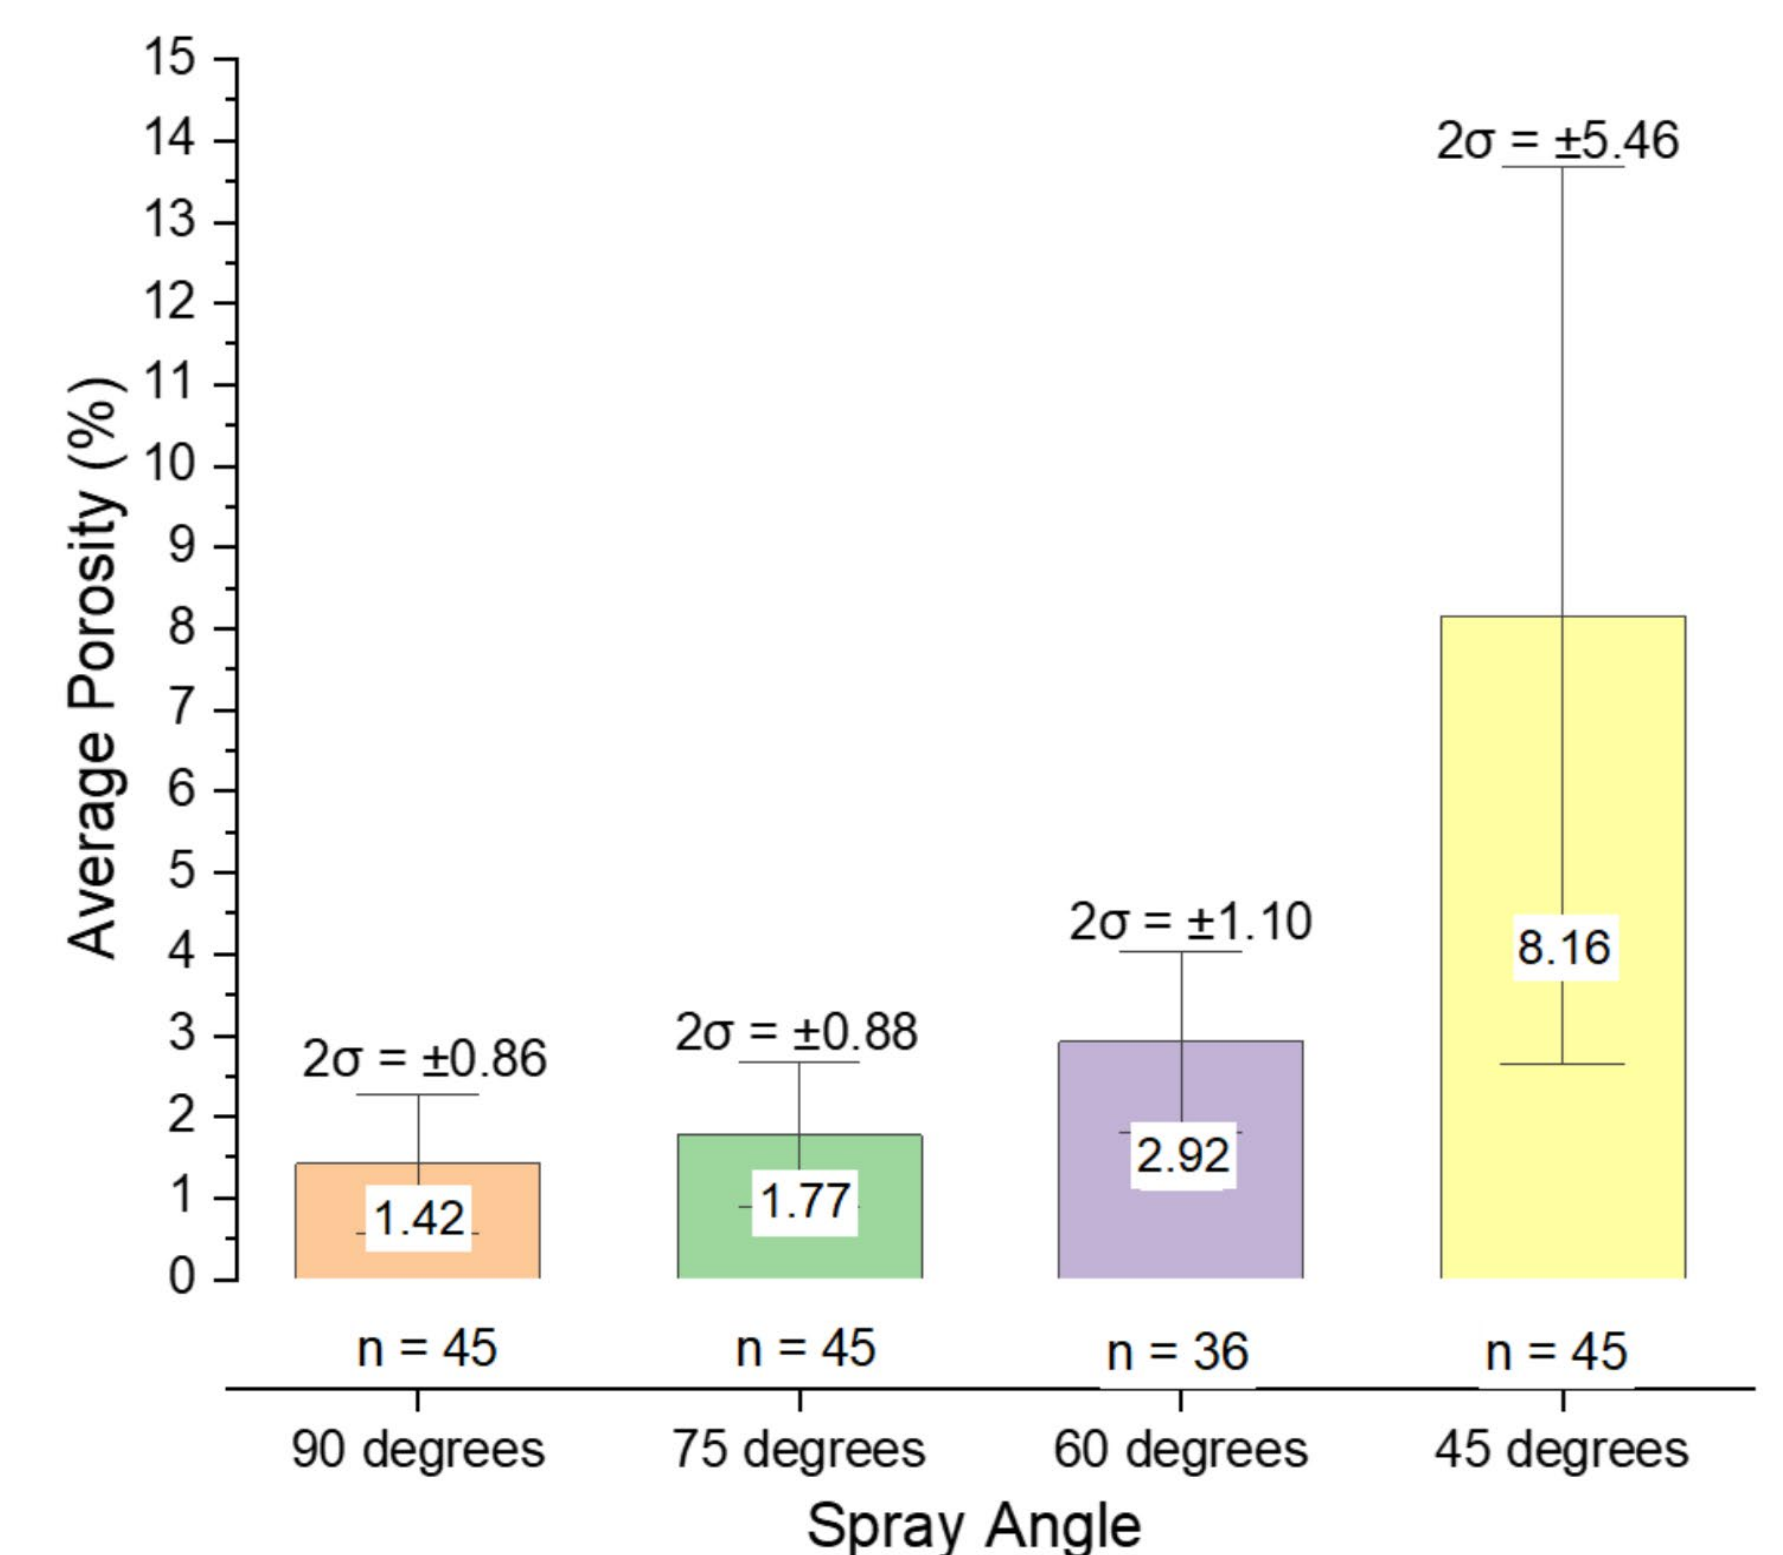
Fig. 9 Plot of average porosity versus spray angle with error bars representing two standard deviations

The average porosity measured from the cross-sectional SEM images is similar between samples sprayed at 90 and 75 degrees. The average porosity increases for the 60-degree spray angle samples by roughly 1.2 to 1.5%. The average porosity increases more for the 45-degree spray angle samples, by almost 5%, due to the development of a combination of columnar and DVC microstructures. Increases in porosity are concerning for mechanical properties such as hardness and coating adhesion strength. The porosity standard deviation for the 45-degree spray angle samples is also much larger than the others, suggesting more variation in porosity and microstructure within the 45-degree spray angle samples.

Fig. 10 demonstrates a slight decrease in average Vickers hardness from 1026 to 984 to 940 MPa exhibited by coatings sprayed at 90, 75, and 60-degree spray angles, respectively, in keeping with the porosities presented in Fig. 9. However, the 45-degree samples exhibited an average hardness of 710 MPa. This decrease in hardness is resultant of the large porosity increase in the DVC-columnar microstructure formed when the incident angle was decreased to 45 degrees. The 45-degree sample data set also demonstrated a wider range in hardness, as shown by the larger standard deviation.

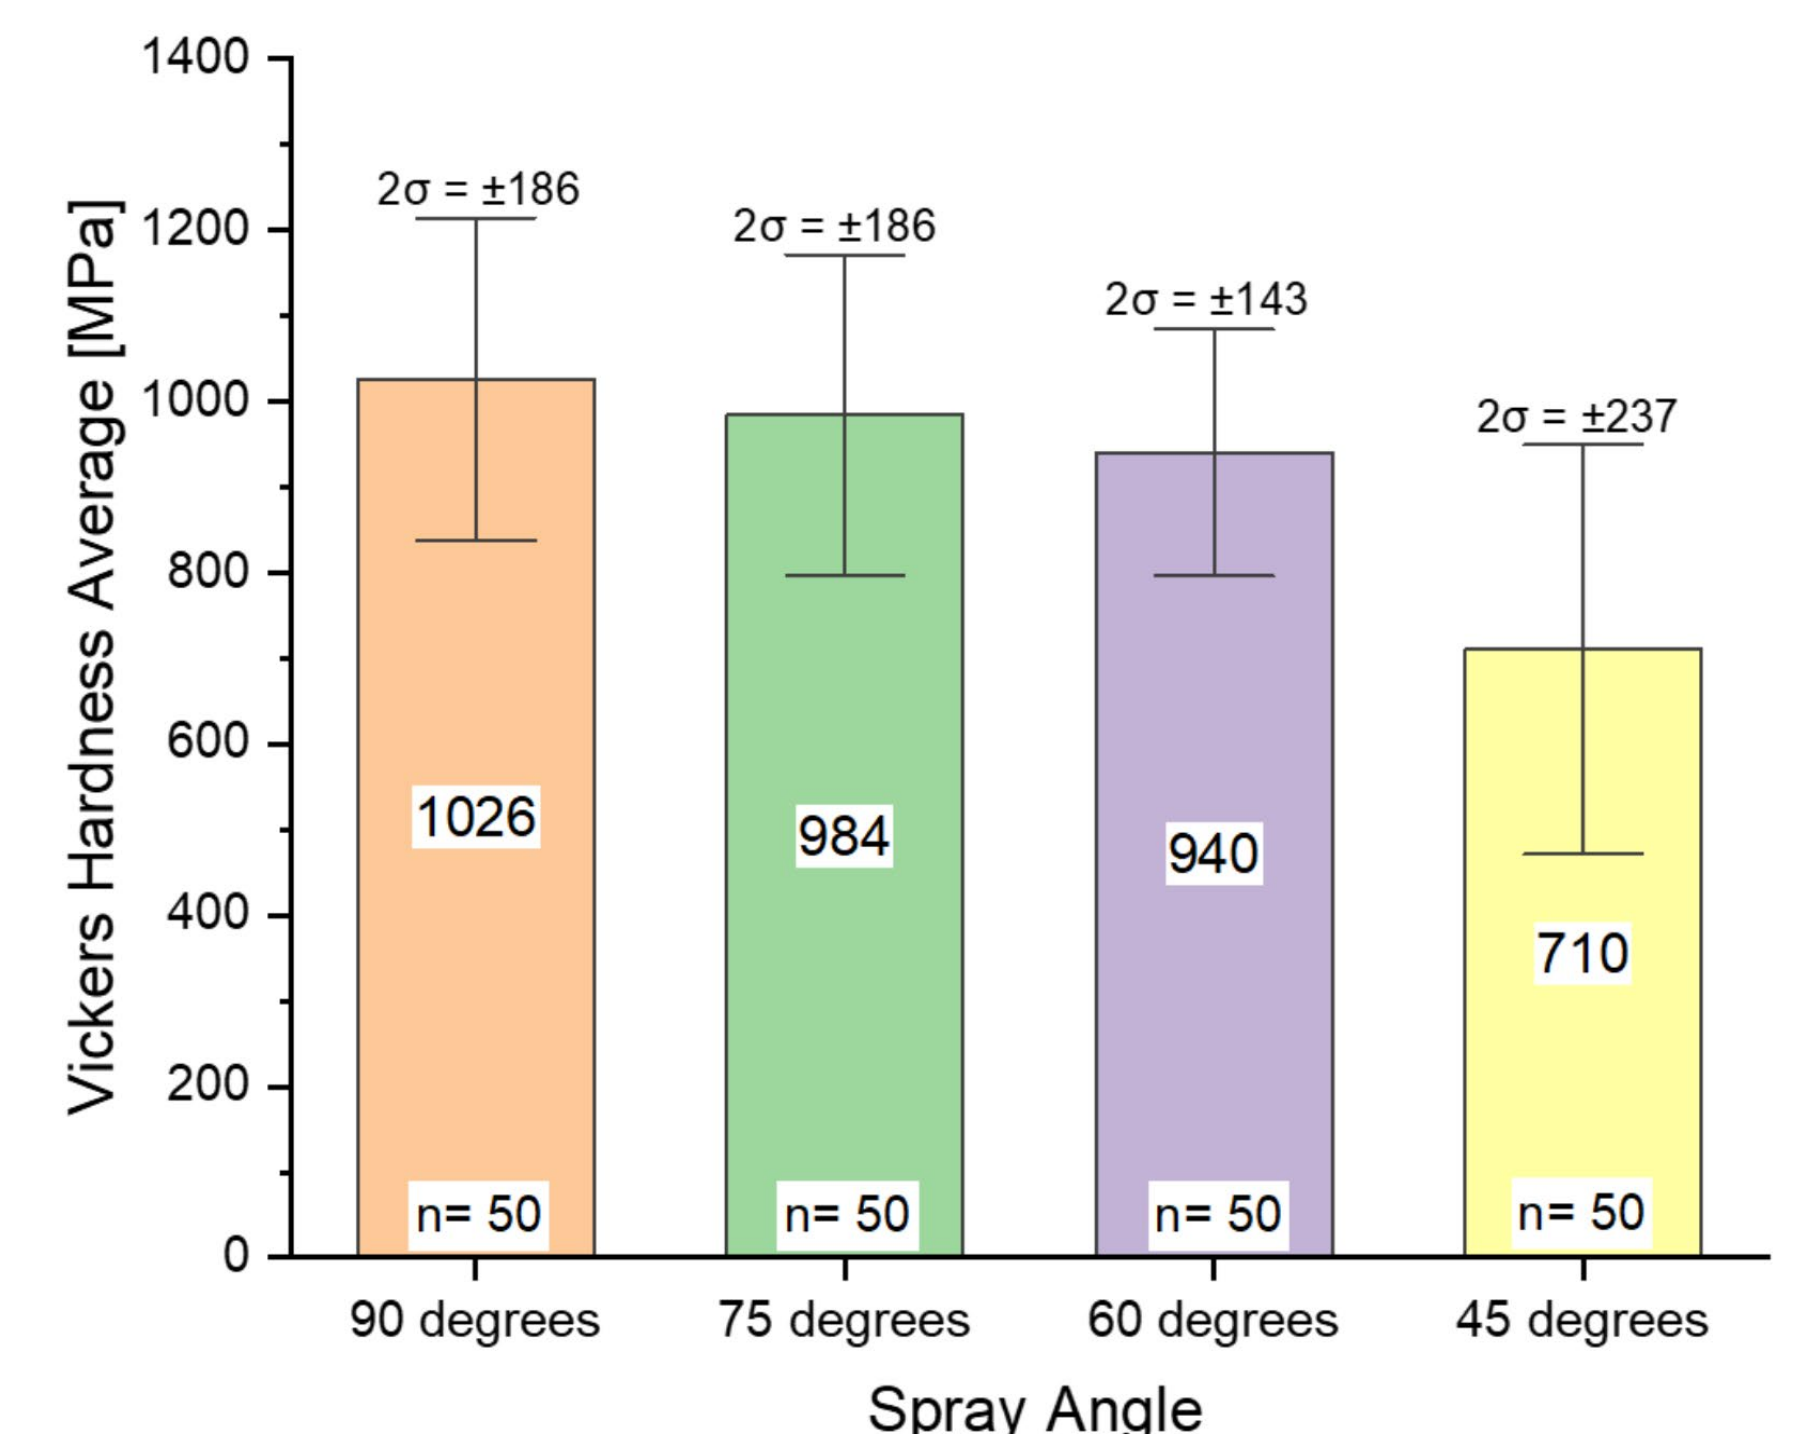
Fig. 10 Plot of average hardness (Vickers) versus spray angle with error bars representing two standard deviations

The results of this investigation demonstrate that spray angle impacts the microstructure and hardness of SPS DVC YSZ coatings. Coatings sprayed at angles of 90, 75, and 60-degrees produced DVC microstructures across 1 square inch surfaces with acceptable crack lengths and densities. Coatings sprayed at 60 degrees showed a slight slant in vertical cracks and increase in porosity, resulting in a small decrease in average hardness. The most obvious microstructural differences were observed in the samples sprayed at 45 degrees. SEM images of cross-sectional planes parallel and perpendicular to the torch travel direction show a mix between a DVC and columnar microstructure in which slanted columns of dense and porous regions are present within dense areas with vertical cracks. The mixed microstructure likely resulted from deposition of droplets both directly upon surface impact and at surface asperities while travelling parallel to the surface still within the plasma plume. The DVC and columnar microstructure combination resulted in an increase in porosity of roughly 5 to 7% and a decrease in average hardness of roughly 230 to 310 MPa in coatings sprayed at 45 degrees.
