11th PURDUE GEOTECHNICAL SOCIETY WORKSHOP

Important Role of Filters in Hydraulic Soil Structures

**Hamid Fallah
Apr. 19, 2013**

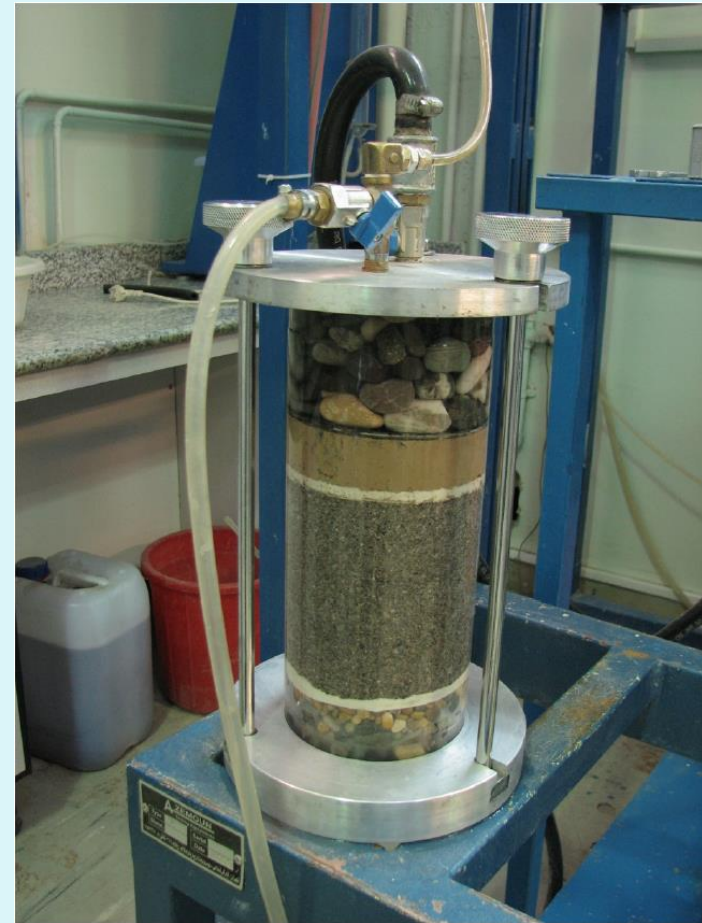
NEF test facility

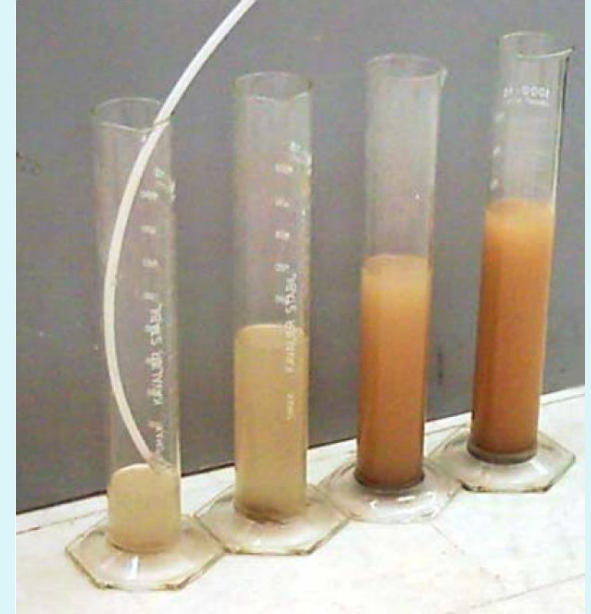
NEF test results (Yasrobi and azad, 2006):

- (a) Base soil after **successful** test,
- (b) Base soil after **unsuccessful** test,
- (c) The **output water** for 4 minutes.

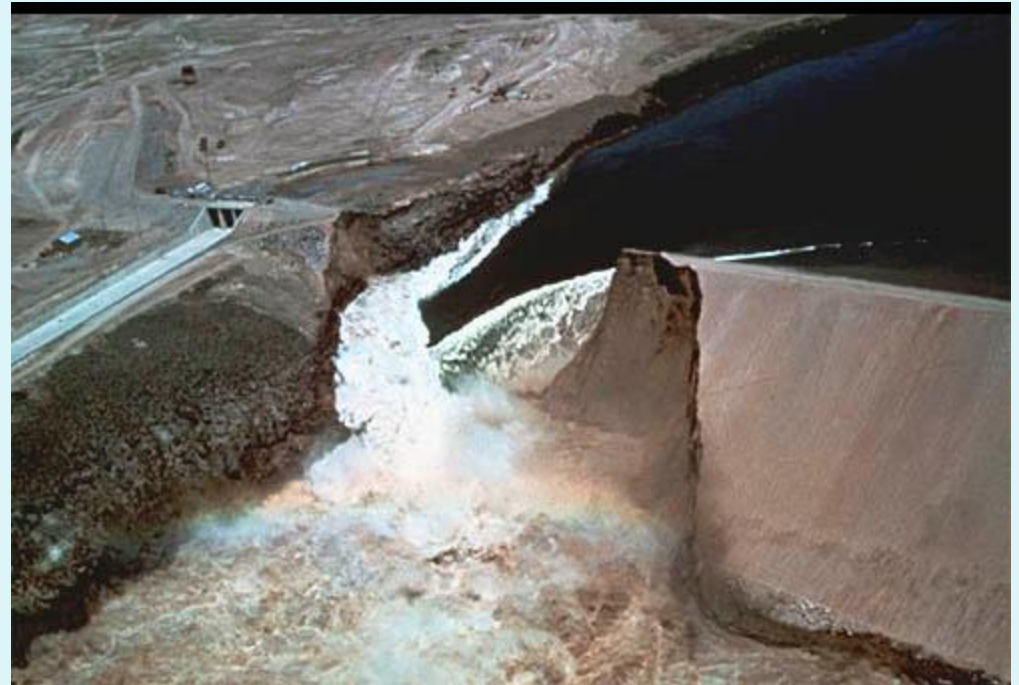
Main causes of failure (Seed and Duncan, 1981):

- Seepage under the grout cap in unsealed bedrock joints (**not** covered with **filter**), leading to erosion and **pipng failure** through the key trench fill
- **Pipng** through **cracks** caused by hydraulic fracturing or differential settlement

- **7:00** – Water was flowing from d/s face, 130 ft below the crest (about 2 ft³/s)
- **10:30** – Flow rate increased to 15 ft³/s, with a loud burst
- **11:20** – The eroded hole was so large that bulldozers sank into the flow.
- **11:55** – Dam crest was breached and complete failure occurred.
- Failure caused **14** losses of life plus **~\$1 billion** in damage

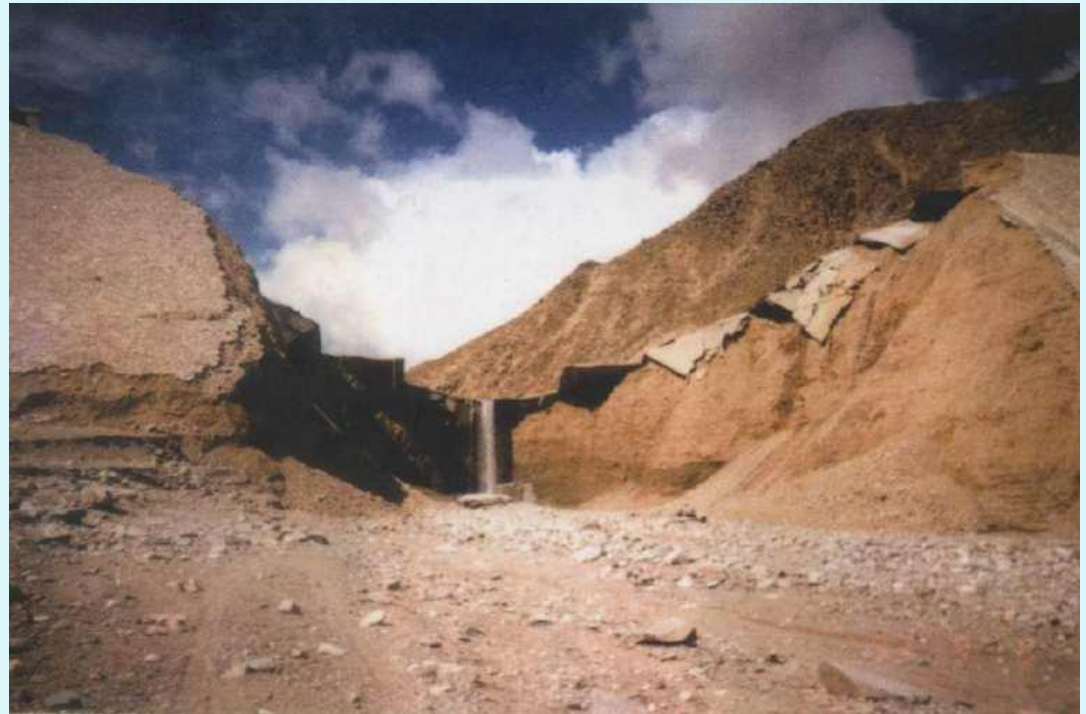
Main causes of failure:

- **Defective** parapet wall-concrete face connection
- **Separation** of concrete face from cushion
- Seepage **channels** through stratified rockfill
- Lack of proper drainage and **filter** action

- **12:00** – water level reached to El. 3277.30 m (0.7 m below NWL) for the first time – water started flowing into the dam, from the parapet wall-concrete face joint.
- **20:00** – seeped water was observed on d/s slope, El. 3260.00
- **21:00** – protection stones started rolling down.
- **22:40** – dam breached
- Loss of life: **288**
