# Evaluation of Exposures to Styrene During Ultraviolet Cured-in-place Pipe Installation

Report No. 2018-0009-3334  
March 2019

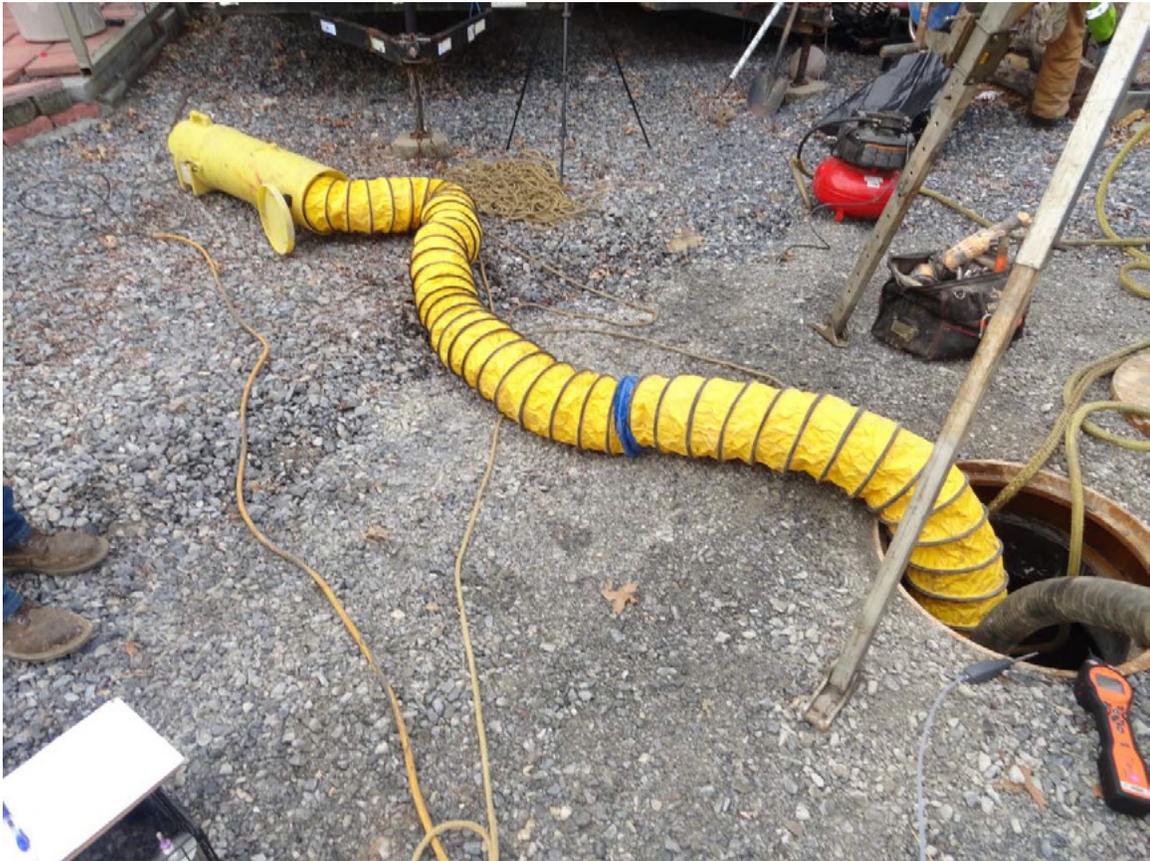
Figure 2. Manhole ventilation blower used to provide dilution ventilation to manhole during CIPP installation tasks, February 6, 2018.
