Mode I Fracture Toughness of a Small-Grained Silicon Nitride: Orientation, Temperature, and Crack Length Effects

Rodney W. Trice^{*,†} and John W. Halloran^{*}

Materials Science and Engineering Department, University of Michigan, Ann Arbor, Michigan 48109-2136

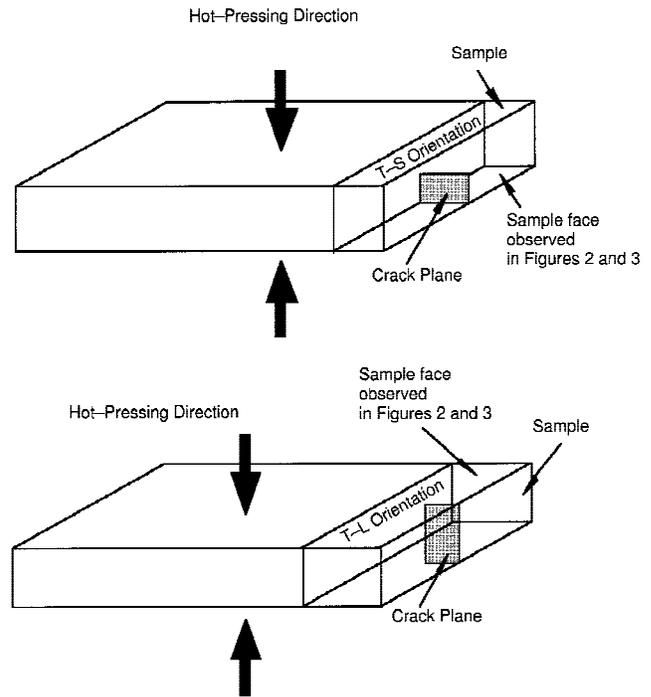
Fig. 1. Schematic indicating two specimen orientations with respect to hot-pressing direction used in the present study. Designations were taken from the ASTM Provisional Standard, C28.01.¹⁵

The two different orientations investigated relative to the hot-pressing direction are defined in Fig. 1. In the T–S orientation, crack growth occurs parallel to the hot-pressing direction, while in the T–L orientation, crack growth occurs perpendicular to the hot-pressing direction.

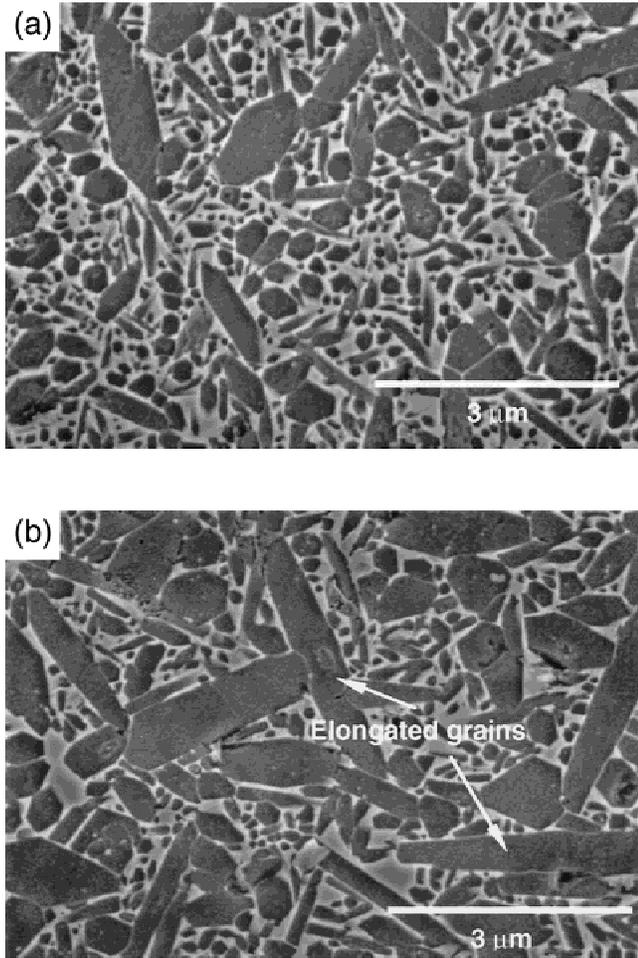
Fig. 2. SEM micrographs of plasma-etched samples indicating the microstructure of (a) T-S and (b) T-L orientations.

Figure 2 shows SEM micrographs of plasma-etched samples for both orientations. The orientation of these images relative to the crack propagation direction is shown in Fig. 1. Both

micrographs reveal predominately small grains with apparent diameters of 0.2–0.4 μm with a few larger 0.6–1.2 μm diameter grains. Of those grains oriented with their long axis parallel to the micrograph, apparent grain lengths vary between 1 and 3 μm , resulting in an aspect ratio of $\sim 2\text{--}8$. More Si_3N_4 grains are oriented lengthwise within the plane of crack growth for the T–L orientation as compared to the T–S orientation.

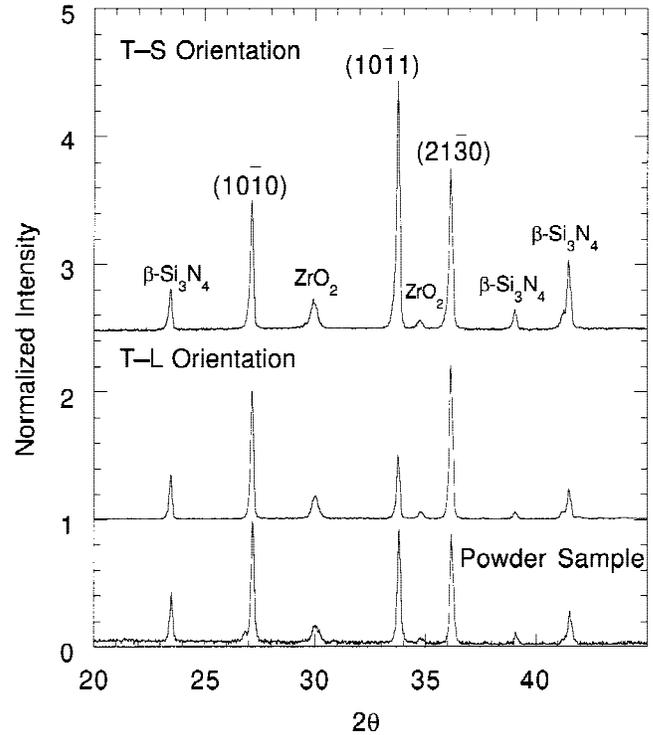
Fig. 3. Comparison of both specimen orientations to a random powder sample reveals texturing. Intensities are normalized to the (1010) plane of $\beta\text{-Si}_3\text{N}_4$. (ZrO_2 is a contaminant from ball milling.)

XRD was used to further demonstrate the differences in orientation. The surface represented in Fig. 2 was chosen for analysis. Figure 3 shows XRD patterns from a powder sample, a T–S-oriented sample, and a T–L-oriented sample with intensities normalized to the $(10\bar{1}0)$ peak of $\beta\text{-Si}_3\text{N}_4$. ZrO_2 was present because of milling media contamination. The relative intensities of a randomly oriented powder sample of $\beta\text{-Si}_3\text{N}_4$ were 100%, 99%, and 93% for the $(10\bar{1}0)$, $(10\bar{1}1)$, and $(21\bar{3}0)$ planes,²⁰ respectively. For samples in the T–S orientation, there was a preference for $(10\bar{1}1)$ -oriented planes. In the T–L orientation, the $(10\bar{1}0)$ and $(21\bar{3}0)$ planes were favored. Thus, the T–L orientation should have more elongated $\beta\text{-Si}_3\text{N}_4$ grains than the T–S orientation, consistent with microscopy observations.

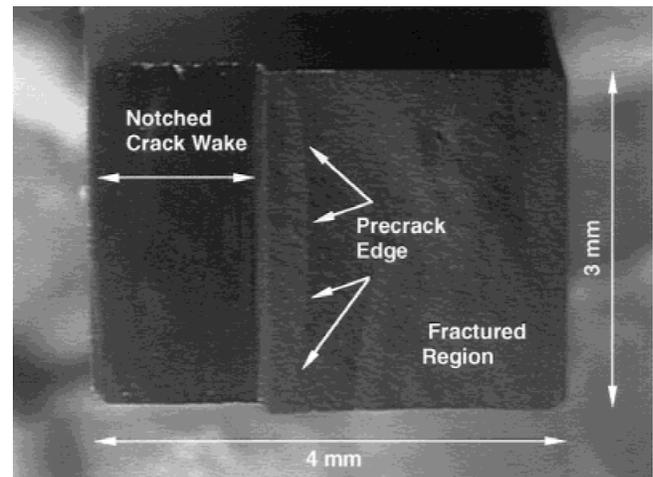
Fig. 4. Optical image of SEPFB fractured at 25°C. Original precrack, machined notch to remove the crack wake, and fracture surface are all visible.

(A) *Short Crack Fracture Toughness at 25° and 100°C:* Figure 4 is an optical micrograph of a fracture surface from an SEPB tested at 25°C. From the figure, the initial precrack, the subsequent notch to remove the crack wake, and the fracture surface are visible. The crack length is 340 μm for this sample.

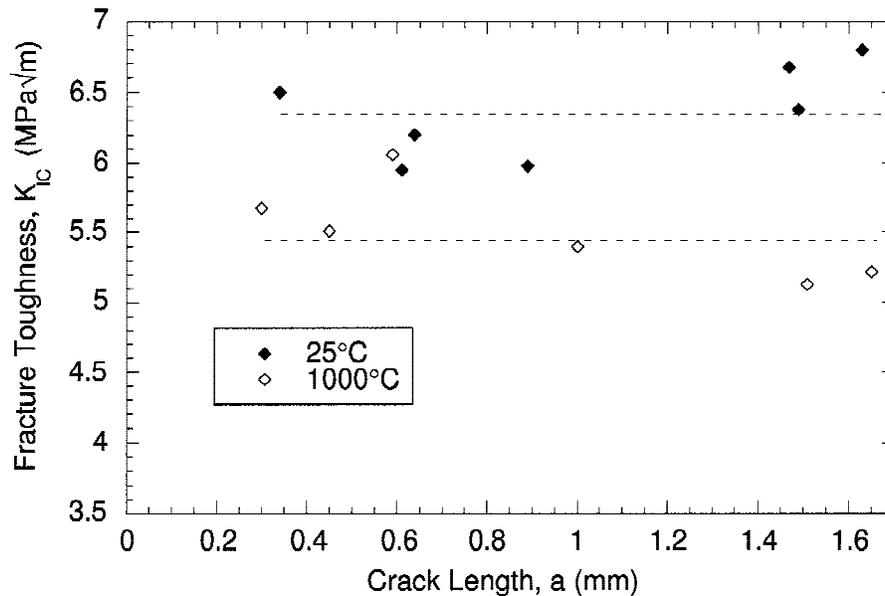
Fig. 5. Plot of K_{IC} as a function of crack length at 25° and 1000°C. No rising R -curve behavior was observed for cracks ≥ 300 μm .

Figure 5 presents K_{IC} as a function of crack length at 25° and 1000°C. The results indicate that no R -curve behavior was observed for cracks as short as 300 μm at either temperature. Previous researchers have shown that the rising trend in K_{IC} with crack length was steeper for a small-grained Si_3N_4 as compared to a coarser-grained Si_3N_4 .³ In their study, a small-

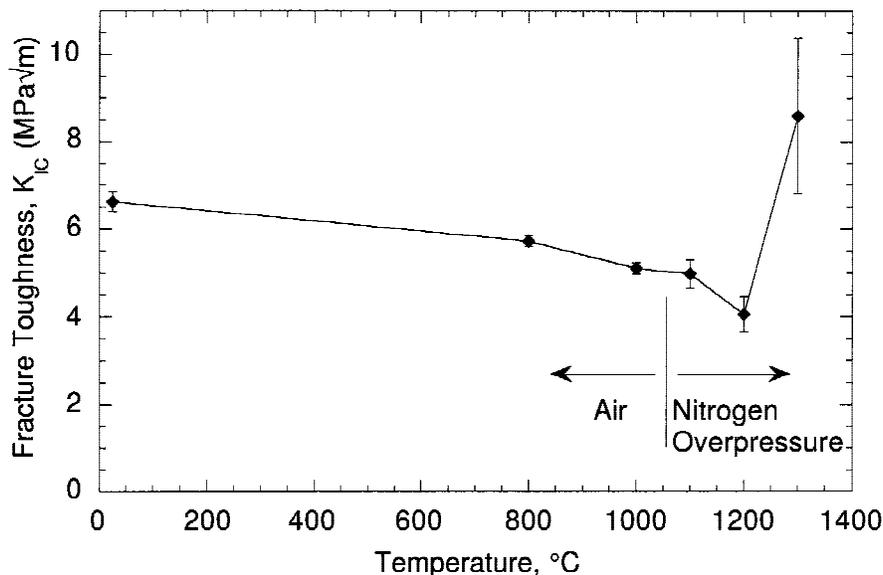
Fig. 6. K_{IC} of T-S-oriented samples as a function of temperature. All crack lengths were between 1.4 and 2.0 mm.

(B) *Long Crack Fracture Toughness between 25° and 1300°C:* The temperature-dependent K_{IC} values in the T-S orientation are shown in Fig. 6. All samples tested between 25° and 1000°C were tested in air. Samples tested between 1100° and 1300°C were tested in nitrogen to prevent the precrack from healing. A general decrease in K_{IC} was observed from $6.6 \pm 0.2\ \text{MPa}\cdot\text{m}^{1/2}$ at 25°C to $4.1 \pm 0.4\ \text{MPa}\cdot\text{m}^{1/2}$ at 1200°C. A sharp increase in toughness was observed at 1300°C to $8.6 \pm 1.8\ \text{MPa}\cdot\text{m}^{1/2}$. These trends compared well with those in the literature.^{12,13}

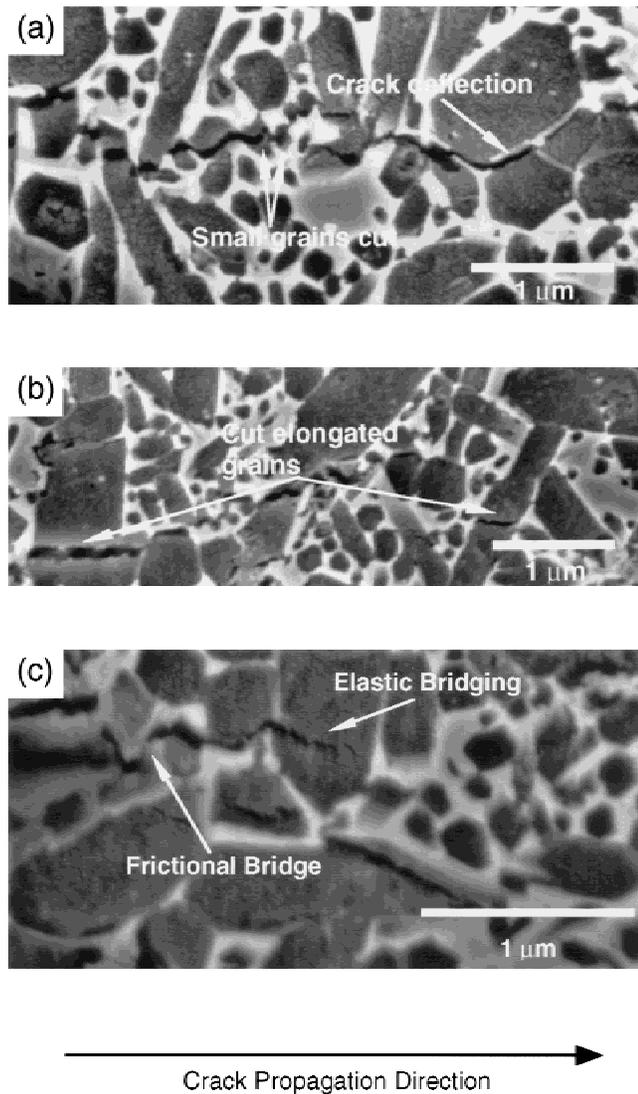
Fig. 7. Plasma-etched micrographs of samples in the T-S orientation near the edge of the crack tip. These samples were tested at 25°C. Crack deflection, elastic bridging, and frictional grain bridges were observed.

(a) *Toughening Mechanisms at 25°C:* Figure 7 shows several plasma-etched T-S-oriented samples near the crack tip. Because all SEPFB samples fracture into two pieces during testing, these micrographs are taken from samples that were cracked via an indentation load. Crack deflection, elastic bridging, and frictional grain bridges were observed. Figure 7(a) shows that the crack tends to be deflected around larger grains ($>0.4\ \mu\text{m}$), while smaller grains are cut by the crack. Furthermore, Fig. 7(b) reveals that it is energetically favorable for the crack to cut elongated Si_3N_4 grains as wide as $0.7\ \mu\text{m}$ rather than be deflected by them or pull them out. Elastic bridging

and frictional grain bridges, as shown in Fig. 7(c), are also observed.

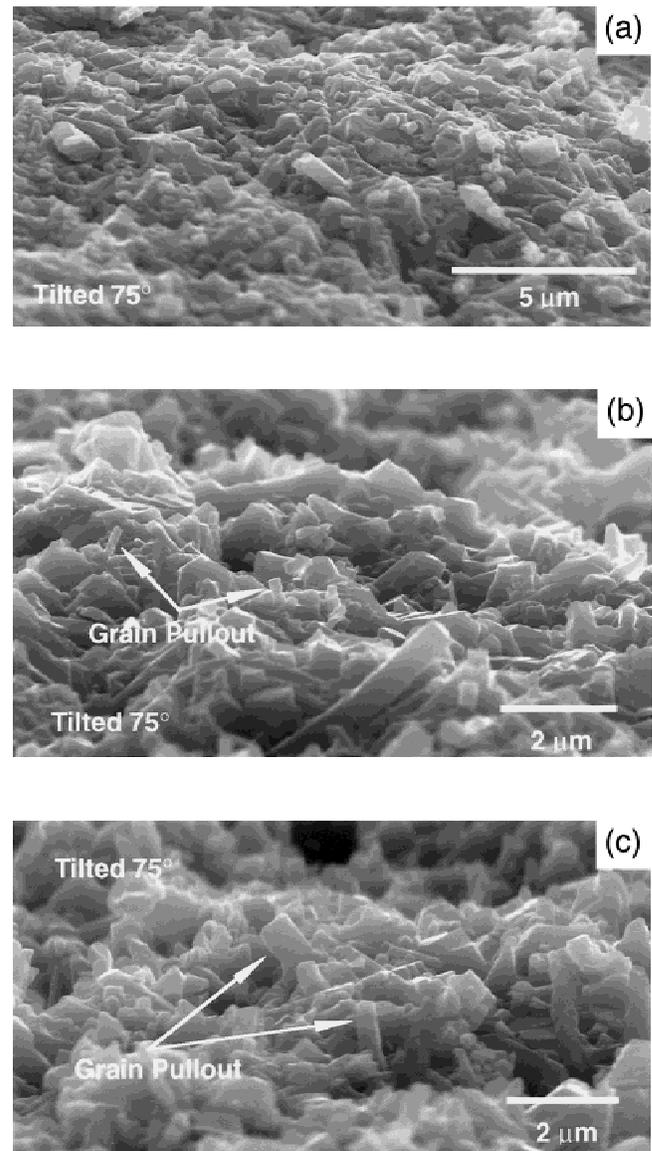
Fig. 8. Typical fracture surfaces of T-S-oriented SEP specimen tested at (a) 25°, (b) 800°, and (c) 1200°C. In each micrograph, the specimen was tilted 75° to reveal the texture of the surface. Large grains of Si_3N_4 were pulled out during fracture at both 800° and 1200°C.

(b) *Effect of Temperature on Toughening Mechanisms:* A typical fracture surface of a T-S-oriented sample tested at 25°C is shown in Fig. 8(a). The fracture surface was tilted 75° to reveal the surface texture. There were no Si_3N_4 grains pulled out during fracture, consistent with Fig. 7 observations of etched samples.

As temperature was increased from 25°C, a change in toughening mechanisms was observed. Consider Fig. 8(b), the fracture surface of a specimen tested at 800°C, tilted at a 75° angle. Large grains ($>0.8\text{--}1\ \mu\text{m}$) oriented perpendicular to the fracture plane were still cut by the propagating crack, as at room temperature. However, very small grains ($<0.3\ \mu\text{m}$) oriented

Figure 8(c) reveals the typical fracture surface of a specimen tested in nitrogen at 1200°C. Faceting of the surface is observed similar to those samples tested at 800°C, with extensive pull out observed for grains ≤ 0.6 μm . The failure surface observations made on samples tested at 1200°C are consistent with continued softening of the amorphous grain-boundary phase. The initial consequence of grain-boundary softening is decreased K_{IC} , as observed in Fig. 6.

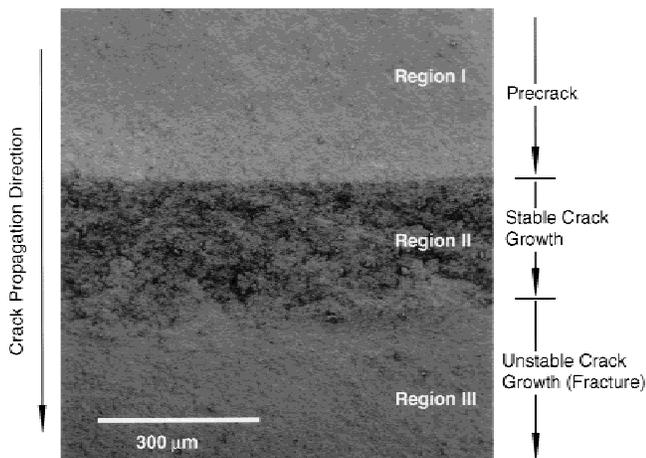
Fig. 9. T–S-oriented fracture surface at 1300°C for a specimen tested in nitrogen. Three distinct regions were observed.

tested at 1300°C. This is revealed in the microstructure, as shown in Fig. 9. The surface texture reveals three distinct regions. Region I is the initial precrack that was created at room temperature, while regions II and III are the areas of stable and unstable crack extension, respectively.

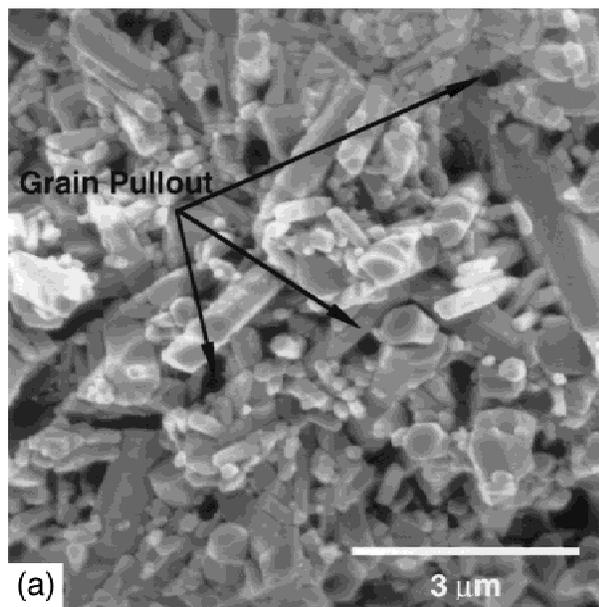
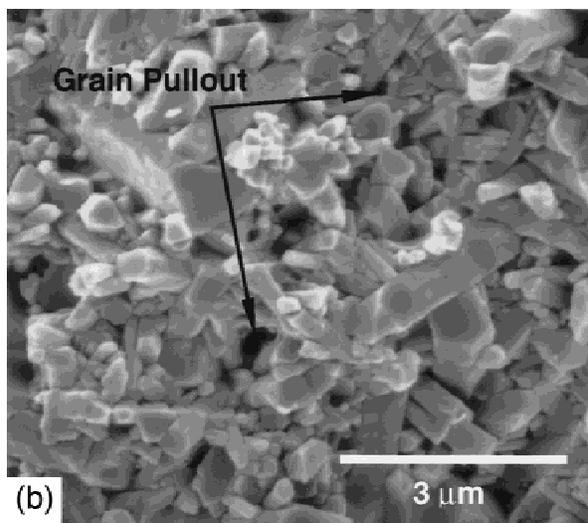
Fig. 10. Comparison of fracture surfaces from specimens tested at 1300°C in (a) region II (stable crack growth) and (b) region III (unstable crack growth) in the T–S orientation. Extensive crack deflection and grain pull out were observed in both.

Region II behavior indicates that cracks in Si_3N_4 at 1300°C can grow slowly under applied stress intensity values well below the critical stress intensity. For example, a stress intensity of 6.7 ± 1.7 $\text{MPa}\cdot\text{m}^{1/2}$ initiates crack growth at this temperature, but a stress intensity of 8.6 ± 1.8 $\text{MPa}\cdot\text{m}^{1/2}$ is ultimately required for fracture. Region II behavior has been observed previously¹³ and was attributed to reorientation of individual grains of Si_3N_4 under the imposed tensile stresses. Figure 10 is a comparison of region II and region III fracture surfaces. In both micrographs, extensive crack deflection and pull out are observed.

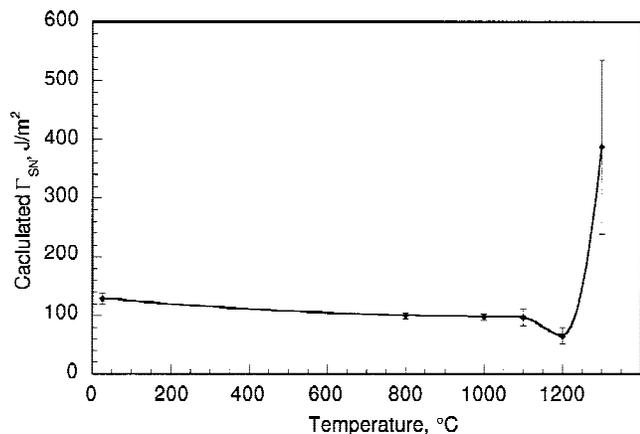
Fig. 11. Fracture energy, Γ_{SN} , in the T-S orientation as a function of temperature.

where ν was Poisson's ratio, and E the longitudinal Young's modulus, varied for each temperature of interest. Poisson's ratio for Si_3N_4 was assumed to be constant with temperature and equal to 0.27.²¹ The change in modulus with temperature²² for this composition of Si_3N_4 is presented in Table I. The calculated results are plotted in Fig. 11.

Fracture energy at 25°C is 129 ± 9 J/m², which compares well with literature values.²³ The fracture energy decreases to 100 ± 5 J/m² at 800°C and remains essentially constant through 1100°C. A significant drop in Γ_{SN} is observed at 1200°C, to 65 ± 15 J/m², before rapidly increasing to 390 ± 150 J/m² at 1300°C. The mechanistic reasons for the decrease and then increase in Γ_{SN} have been attributed to softening of the glassy phase and reorientation of the elongated Si_3N_4 grains, respectively.¹³

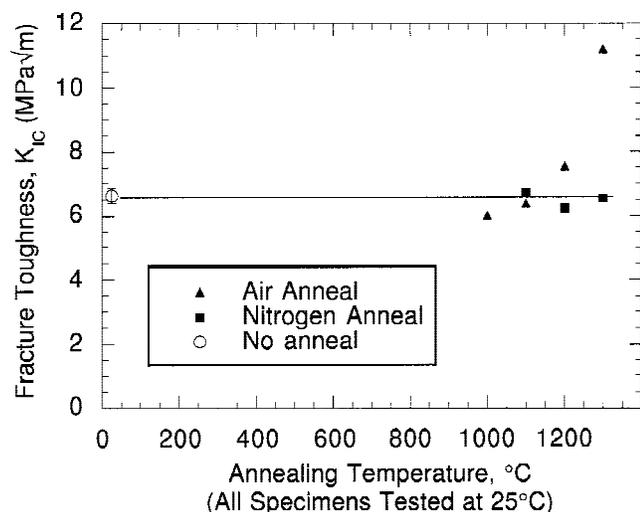
Fig. 12. K_{Ic} as a function of anneal temperature in air for the T-S orientation. Samples annealed in air showed evidence of crack healing, beginning at 1100°C, with marked increases in toughness observed at 1200° and 1300°C.

The crack healing phenomena for a more refractory composition of Si_3N_4 was investigated in this series of experiments, where precracked SEP samples were heated in 1 h to temperatures ranging from 1000° through 1300°C in air or nitrogen, held for 10 min, then furnace cooled. The annealed specimens were then tested at ambient temperatures. These results were compared to those for unannealed specimens tested at 25°C, as shown in Fig. 12. All crack lengths were >1.4 mm.

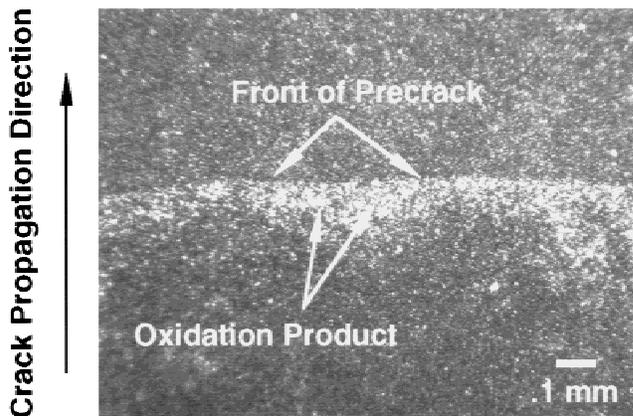
Fig. 13. Fracture surface of a sample annealed at 1300°C in air then tested at room temperature. An oxidation product was observed behind the original precrack.

Figure 13 reveals the fracture surface of a specimen annealed at 1300°C in air and subsequently tested at 25°C, revealing an oxidation product existing *behind* the original tip of the precrack. SEM investigation of this area revealed a glazed surface. Previous research on a similar composition of Si_3N_4 ²⁵ indicated that the final phases formed during oxidation are cristobalite and yttrium silicate.

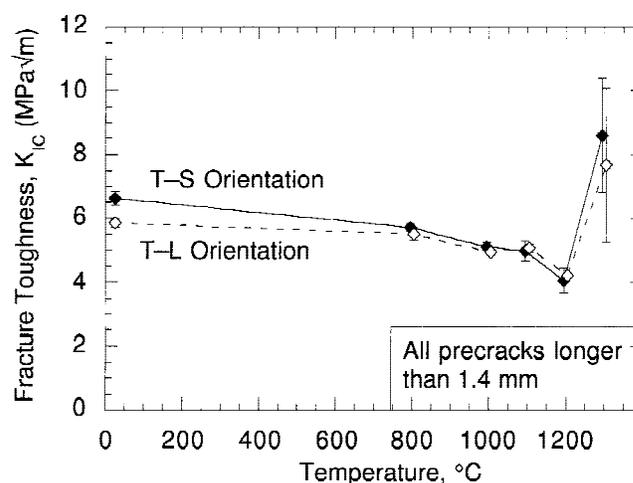
Fig. 14. Plot of K_{Ic} as a function of temperature for both orientations investigated. Some of the data points have been offset slightly for clarity.

The long crack K_{IC} data with respect to orientation and temperature are plotted in Fig. 14. The measured toughness in the T–L orientation at 25°C was $5.9 \pm 0.1 \text{ MPa}\cdot\text{m}^{1/2}$. This value remained essentially constant through 800°C. K_{IC} values of 5.0 ± 0.1 and $5.1 \pm 0.1 \text{ MPa}\cdot\text{m}^{1/2}$ were measured at 1000° and 1100°C, respectively. A sharp decrease in K_{IC} was observed near 1200°C to $4.2 \pm 0.01 \text{ MPa}\cdot\text{m}^{1/2}$, before increasing to $7.7 \pm 2.4 \text{ MPa}\cdot\text{m}^{1/2}$ at 1300°C.
