### Wildfires and their effects on potable water systems

Andrew J. Whelton, Ph.D. Civil, Environmental, and Ecological Engineering

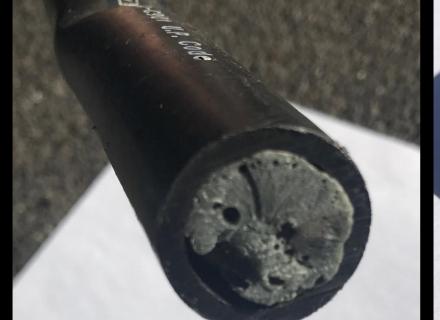
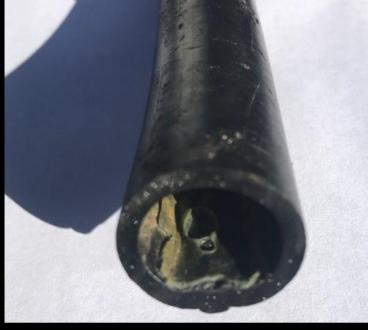
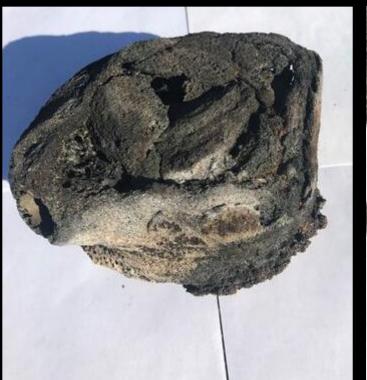
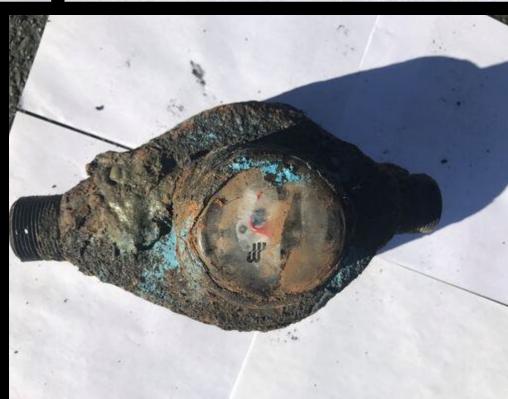
# Damage

90%+ of their
172 mile water
distribution
system was
depressurized for
hours to weeks

100s+ of leaks

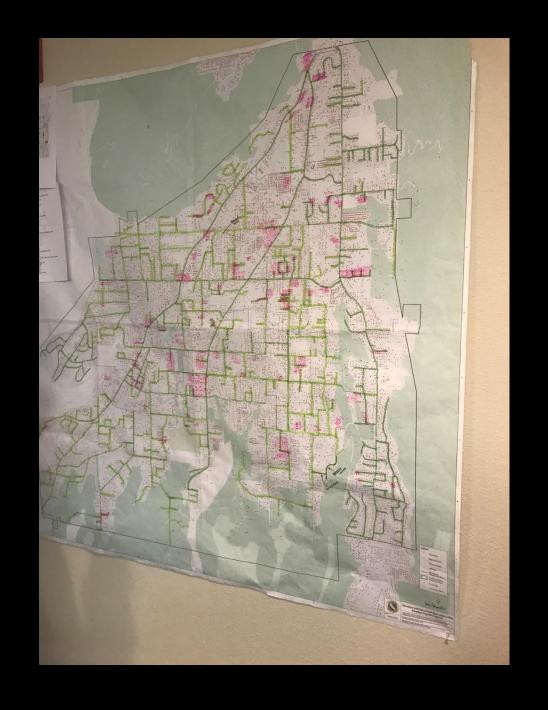
90%+ of their 172 mile water distribution system depressurized for hours to weeks

100s+ of leaks

Standing homes were scattered throughout the contaminated water systems: PID Example

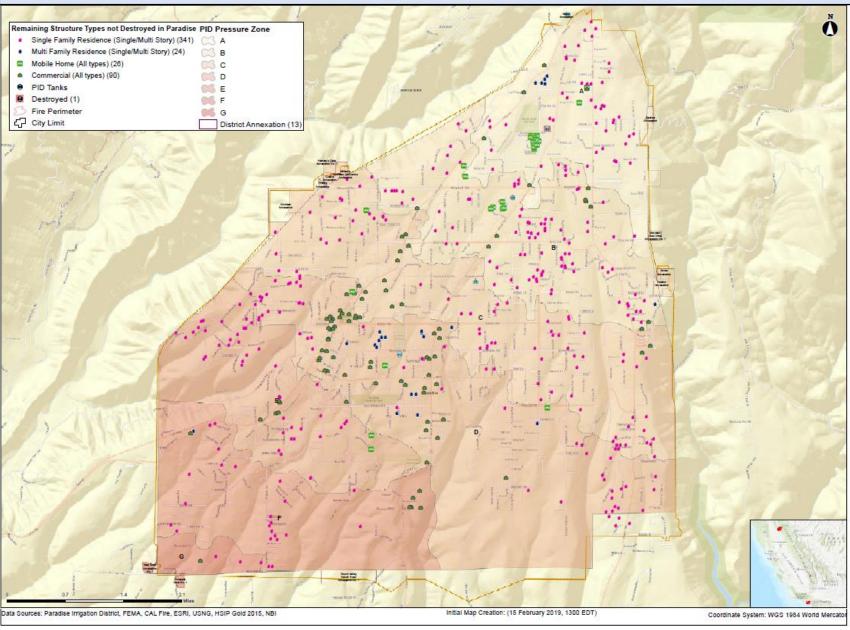
#### **PID Pressure Zones vs. Standing Structures**

2 sources1 treatment plant

7 pressure zones
172 miles of buried pipe
PVC (35%)
Steel (33%)
CML (19%)
AC (10%)
Irons (6%)
1,400 fire hydrants
10,600 service lines and meters
Cu, Brass, GIP,

GSP, HDPE, PB

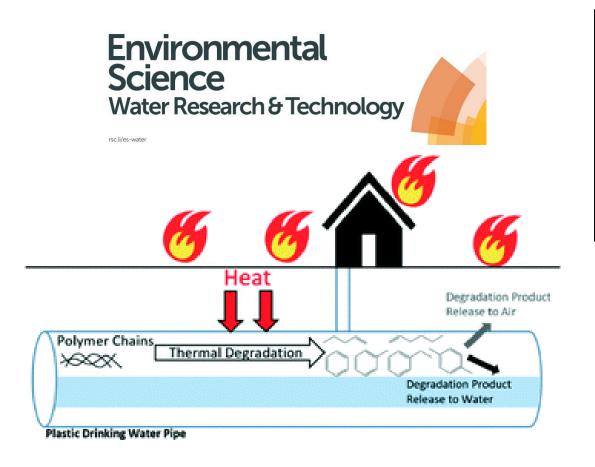
Drinking water contamination from the thermal degradation of plastics: implications for wildfire and structure fire response

Heating new HDPE, PEX, PVC, CPVC, and PP pipes < T<sub>deg</sub> generated VOCs and SVOCs

Benzene was generated by all pipes except PP

Once plastic cooled, chemicals leached into water

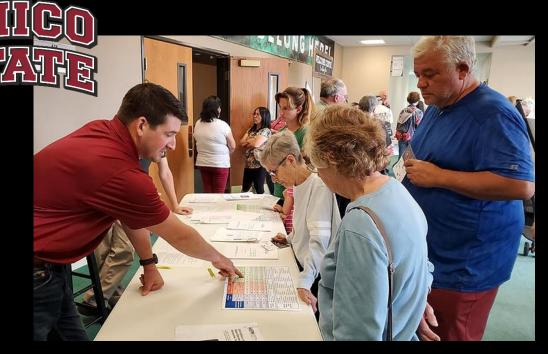
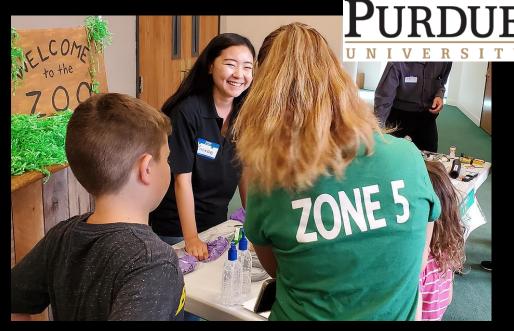
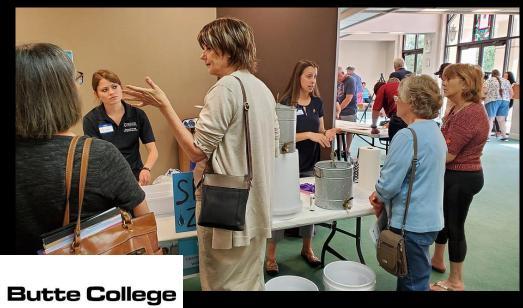
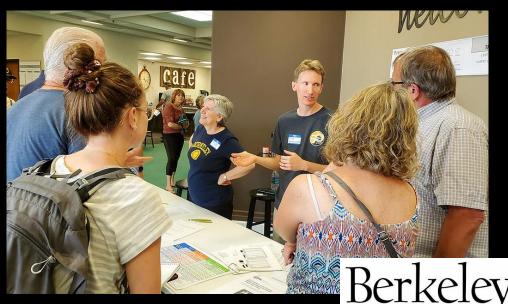
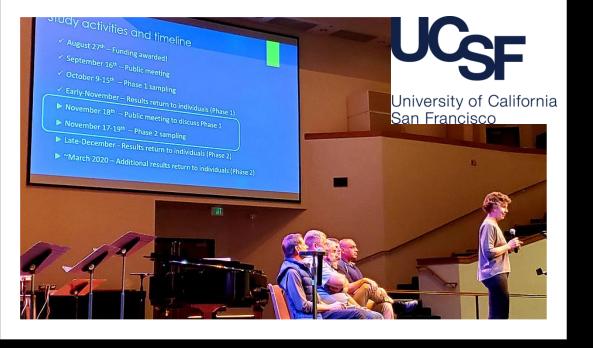
# In-home testing was conducted 11 months after the fire

125 homes: PID (101), Del Oro (24)
First draw, kitchen sink cold water only,
12+ hr stagnation.

2 homes: benzene found, and less than 1 ppb CA MCL (11 months later)

THF found above other state limits (no CA or federal limit)

Testing needs to occur as soon as possible. We recommended this 8 months earlier.

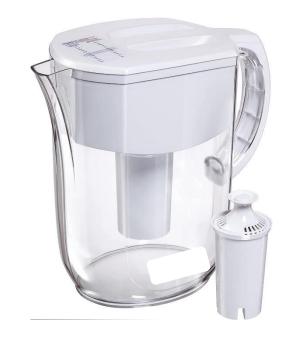
# Should in-home POU water filtration devices be used to treat wildfire contaminated drinking water?

Water Collected		Prelimina:	y Results, ppb	
and Analyze	Benzene	Toluene	<b>Ethyl Benzene</b>	Xylene
<b>Entering the filter</b>	713	911	87	212
<b>Exiting the filter</b>	_			
1 L	20	15	3	4
1.5 L	33	30	5	9
2 L	47	46	6	11
3 L	64	75	10	21
3.5 L	62	75	10	20
4 L	24	22	4	5
4.5 L	87	98	11	21
5 L	37	37	5	8

The devices are <u>NOT</u> designed for this.

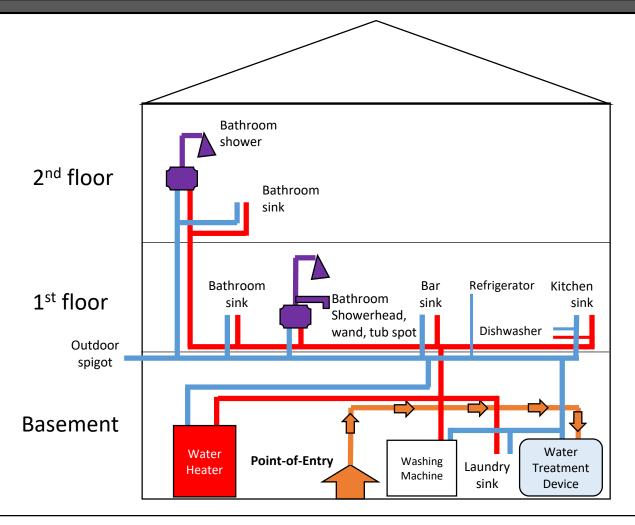
# Example single family home / trunk and branch design with a centralized water heater

Cold and hot water flow through separate pipes

Some locations are downstream from others, but branch off into separate pipes

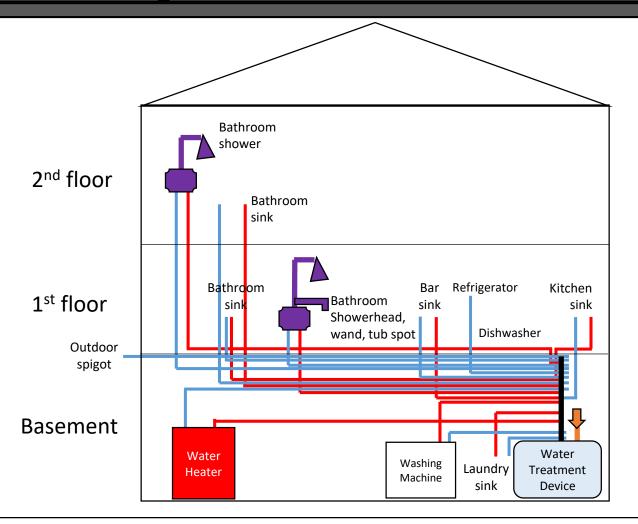
# Example single family home / PEX manifold plumbing design and centralized water heater

Cold and hot water flow through separate pipes
Each fixture has it's own isolated pipe
No two pipes convey the same water
Co-located shutoff location for all each fixture
Smaller diameter pipes compared to T/B design
